Re: Renaissance Condominiums – Seattle, WA

OAC Services, Inc. (OAC), per your request, has visited the above reference site to review the installation of the fluid applied flashing system incorporated into this project. We first visited the site on June 1, 2009 and provided a report of our findings dated July 24, 2009. We visited the site again on February 17, 2015 to review the current condition of the flashing system. During our recent visit we met with the Tatley-Grund, Inc. crew performing the investigation and based on our observations we offer the following information.

INVESTIGATION FINDINGS FROM:

Renaissance

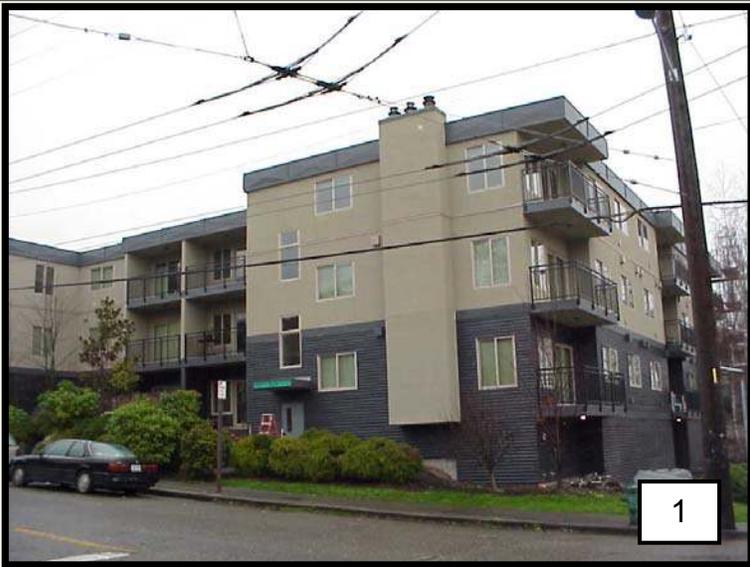
Tatley-Grund was contracted to perform a strip and reclad of the Renaissance Condominium Building in 2005. A wet flash system sponsored by BEI was used on the windows installations.

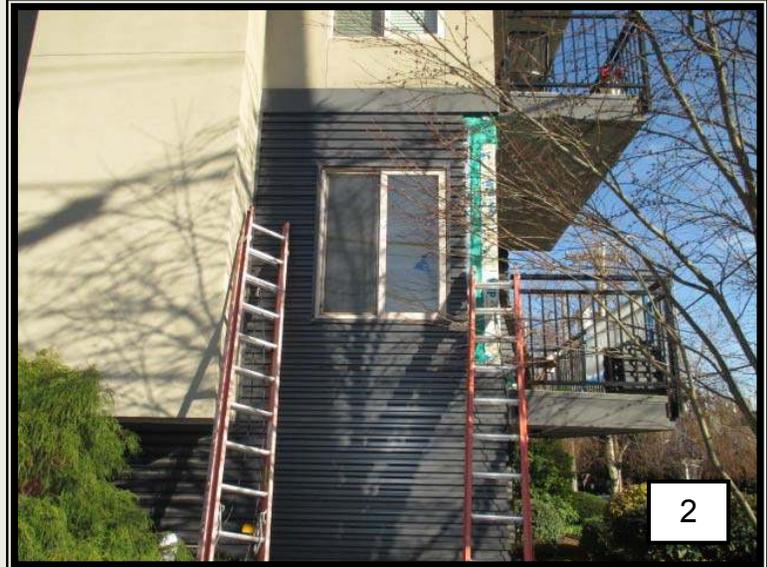
An inspection of the BEI Wet-Flash System after ten years of service was conducted by Tatley-Grund on February 17, 2015.

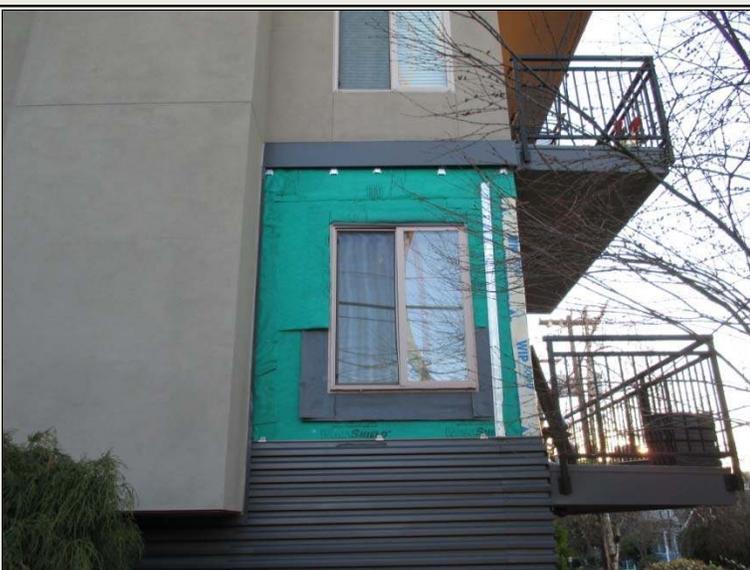
The surrounding metal cladding was removed to expose the window. The BEI Wet-Flash System was also inspected at the five year mark, and found to be performing as intended.

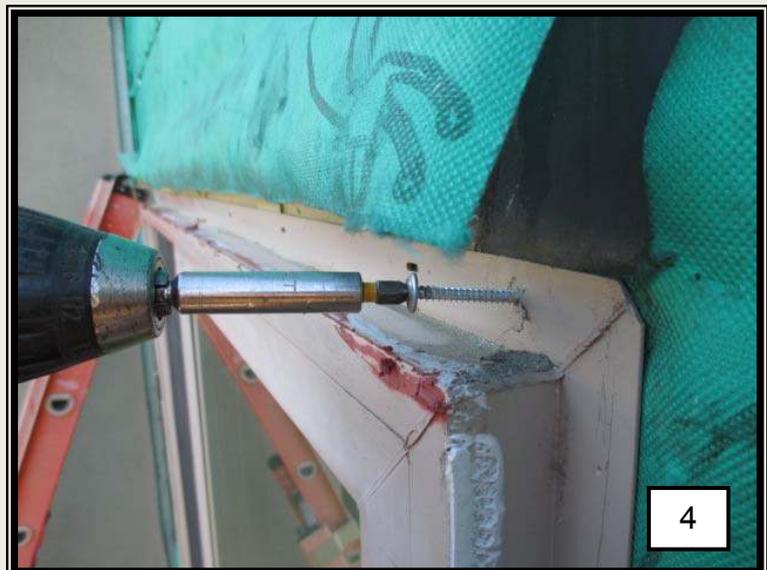
Mechanical fasteners that secure the window were found to be corrosion free upon removal. The Vapro-Shield Weather Resistant Barrier was observed in good condition.

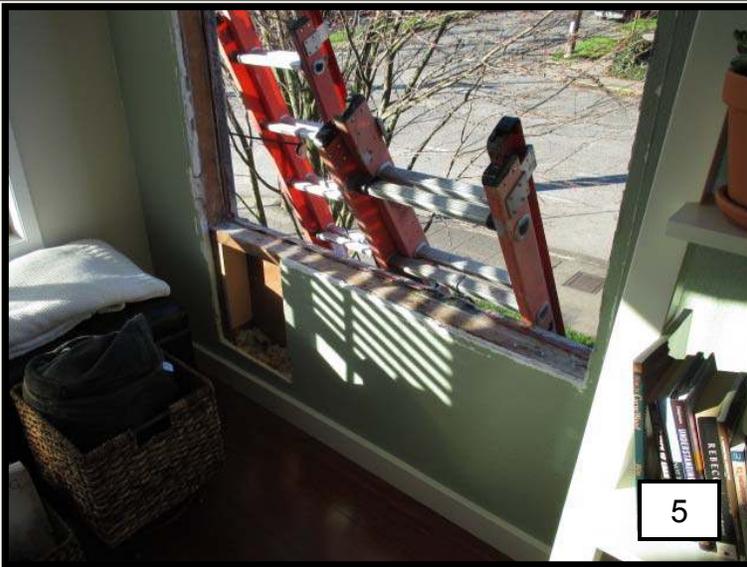
A cutout in the wallboard was made to observe the conditions in the wall cavity below the windows rough opening.

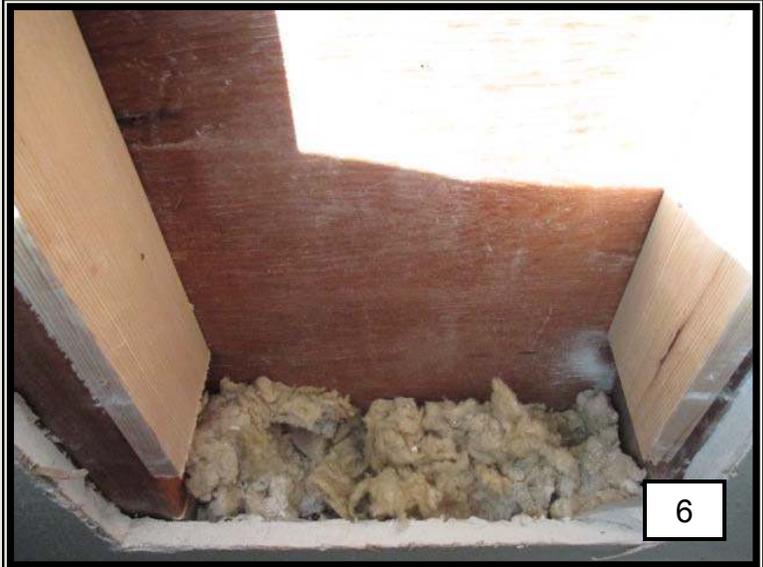
No staining was observed on the inboard side of the sheathing or the framing members and the insulation was noted clean and dry.

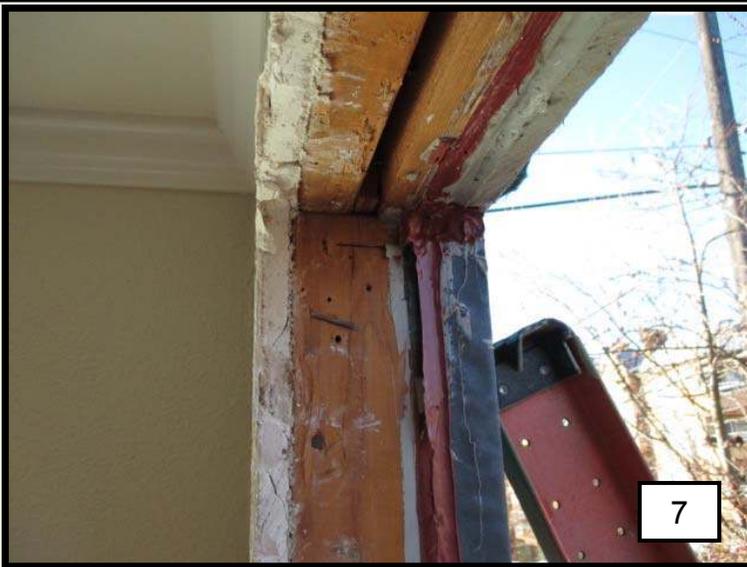
The BEI Wet-Flash is maintaining excellent adhesion to the wood substrate at the head and jambs of the rough opening.

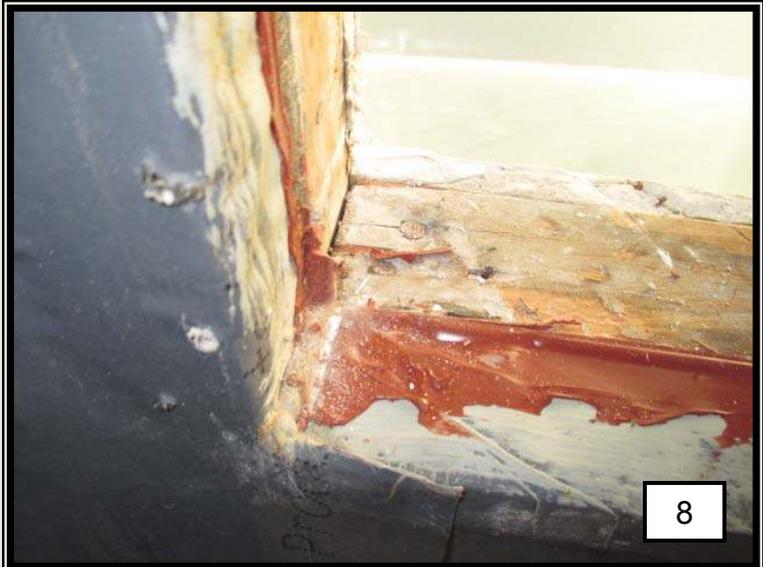
The Sure-Flash at the sill of the window is fully embedded into the Wet-Flash liquid applied membrane. No signs of water intrusion were visible at the framing of the rough opening.

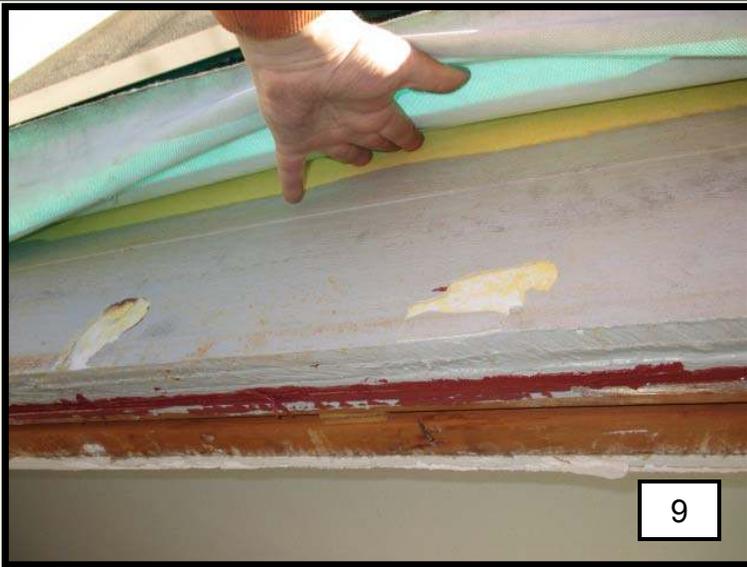
The Wet-Flash membrane is applied 9 inches above, and two inches into the rough opening of the Dens-Glass sheathing. No staining was observed on the exterior sheathing above the window opening.

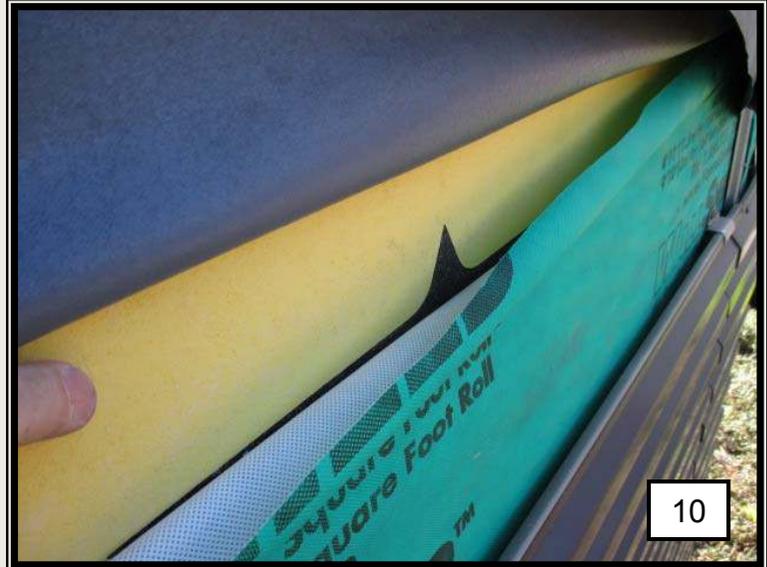
10

The Dens-glass exterior sheathing below the Sure-flash at the sill of the opening was noted to be in as new condition. No deterioration or staining was observed on the face of the Dens-Glass.

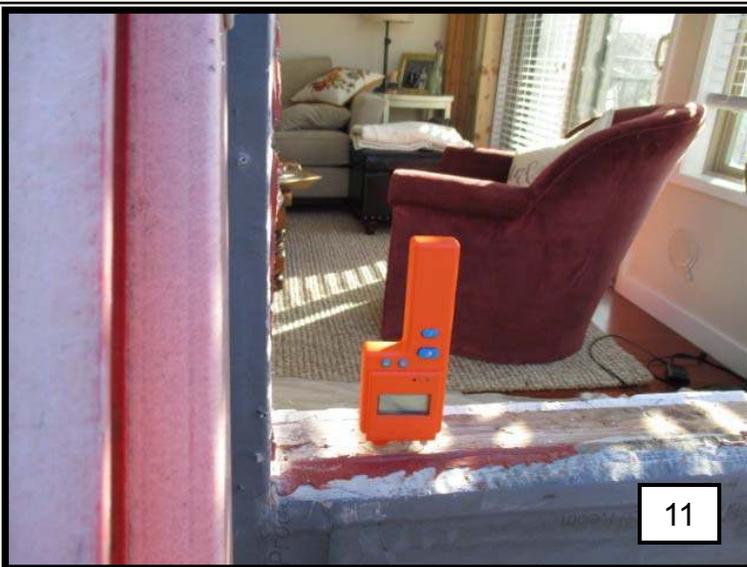
11

Moisture Meter Readings (MMR's) were gathered from the framing members after the windows removal. All readings were recorded in the normal range.

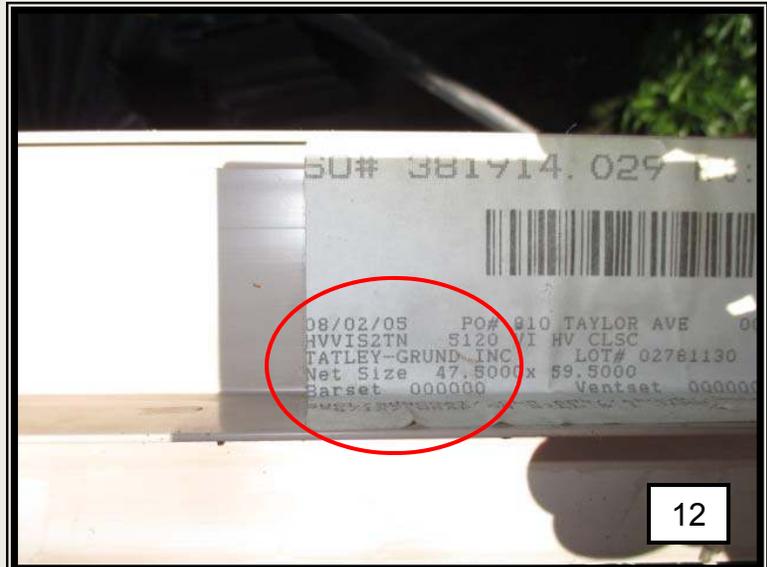
12

The tag on the jamb of the Milgard window is still legible, showing the born on date, of August 2nd, 2005. All components of the installation are performing as designed.
