*Pallet Tag Program  
Laboratory Report*

**Petersen Tegl**  
Broager, Denmark

*Project No. 1905-05 PTP*

**SUBJECT:** Petersen Tegl  
Broager, Denmark  
New Construction Cleaning and Adverse Effects Evaluation

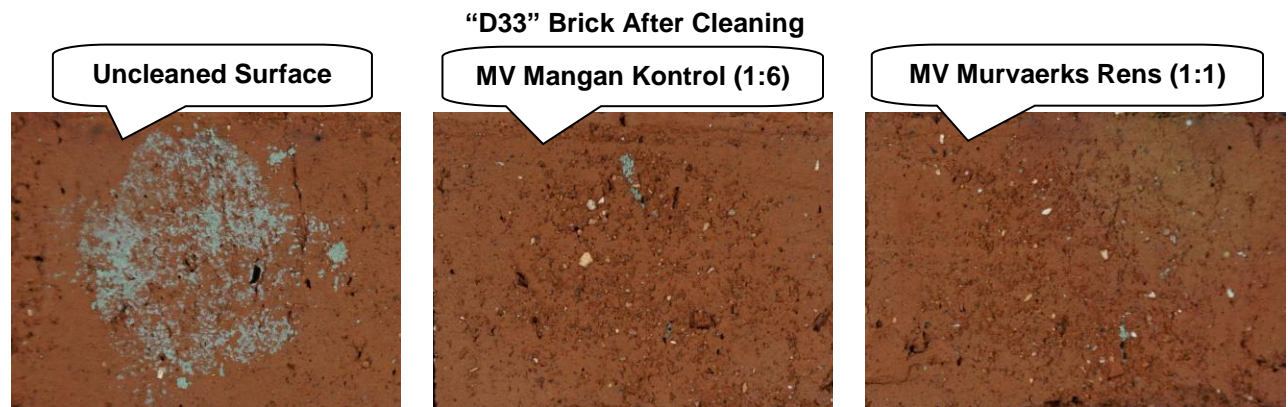
Name: "D33" Brick					
Product	Dilution	Surface Finish Removal	Substrate Deterioration	Color Change	Staining
MV Mangan Kontrol	1:6	0	1	0	0
MV Murvaerks Rens	1:1	0	1	0	0

In the cleaning tests conducted, neither MV Mangan Kontrol nor MV Murvaerks Rens caused any change to the appearance of the submitted samples, with the exception of the “D33” and “D39B” bricks. While neither cleaner altered the color of the bricks, both cleaners resulted in a very slight to slight substrate deterioration.

It is recommended that the selected cleaners always be used in the lowest possible concentration.

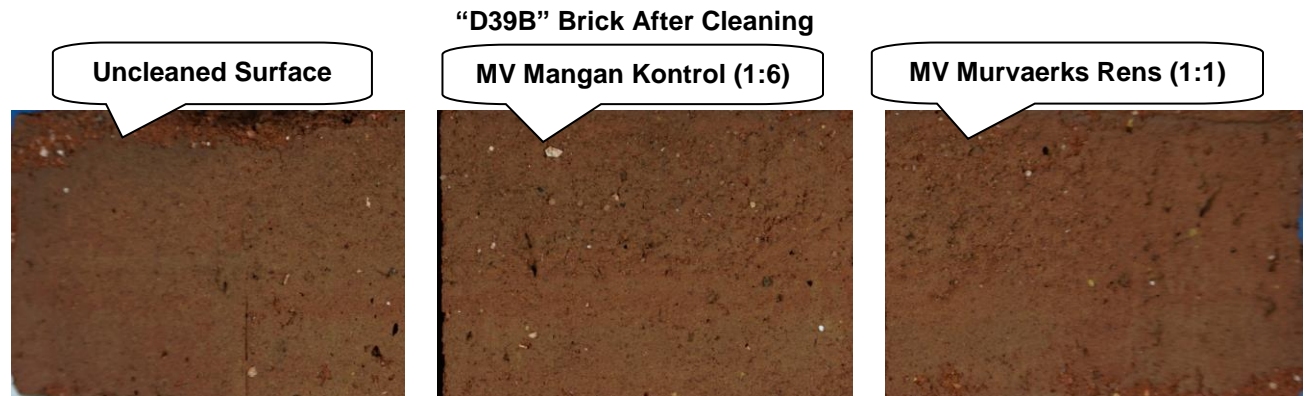
Name: "D39B" Brick					
Product	Dilution	Surface Finish Removal	Substrate Deterioration	Color Change	Staining
MV Mangan Kontrol	1:6	0	1*	0	0
MV Murvaerks Rens	1:1	0	1*	0	0

**\*NOTE: Very slight change compared to uncleaned surface.**

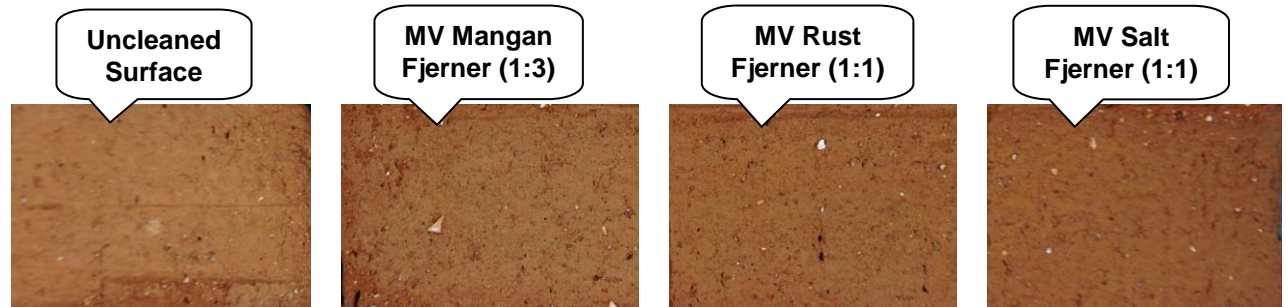
Name: "D33" Brick					
Product	Dilution	Surface Finish Removal	Substrate Deterioration	Color Change	Staining
MV Mangan Fjerner	1:3	0	1	0	0
MV Rust Fjerner	1:1	0	1	0	0
MV Salt Fjerner	1:1	0	1	0	0

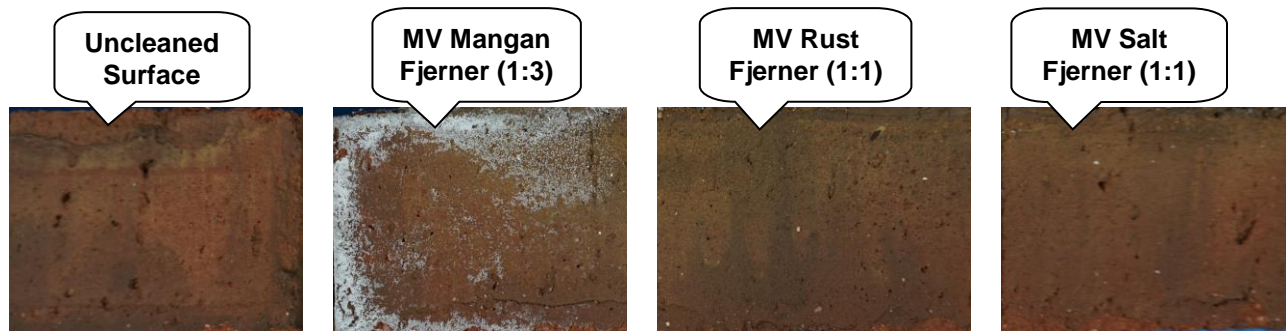
Name: "D36" Brick					
Product	Dilution	Surface Finish Removal	Substrate Deterioration	Color Change	Staining
MV Mangan Fjerner	1:3	0	0	0	2
MV Rust Fjerner	1:1	0	0	0	0
MV Salt Fjerner	1:1	0	0	0	0

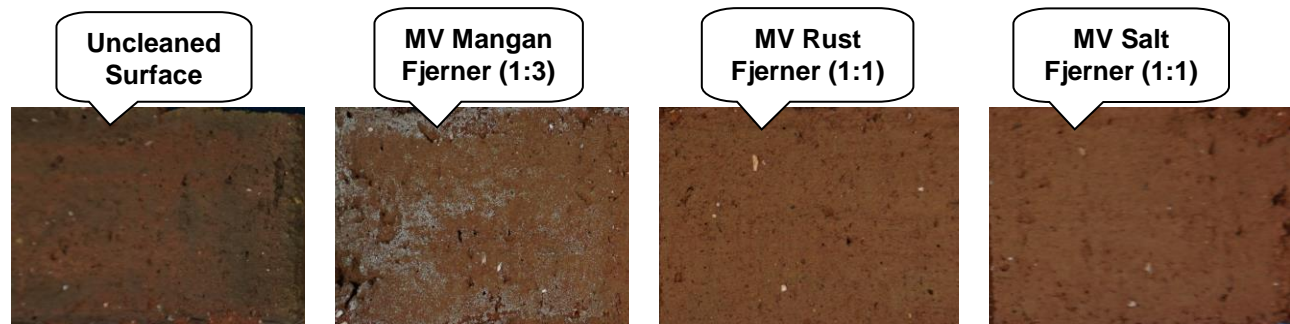
Name: "D39A" Brick					
Product	Dilution	Surface Finish Removal	Substrate Deterioration	Color Change	Staining
MV Mangan Fjerner	1:3	0	0	0	2
MV Rust Fjerner	1:1	0	0	0	0
MV Salt Fjerner	1:1	0	0	0	0

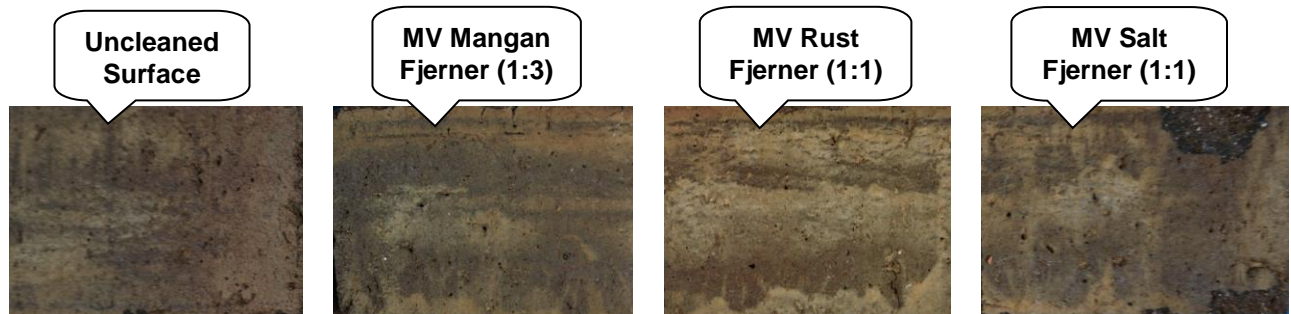
Name: "D46" Brick					
Product	Dilution	Surface Finish Removal	Substrate Deterioration	Color Change	Staining
MV Mangan Fjerner	1:3	0	0	0	0
MV Rust Fjerner	1:1	0	0	0	0
MV Salt Fjerner	1:1	0	0	0	0

**NOTE: The "D46" Brick as submitted displayed significant color variation prior to testing.**

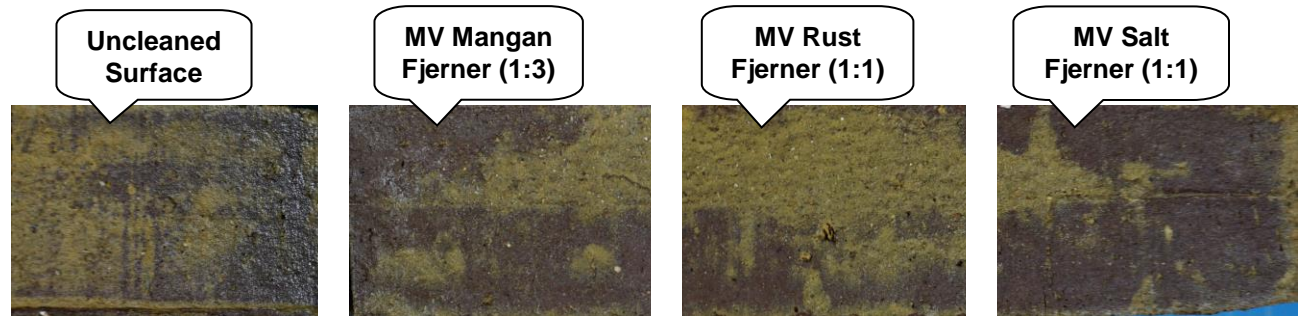
Name: "D47" Brick					
Product	Dilution	Surface Finish Removal	Substrate Deterioration	Color Change	Staining
MV Mangan Fjerner	1:3	0	0	0	1
MV Rust Fjerner	1:1	0	0	0	0
MV Salt Fjerner	1:1	0	0	0	0

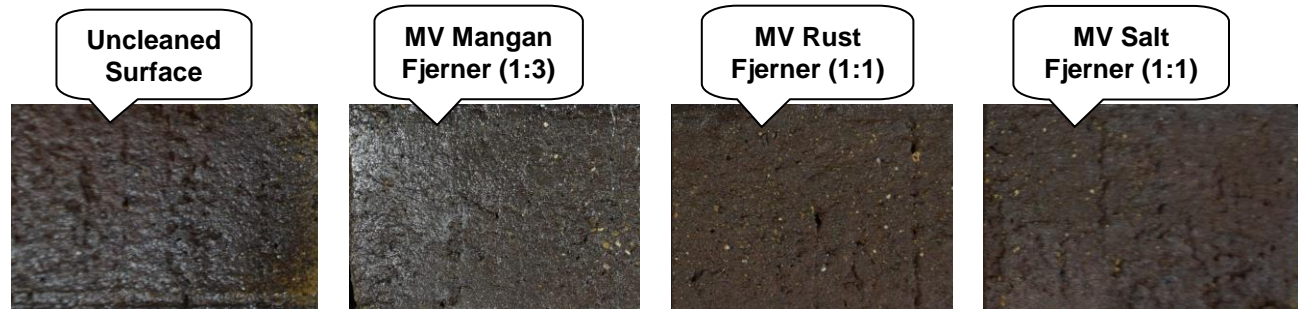
Name: "D48" Brick					
Product	Dilution	Surface Finish Removal	Substrate Deterioration	Color Change	Staining
MV Mangan Fjerner	1:3	0	0	0	1
MV Rust Fjerner	1:1	0	0	0	0
MV Salt Fjerner	1:1	0	0	0	0

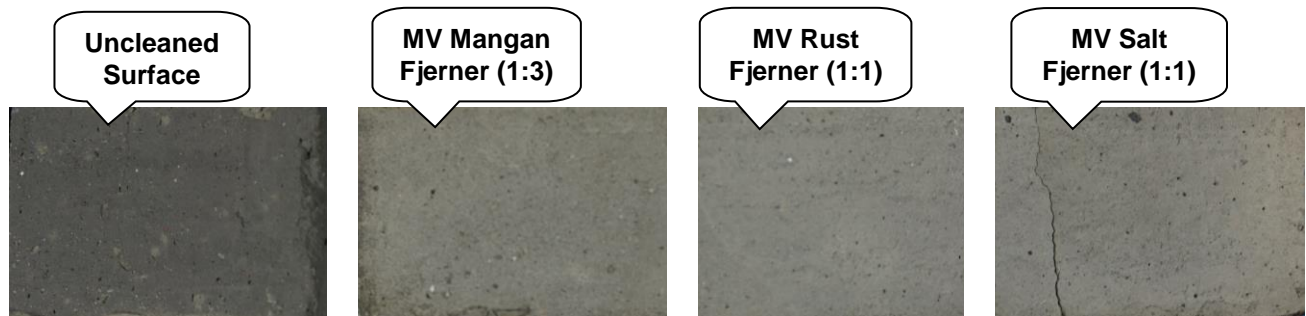
Name: "D51" Brick					
Product	Dilution	Surface Finish Removal	Substrate Deterioration	Color Change	Staining
MV Mangan Fjerner	1:3	0	0	0	0
MV Rust Fjerner	1:1	0	0	0	0
MV Salt Fjerner	1:1	0	0	0	0

**NOTE: The "D51" Brick as submitted displayed significant color variation prior to testing.**

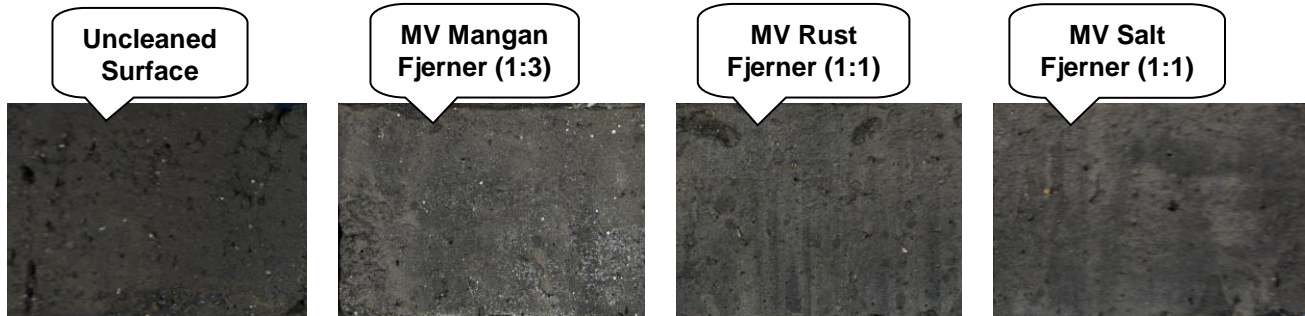
Name: "D99" Brick					
Product	Dilution	Surface Finish Removal	Substrate Deterioration	Color Change	Staining
MV Mangan Fjerner	1:3	0	0	0	1
MV Rust Fjerner	1:1	0	0	0	0
MV Salt Fjerner	1:1	0	0	0	0
