Pallet Tag Program Laboratory Report

Wienerberger Denmark Helsinge, Denmark

Project No. 1905-05 PTP

New Construction Cleaning and Adverse Effects Evaluation

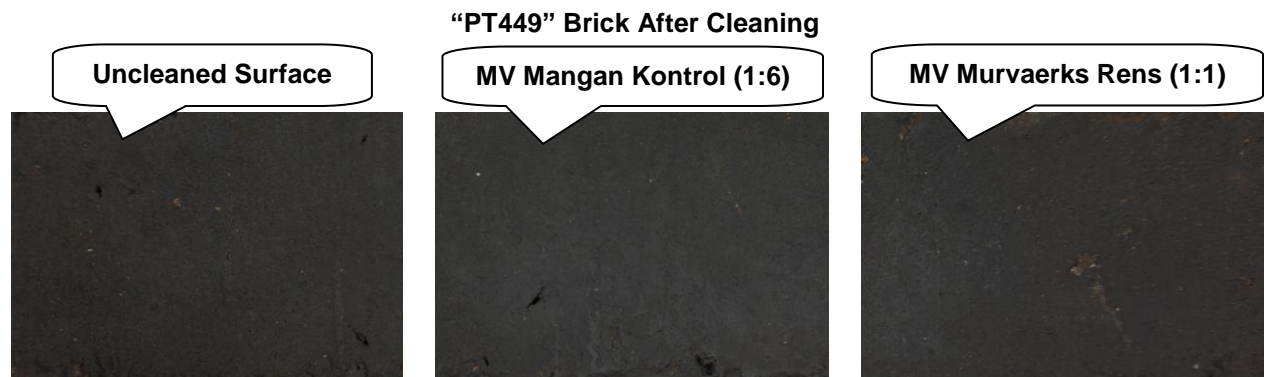
Name: "PT449" Brick					
Product	Dilution	Surface Finish Removal	Substrate Deterioration	Color Change	Staining
MV Mangan Kontrol	1:6	0	0	0	0
MV Murvaerks Rens	1:1	0	0	0	0

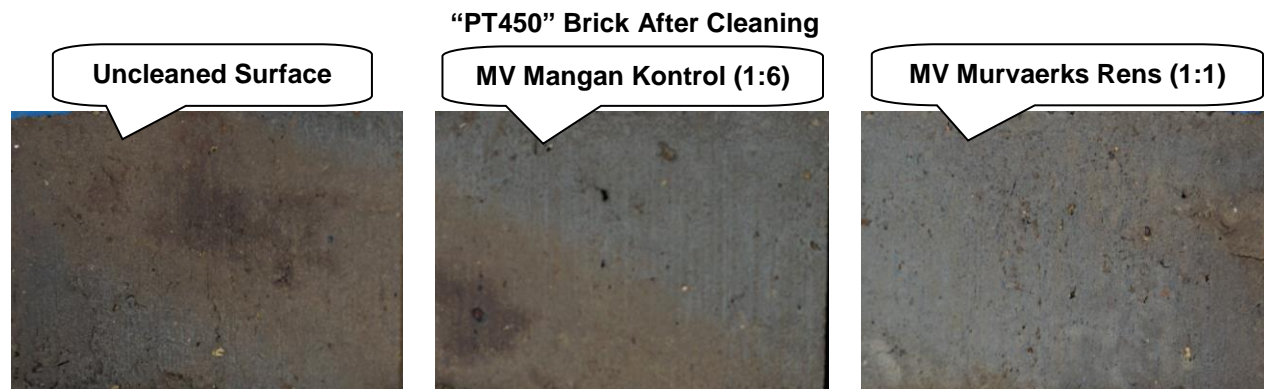
Name: "PT450" Brick					
Product	Dilution	Surface Finish Removal	Substrate Deterioration	Color Change	Staining
MV Mangan Kontrol	1:6	0	0	0	0
MV Murvaerks Rens	1:1	0	0	0	0

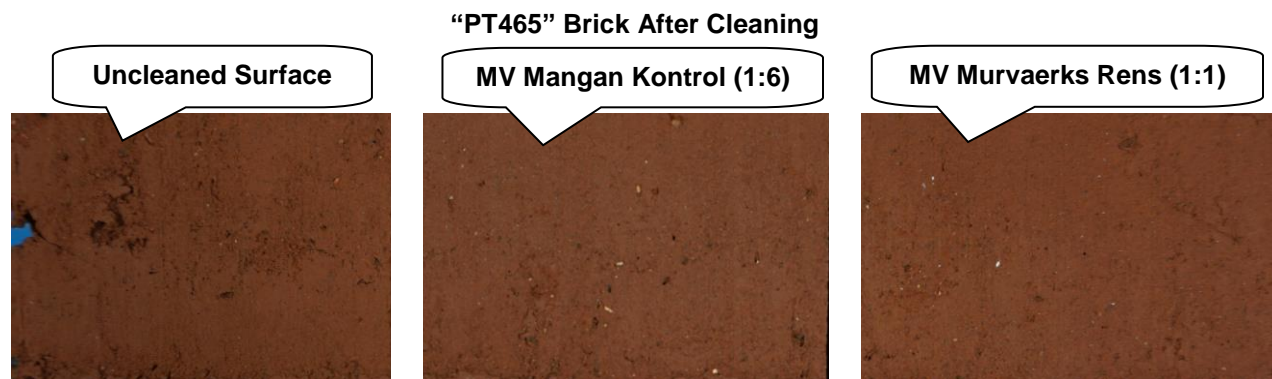
Name: "PT465" Brick					
Product	Dilution	Surface Finish Removal	Substrate Deterioration	Color Change	Staining
MV Mangan Kontrol	1:6	0	0	0	0
MV Murvaerks Rens	1:1	0	0	0	0

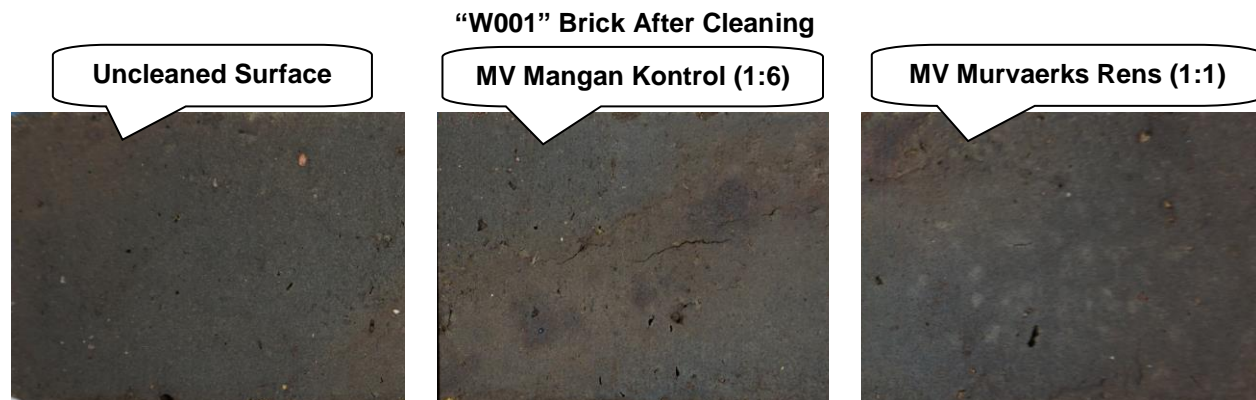
Name: "W001" Brick					
Product	Dilution	Surface Finish Removal	Substrate Deterioration	Color Change	Staining
MV Mangan Kontrol	1:6	0	0	0	0
MV Murvaerks Rens	1:1	0	0	0	0

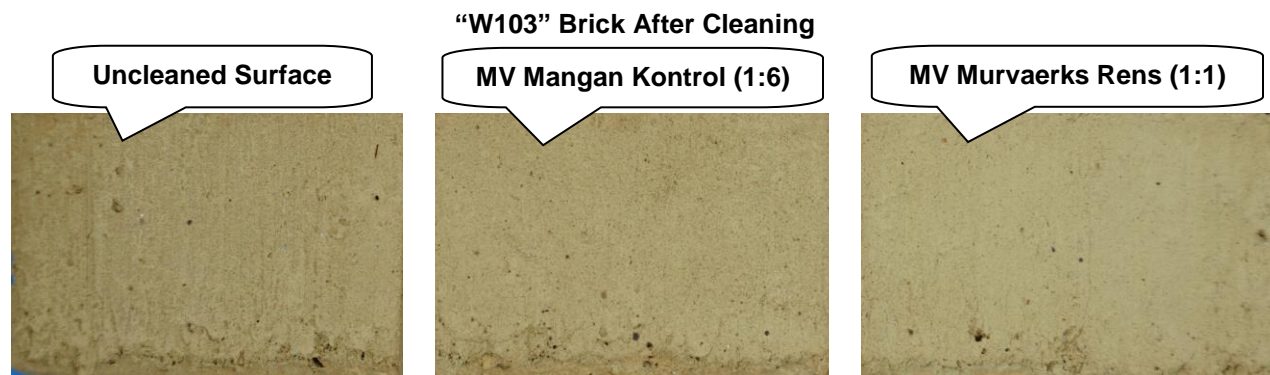
Name: "W103" Brick					
Product	Dilution	Surface Finish Removal	Substrate Deterioration	Color Change	Staining
MV Mangan Kontrol	1:6	0	0	0	0
MV Murvaerks Rens	1:1	0	0	0	0

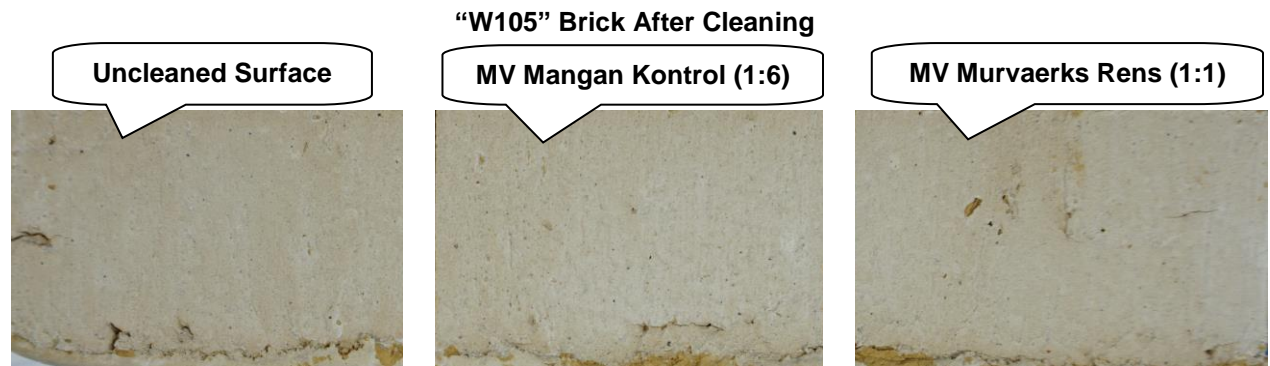
Name: "W105" Brick					
Product	Dilution	Surface Finish Removal	Substrate Deterioration	Color Change	Staining
MV Mangan Kontrol	1:6	0	0	0	0
MV Murvaerks Rens	1:1	0	0	0	0

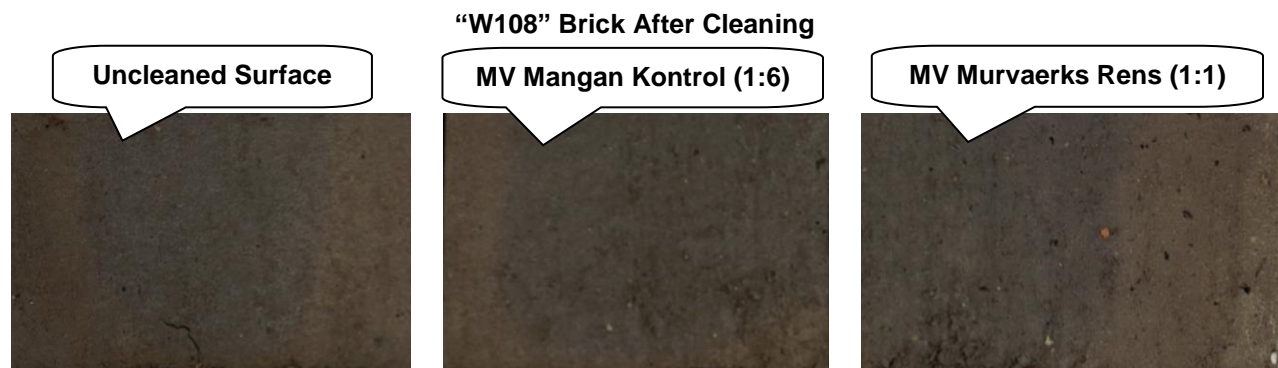
Name: "W108" Brick					
Product	Dilution	Surface Finish Removal	Substrate Deterioration	Color Change	Staining
MV Mangan Kontrol	1:6	0	0	0	0
MV Murvaerks Rens	1:1	0	0	0	0

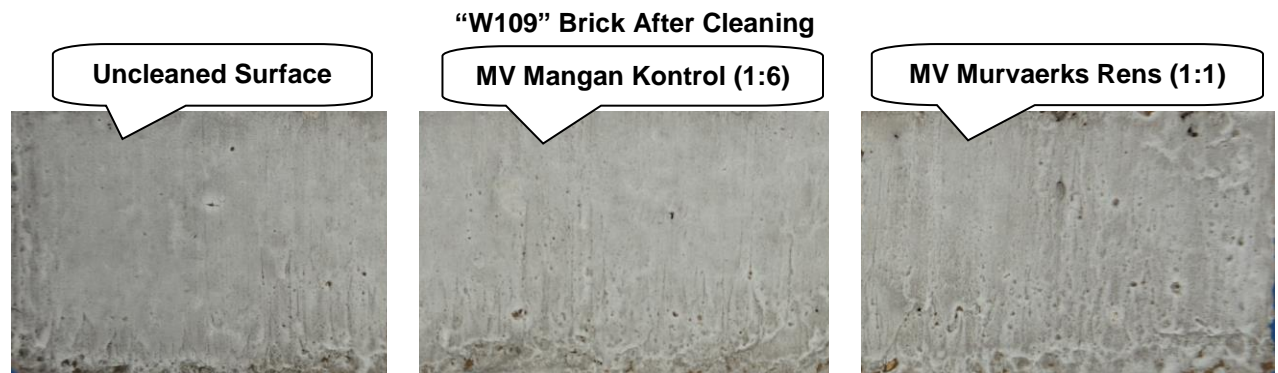
Name: "W109" Brick					
Product	Dilution	Surface Finish Removal	Substrate Deterioration	Color Change	Staining
MV Mangan Kontrol	1:6	0	0	0	0
MV Murvaerks Rens	1:1	0	0	0	0

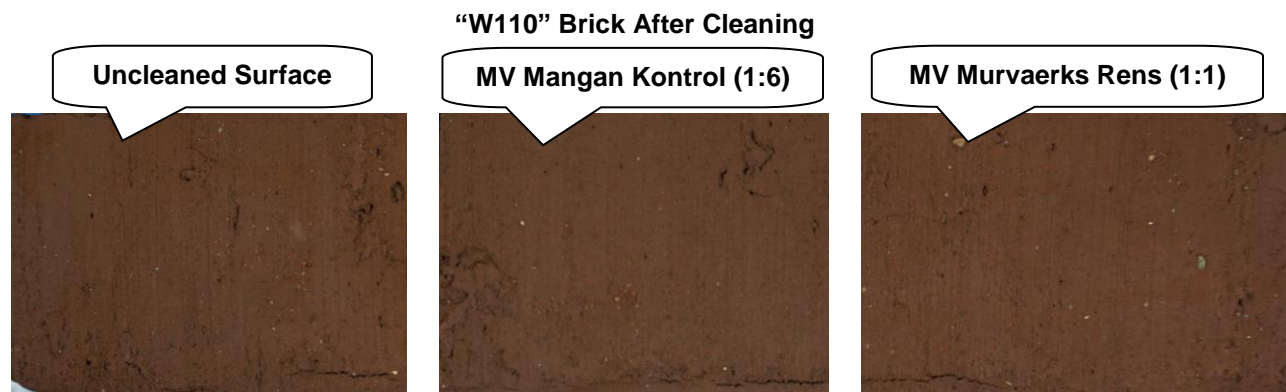
Name: "W110" Brick					
Product	Dilution	Surface Finish Removal	Substrate Deterioration	Color Change	Staining
MV Mangan Kontrol	1:6	0	0	0	0
MV Murvaerks Rens	1:1	0	0	0	0

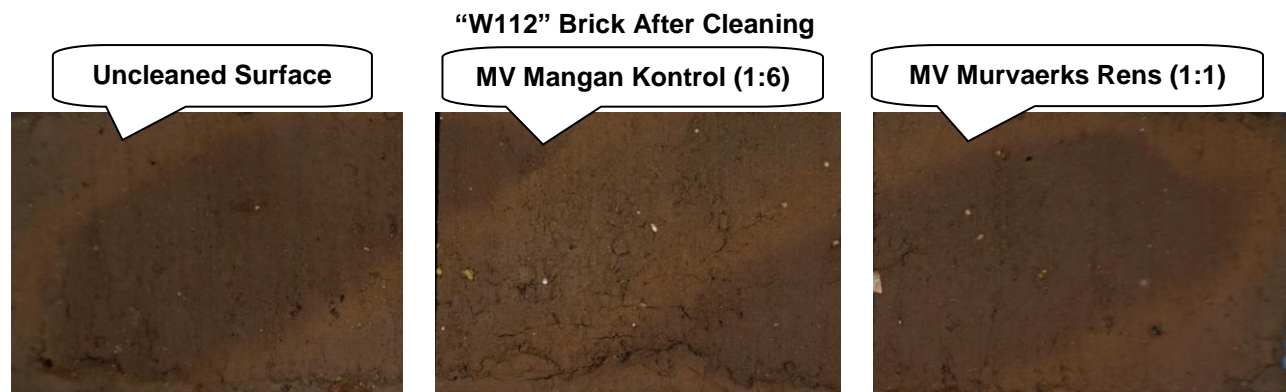
Name: "W112" Brick					
Product	Dilution	Surface Finish Removal	Substrate Deterioration	Color Change	Staining
MV Mangan Kontrol	1:6	0	0	0	0
MV Murvaerks Rens	1:1	0	0	0	0

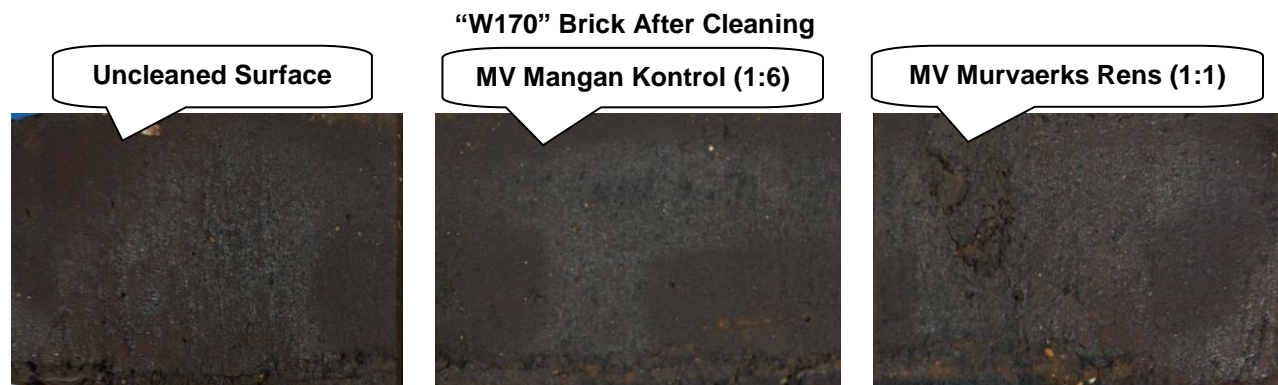
Name: "W170" Brick					
Product	Dilution	Surface Finish Removal	Substrate Deterioration	Color Change	Staining
MV Mangan Kontrol	1:6	0	0	0	0
MV Murvaerks Rens	1:1	0	0	0	0

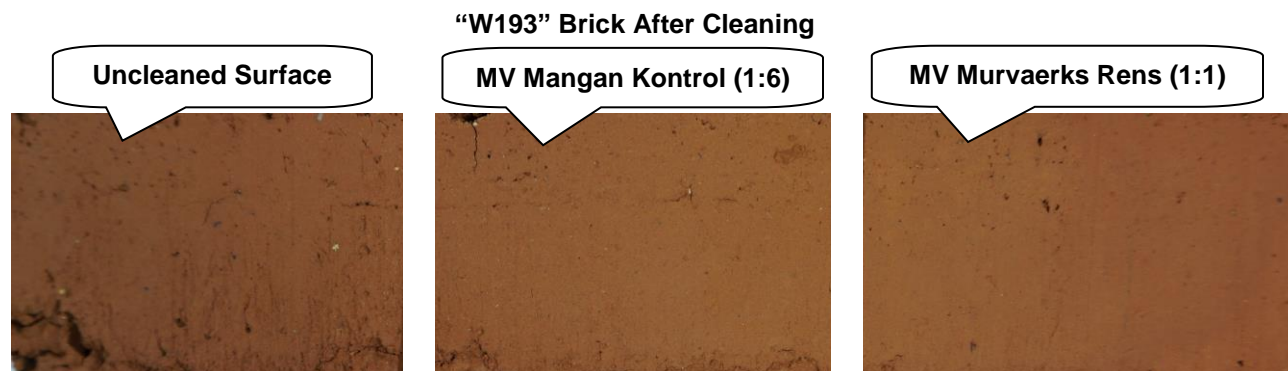
Name: "W193" Brick					
Product	Dilution	Surface Finish Removal	Substrate Deterioration	Color Change	Staining
MV Mangan Kontrol	1:6	0	0	0	0
MV Murvaerks Rens	1:1	0	0	0	0

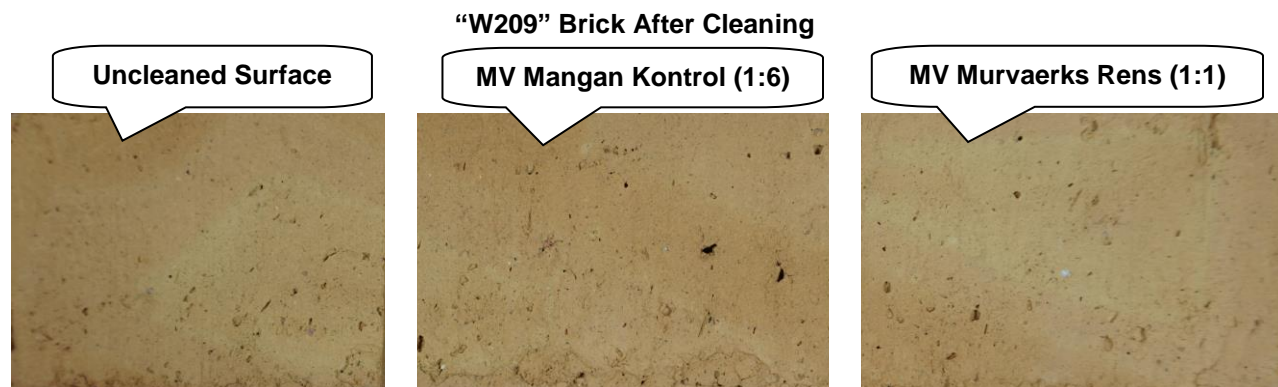
Name: "W209" Brick					
Product	Dilution	Surface Finish Removal	Substrate Deterioration	Color Change	Staining
MV Mangan Kontrol	1:6	0	0	0	0
MV Murvaerks Rens	1:1	0	0	0	0

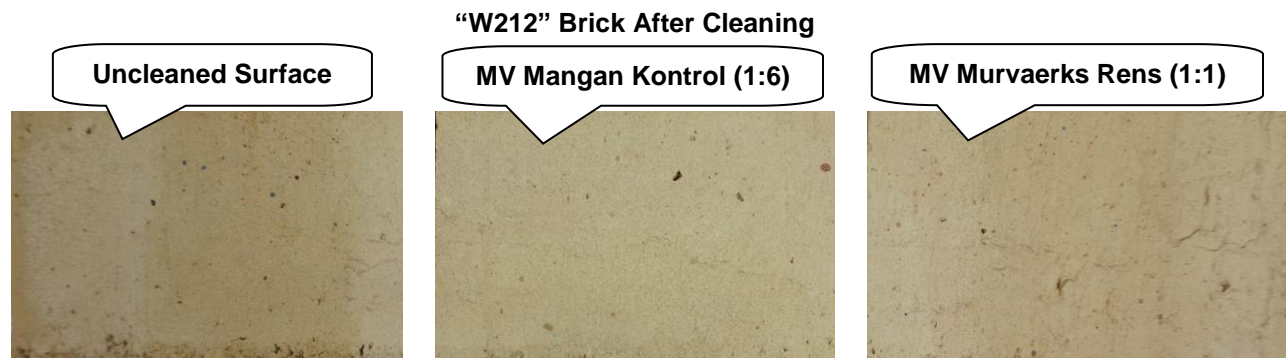
Name: "W212" Brick					
Product	Dilution	Surface Finish Removal	Substrate Deterioration	Color Change	Staining
MV Mangan Kontrol	1:6	0	0	0	0
MV Murvaerks Rens	1:1	0	0	0	0

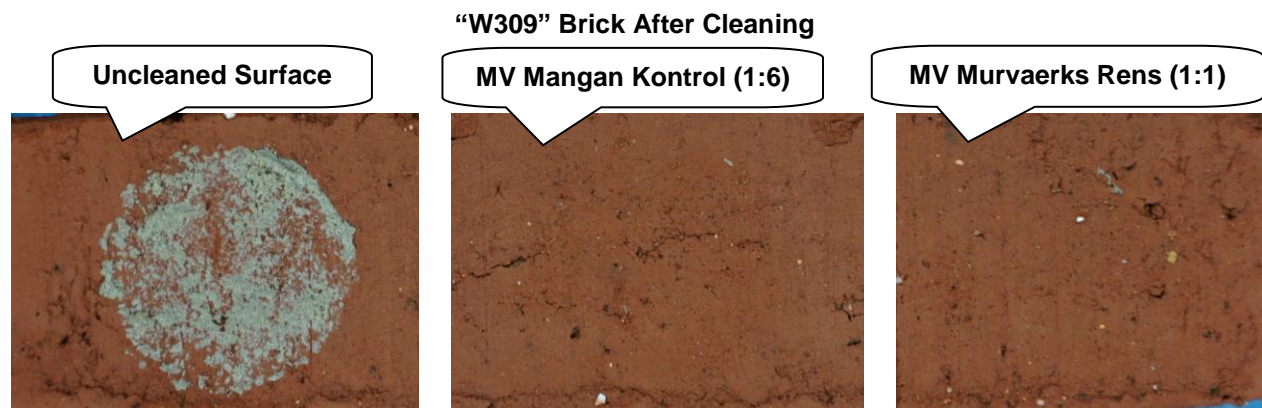
Name: "W309" Brick					
Product	Dilution	Surface Finish Removal	Substrate Deterioration	Color Change	Staining
MV Mangan Kontrol	1:6	0	0	0	0
MV Murvaerks Rens	1:1	0	0	0	0

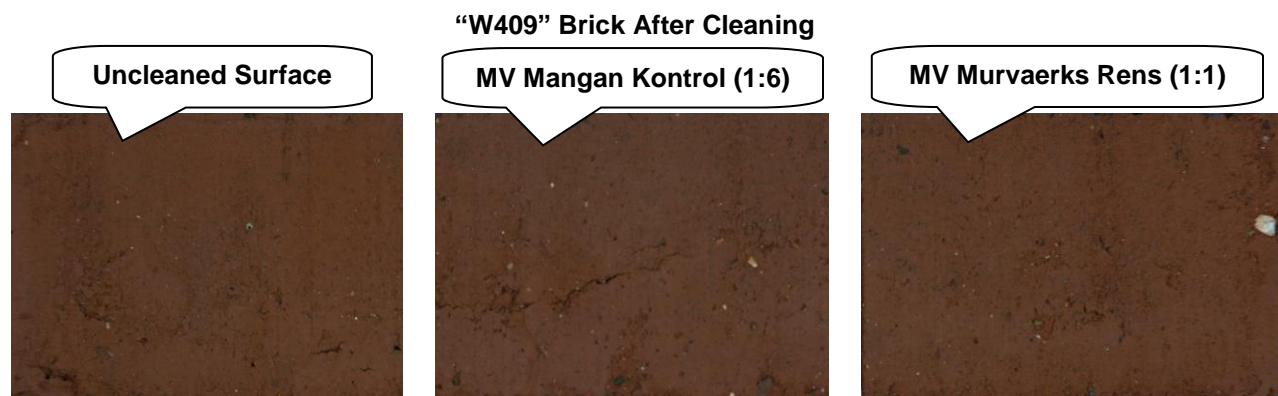
Name: "W409" Brick					
Product	Dilution	Surface Finish Removal	Substrate Deterioration	Color Change	Staining
MV Mangan Kontrol	1:6	0	0	0	0
MV Murvaerks Rens	1:1	0	0	0	0

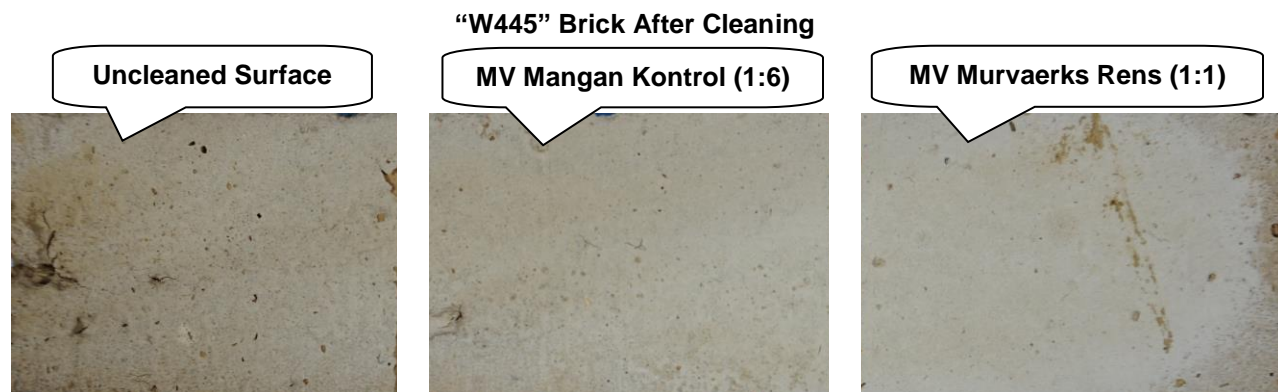
Name: "W445" Brick					
Product	Dilution	Surface Finish Removal	Substrate Deterioration	Color Change	Staining
MV Mangan Kontrol	1:6	0	0	0	0
MV Murvaerks Rens	1:1	0	0	0	0

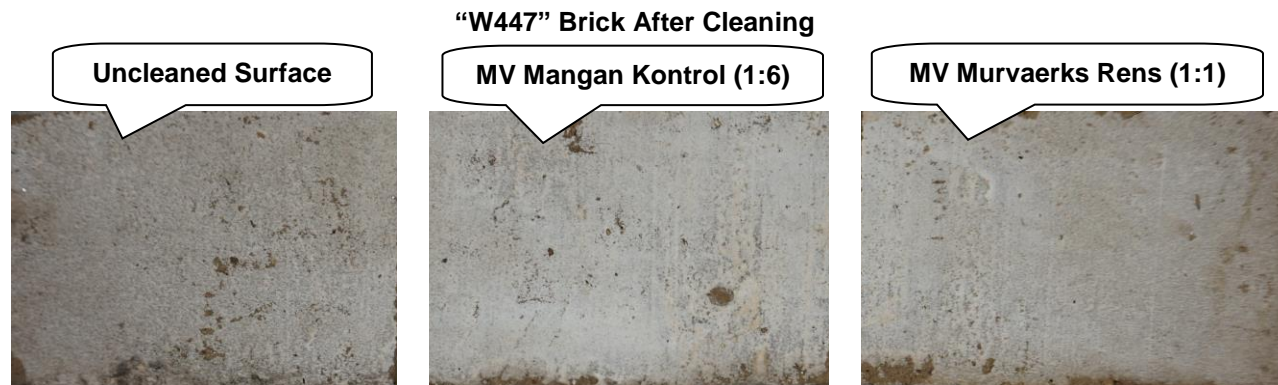
Name: "W447" Brick					
Product	Dilution	Surface Finish Removal	Substrate Deterioration	Color Change	Staining
MV Mangan Kontrol	1:6	0	0	0	0
MV Murvaerks Rens	1:1	0	0	0	0

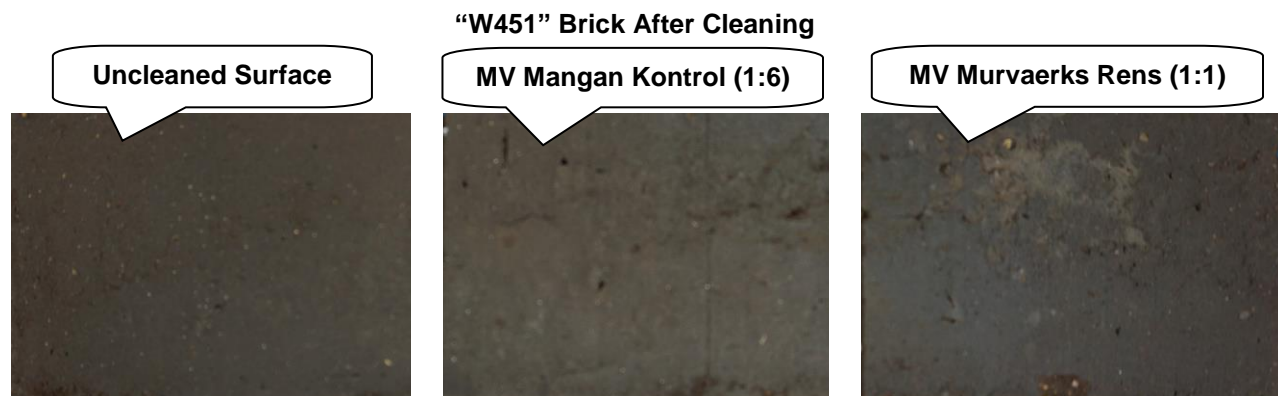
Name: "W451" Brick					
Product	Dilution	Surface Finish Removal	Substrate Deterioration	Color Change	Staining
MV Mangan Kontrol	1:6	0	0	0	0
MV Murvaerks Rens	1:1	0	0	0	0

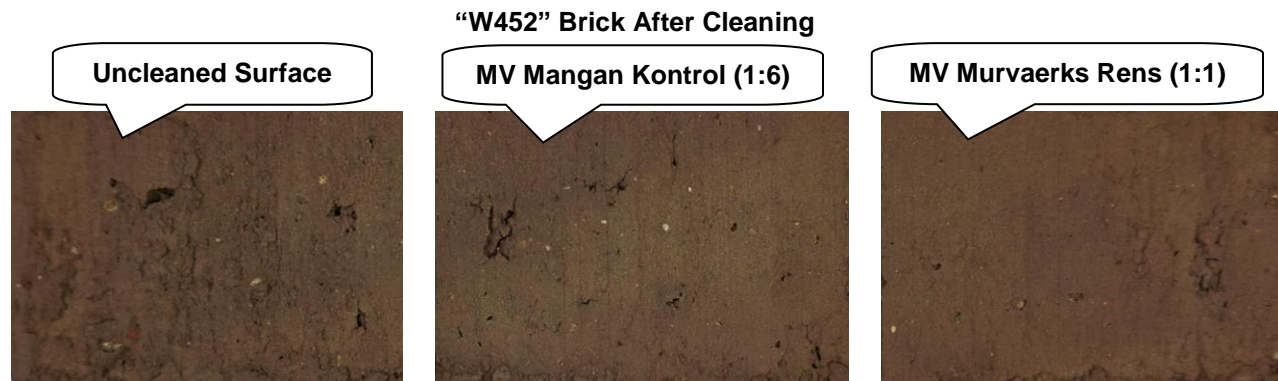
Name: "W452" Brick					
Product	Dilution	Surface Finish Removal	Substrate Deterioration	Color Change	Staining
MV Mangan Kontrol	1:6	0	0	0	0
MV Murvaerks Rens	1:1	0	0	0	0

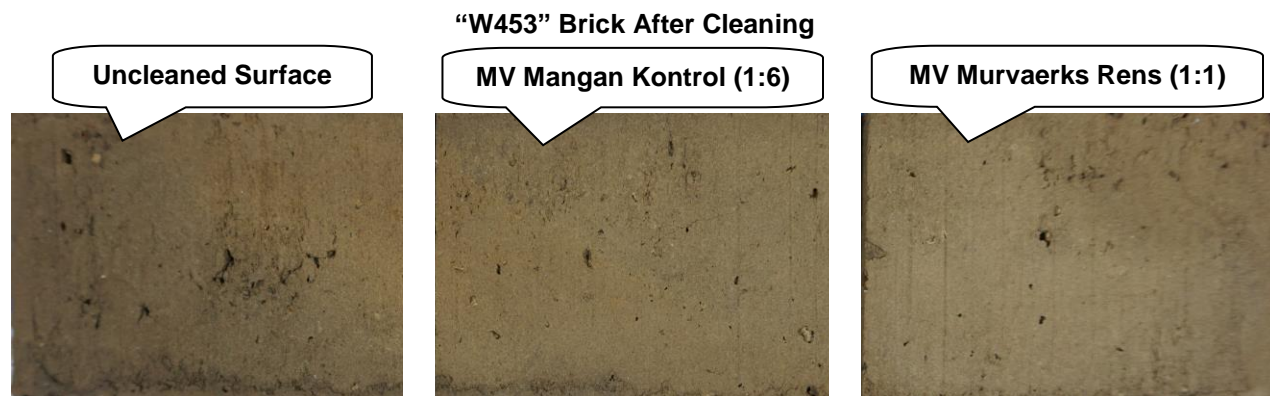
Name: "W453" Brick					
Product	Dilution	Surface Finish Removal	Substrate Deterioration	Color Change	Staining
MV Mangan Kontrol	1:6	0	0	0	0
MV Murvaerks Rens	1:1	0	0	0	0

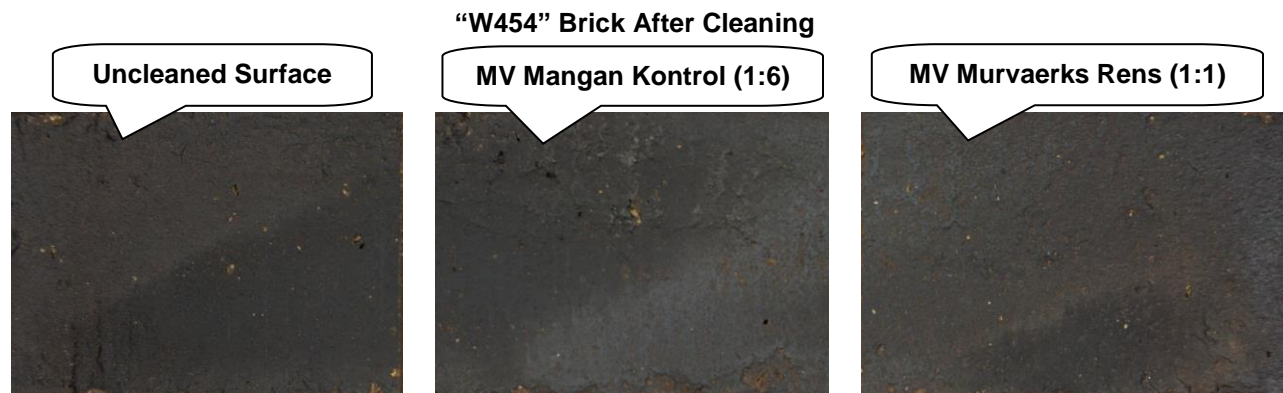
Name: "W454" Brick					
Product	Dilution	Surface Finish Removal	Substrate Deterioration	Color Change	Staining
MV Mangan Kontrol	1:6	0	0	0	0
MV Murvaerks Rens	1:1	0	0	0	0

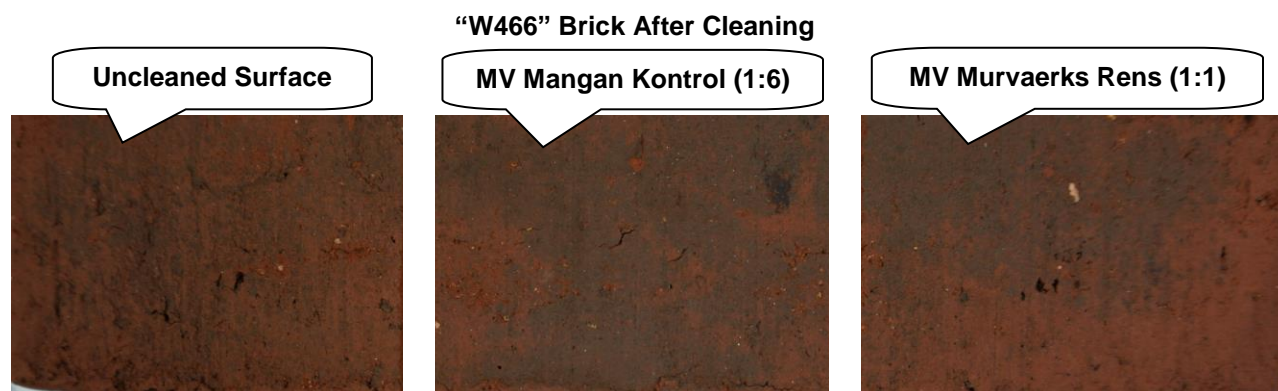
Name: "W466" Brick					
Product	Dilution	Surface Finish Removal	Substrate Deterioration	Color Change	Staining
MV Mangan Kontrol	1:6	0	0	0	0
MV Murvaerks Rens	1:1	0	0	0	0

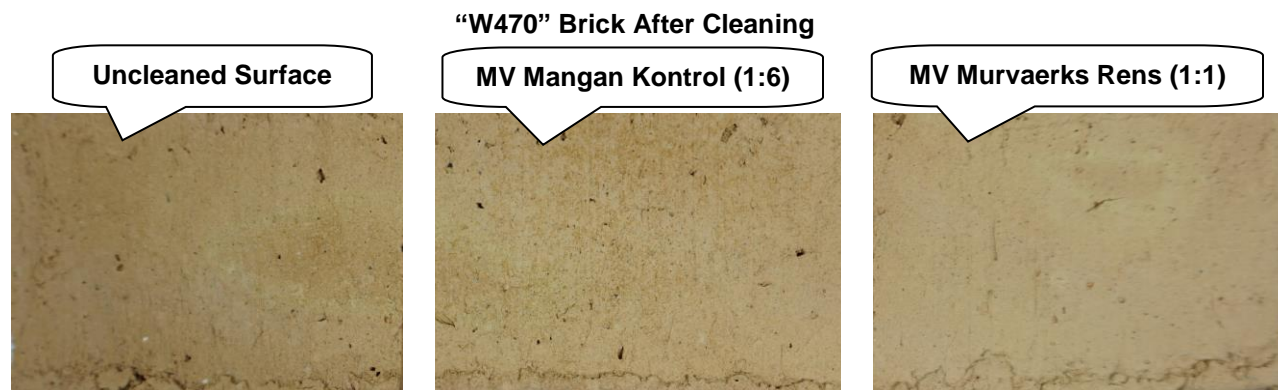
Name: "W470" Brick					
Product	Dilution	Surface Finish Removal	Substrate Deterioration	Color Change	Staining
MV Mangan Kontrol	1:6	0	0	0	0
MV Murvaerks Rens	1:1	0	0	0	0

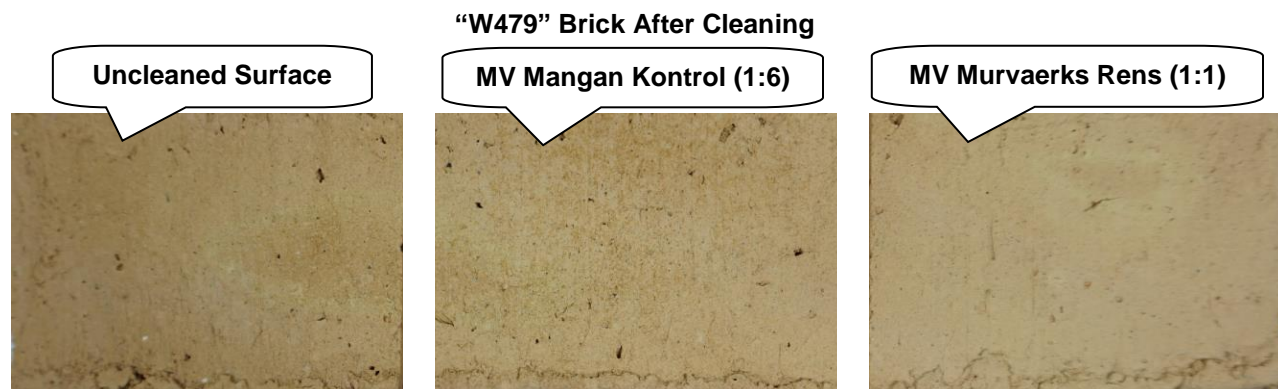
Name: "W479" Brick					
Product	Dilution	Surface Finish Removal	Substrate Deterioration	Color Change	Staining
MV Mangan Kontrol	1:6	0	0	0	0
MV Murvaerks Rens	1:1	0	0	0	0

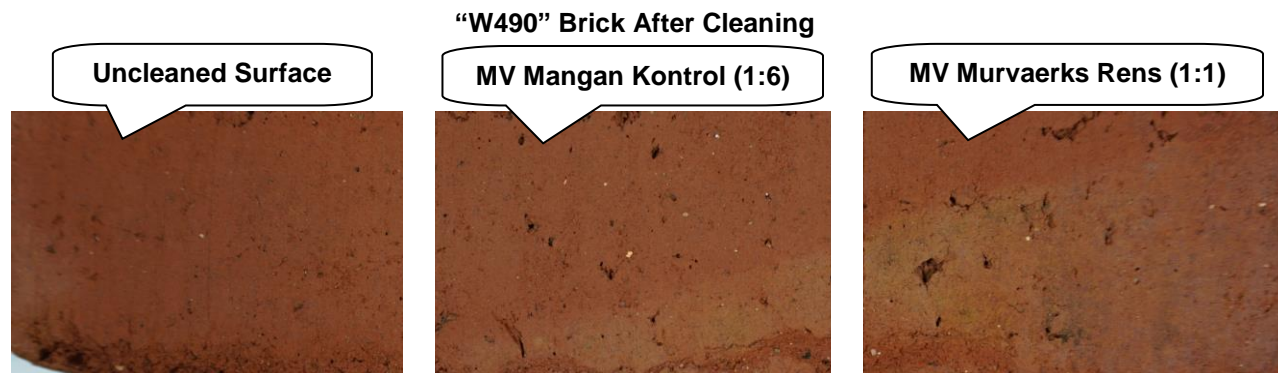
Name: "W490" Brick					
Product	Dilution	Surface Finish Removal	Substrate Deterioration	Color Change	Staining
MV Mangan Kontrol	1:6	0	0	0	0
MV Murvaerks Rens	1:1	0	0	0	0

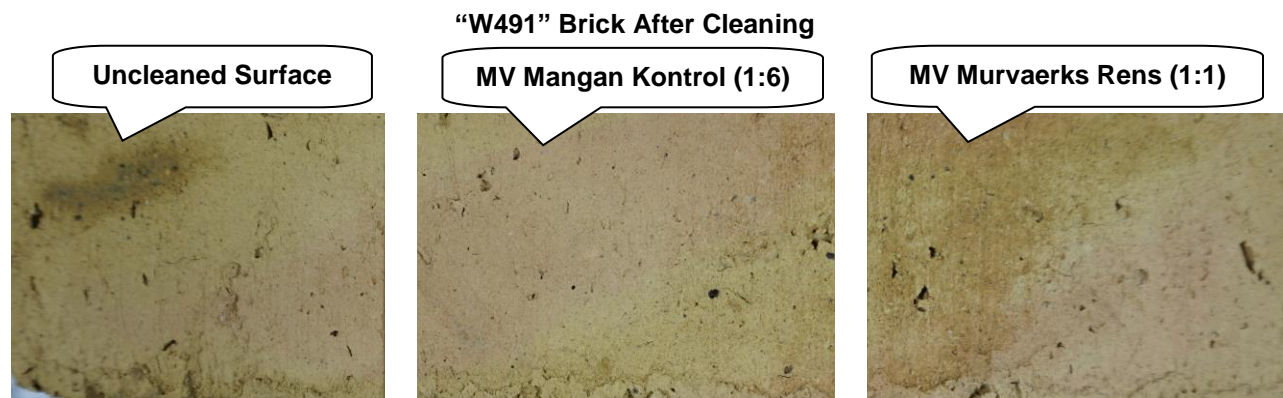
Name: "W491" Brick					
Product	Dilution	Surface Finish Removal	Substrate Deterioration	Color Change	Staining
MV Mangan Kontrol	1:6	0	0	0	0
MV Murvaerks Rens	1:1	0	0	0	0

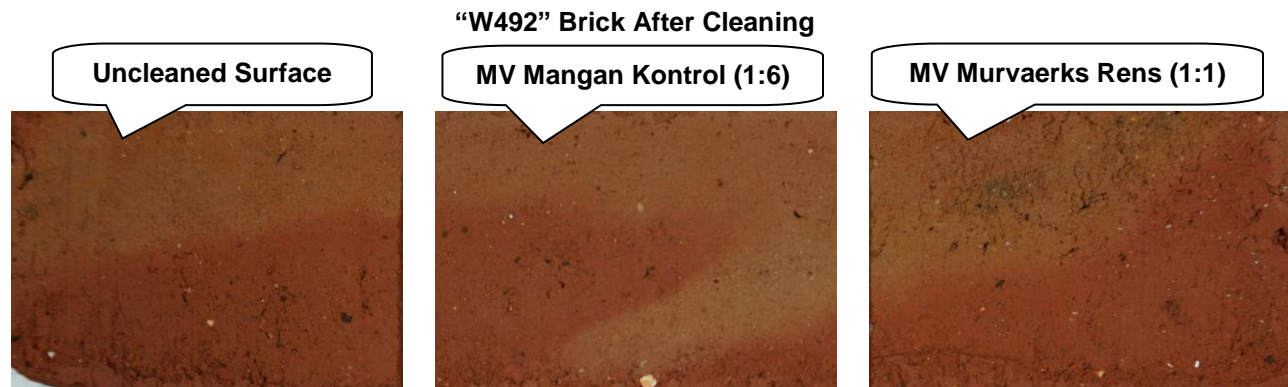
Name: "W492" Brick					
Product	Dilution	Surface Finish Removal	Substrate Deterioration	Color Change	Staining
MV Mangan Kontrol	1:6	0	0	0	0
MV Murvaerks Rens	1:1	0	0	0	0

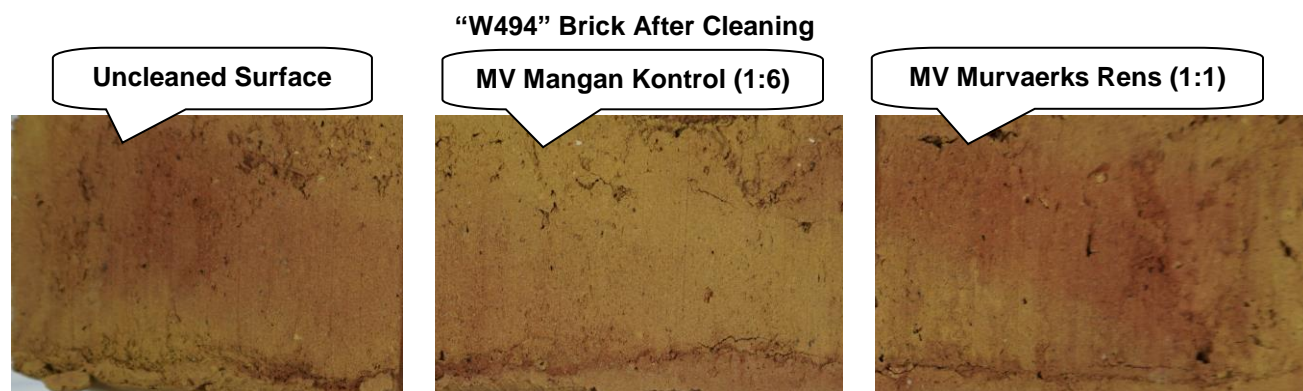
Name: "W494" Brick					
Product	Dilution	Surface Finish Removal	Substrate Deterioration	Color Change	Staining
MV Mangan Kontrol	1:6	0	0	0	0
MV Murvaerks Rens	1:1	0	0	0	0

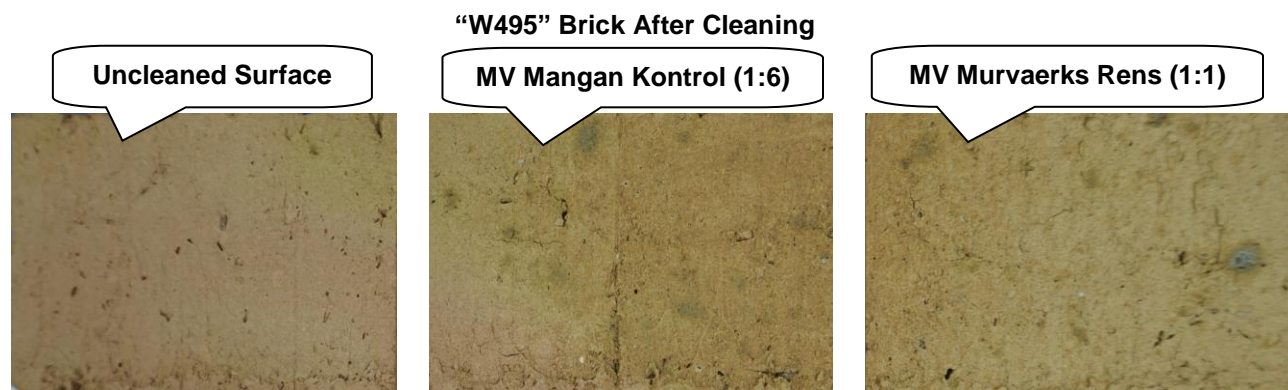
Name: "W495" Brick					
Product	Dilution	Surface Finish Removal	Substrate Deterioration	Color Change	Staining
MV Mangan Kontrol	1:6	0	0	0	0
MV Murvaerks Rens	1:1	0	0	0	0

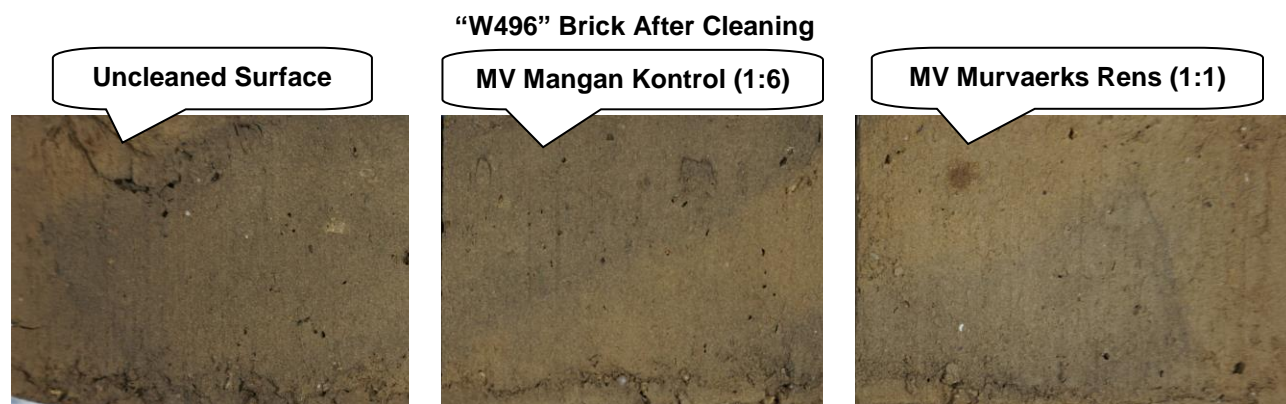
Name: "W496" Brick					
Product	Dilution	Surface Finish Removal	Substrate Deterioration	Color Change	Staining
MV Mangan Kontrol	1:6	0	0	0	0
MV Murvaerks Rens	1:1	0	0	0	0

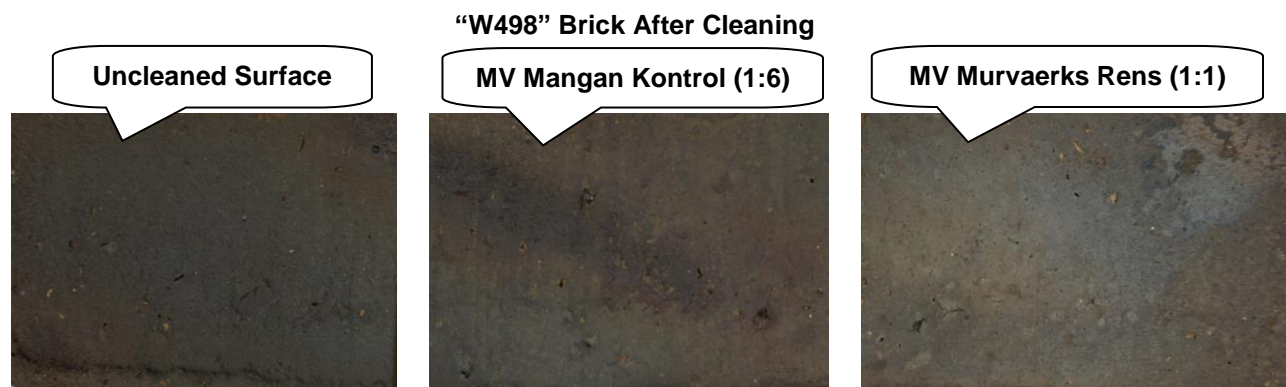
Name: "W498" Brick					
Product	Dilution	Surface Finish Removal	Substrate Deterioration	Color Change	Staining
MV Mangan Kontrol	1:6	0	0	0	0
MV Murvaerks Rens	1:1	0	0	0	0

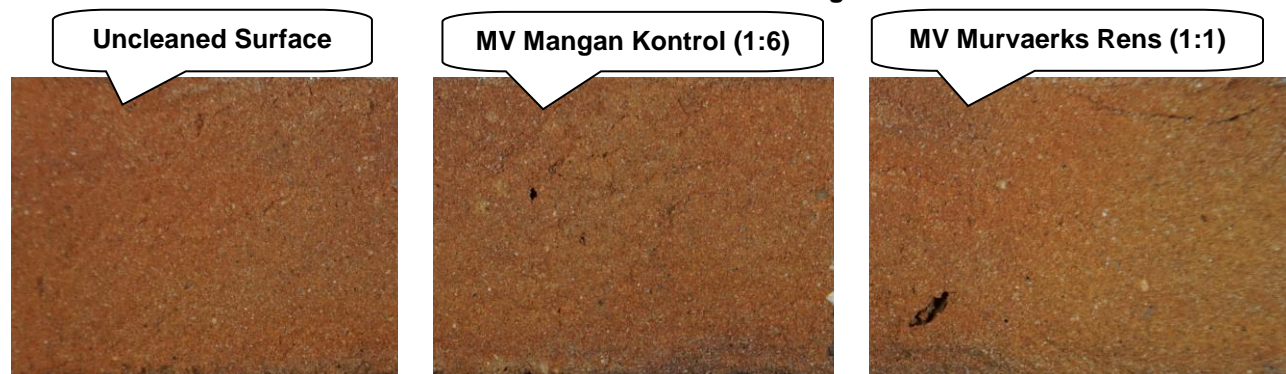
Name: "Veldbrons" Brick					
Product	Dilution	Surface Finish Removal	Substrate Deterioration	Color Change	Staining
MV Mangan Kontrol	1:6	0	0	0	0
MV Murvaerks Rens	1:1	0	0	0	0

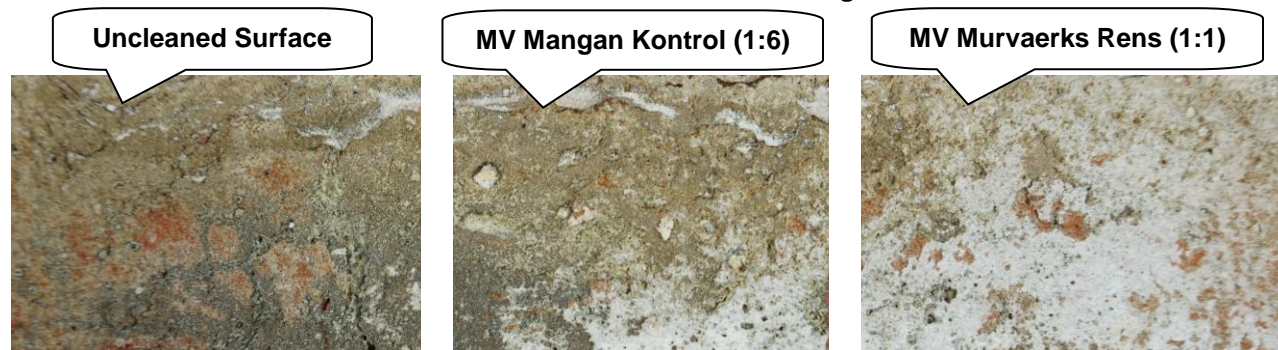
Name: "Bronsdroen" Brick					
Product	Dilution	Surface Finish Removal	Substrate Deterioration	Color Change	Staining
MV Mangan Kontrol	1:6	0	0	0	0
MV Murvaerks Rens	1:1	0	0	0	0

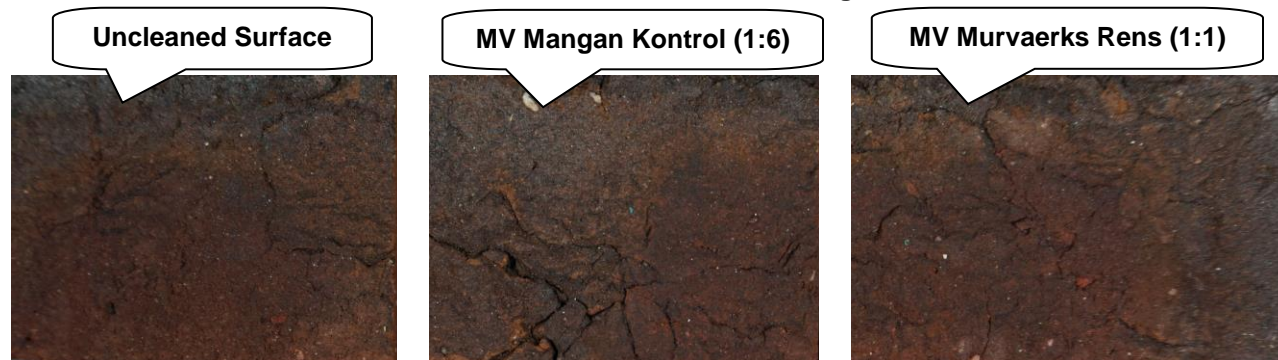
Name: "Blau Wrood" Brick					
Product	Dilution	Surface Finish Removal	Substrate Deterioration	Color Change	Staining
MV Mangan Kontrol	1:6	0	0	0	0
MV Murvaerks Rens	1:1	0	0	0	0

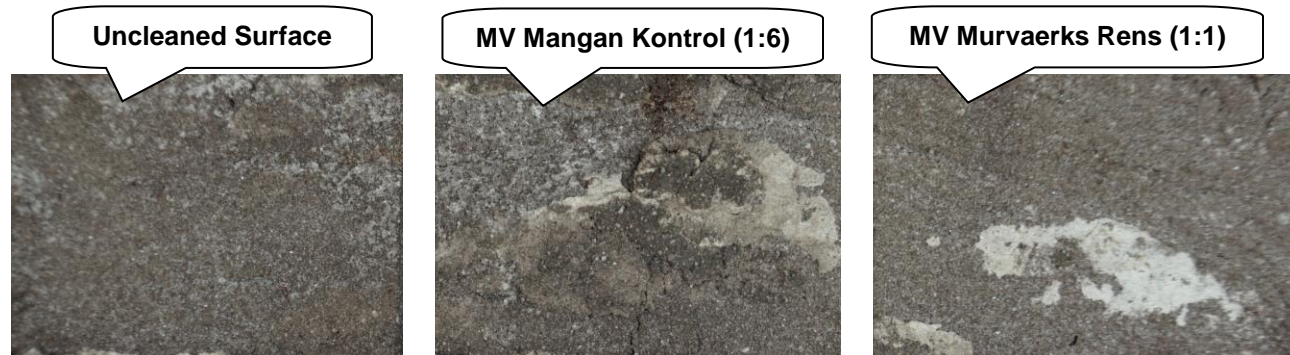
Name: "Vigo Rosa" Brick					
Product	Dilution	Surface Finish Removal	Substrate Deterioration	Color Change	Staining
MV Mangan Kontrol	1:6	0	0	0	0
MV Murvaerks Rens	1:1	0	0	0	0

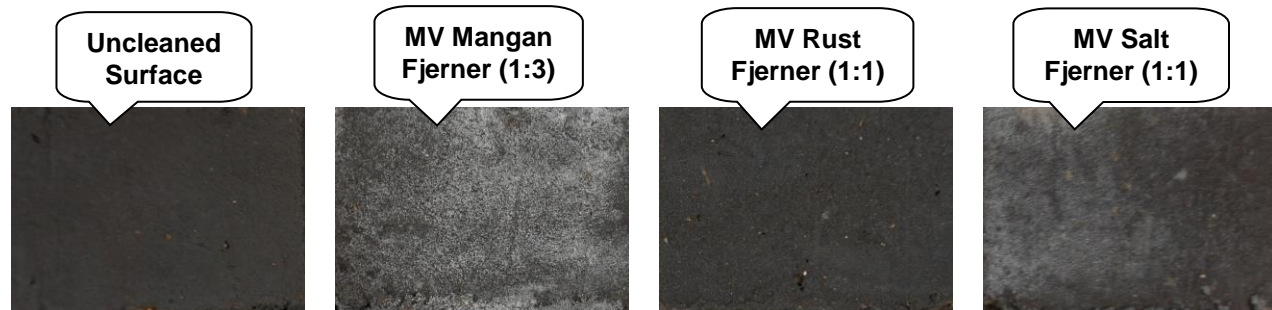
Name: "PT449" Brick					
Product	Dilution	Surface Finish Removal	Substrate Deterioration	Color Change	Staining
MV Mangan Fjerner	1:3	0	0	0	2
MV Rust Fjerner	1:1	0	0	0	0
MV Salt Fjerner	1:1	0	0	0	2

- MV Salt Fjerner resulted in moderate staining on the “PT449” brick.
- MV Salt Fjerner resulted in moderate surface finish removal of the “Bronsdroen” brick.

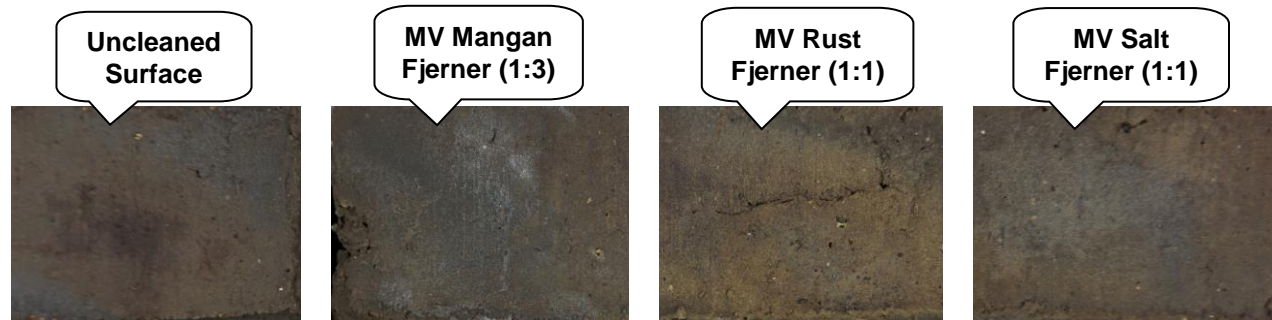
Name: "PT450" Brick					
Product	Dilution	Surface Finish Removal	Substrate Deterioration	Color Change	Staining
MV Mangan Fjerner	1:3	0	0	0	1
MV Rust Fjerner	1:1	0	0	0	0
MV Salt Fjerner	1:1	0	0	0	0

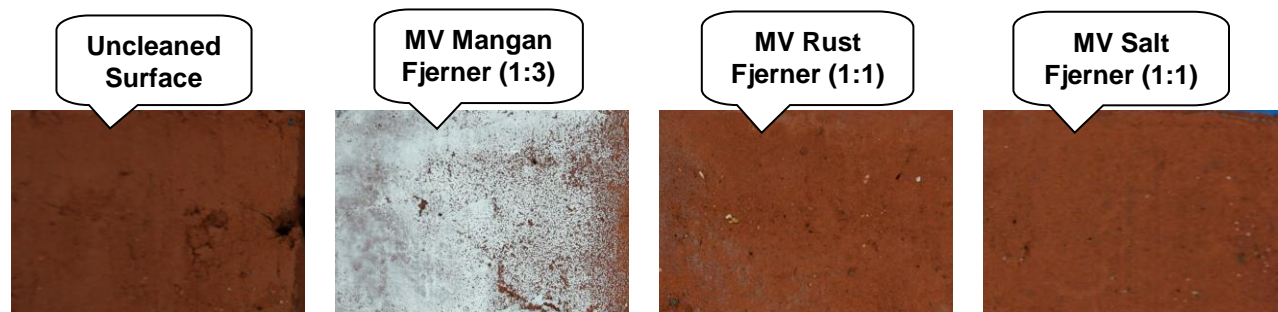
Name: "PT465" Brick					
Product	Dilution	Surface Finish Removal	Substrate Deterioration	Color Change	Staining
MV Mangan Fjerner	1:3	0	0	0	3
MV Rust Fjerner	1:1	0	0	0	0
MV Salt Fjerner	1:1	0	0	0	0

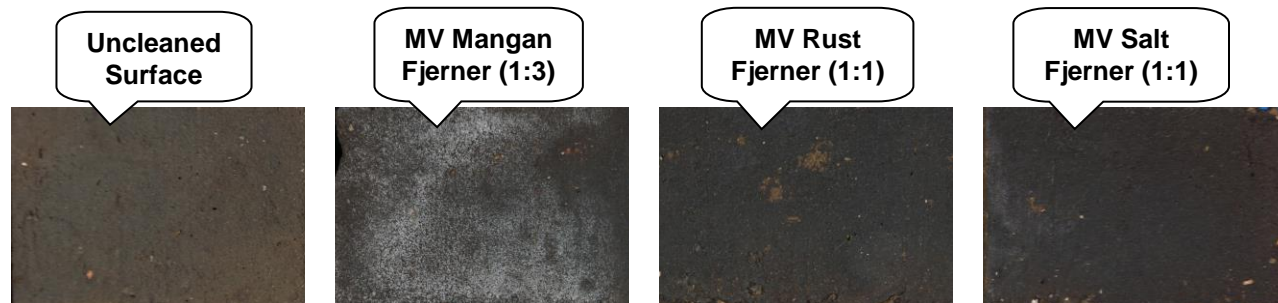
Name: "W001" Brick					
Product	Dilution	Surface Finish Removal	Substrate Deterioration	Color Change	Staining
MV Mangan Fjerner	1:3	0	0	0	2
MV Rust Fjerner	1:1	0	0	0	0
MV Salt Fjerner	1:1	0	0	0	0

NOTE: The "W001" Brick as submitted displayed significant color variation prior to testing.

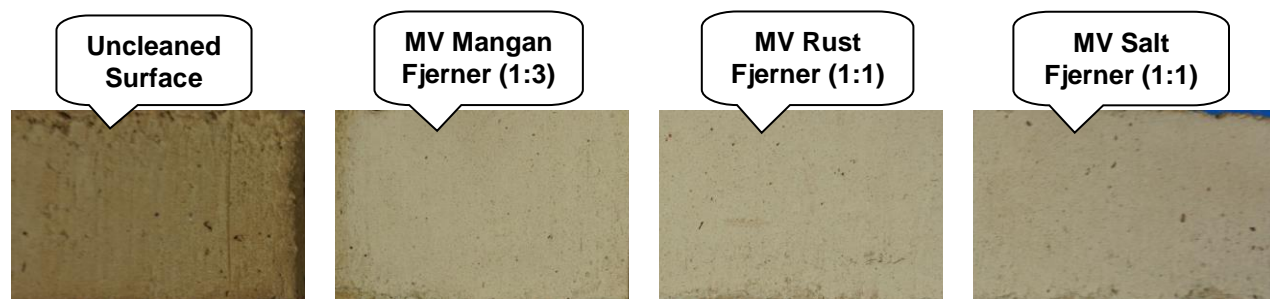
Name: "W103" Brick					
Product	Dilution	Surface Finish Removal	Substrate Deterioration	Color Change	Staining
MV Mangan Fjerner	1:3	0	0	0	0
MV Rust Fjerner	1:1	0	0	0	0
MV Salt Fjerner	1:1	0	0	0	0

NOTE: The "W103" Brick as submitted displayed significant color variation prior to testing.

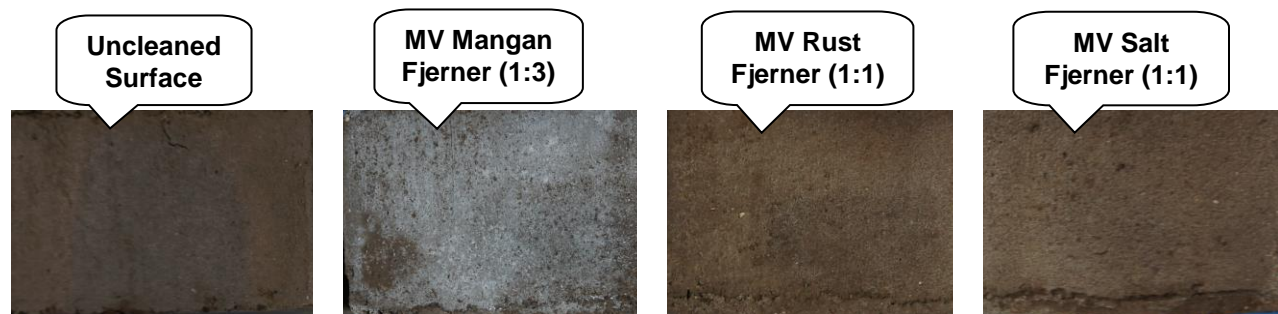
Name: "W108" Brick					
Product	Dilution	Surface Finish Removal	Substrate Deterioration	Color Change	Staining
MV Mangan Fjerner	1:3	1	0	0	2
MV Rust Fjerner	1:1	0	0	0	0
MV Salt Fjerner	1:1	1	0	0	0

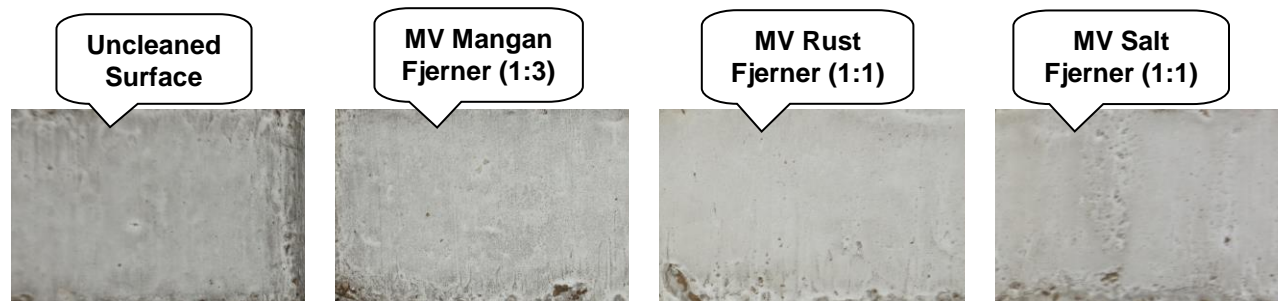
Name: "W109" Brick					
Product	Dilution	Surface Finish Removal	Substrate Deterioration	Color Change	Staining
MV Mangan Fjerner	1:3	0	0	0	0
MV Rust Fjerner	1:1	0	0	0	0
MV Salt Fjerner	1:1	0	0	0	0

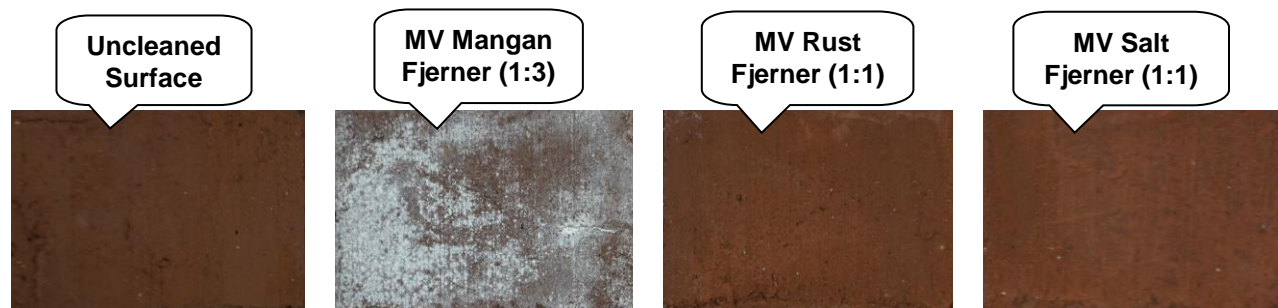
Name: "W110" Brick					
Product	Dilution	Surface Finish Removal	Substrate Deterioration	Color Change	Staining
MV Mangan Fjerner	1:3	0	0	0	3
MV Rust Fjerner	1:1	0	0	0	0
MV Salt Fjerner	1:1	0	0	0	0
