Pallet Tag Program Laboratory Report

Wienerberger Denmark Helsinge, Denmark

Project No. 1905-05 PTP

New Construction Cleaning and Adverse Effects Evaluation

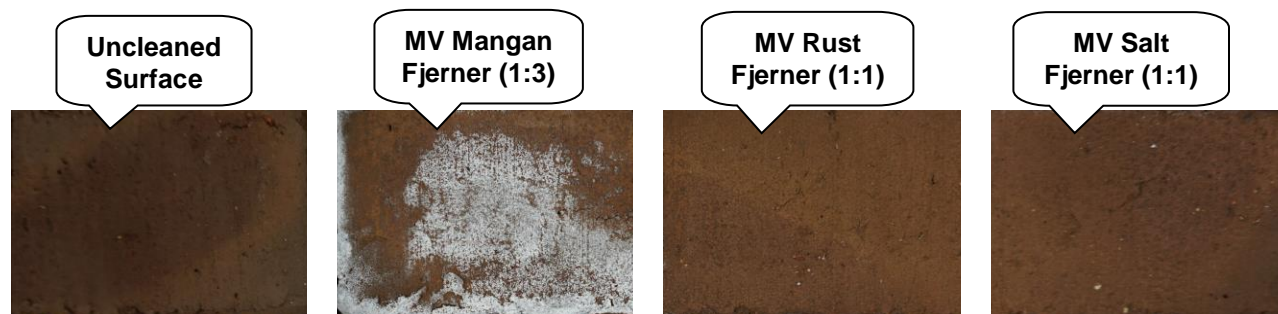
Name: "W112" Brick					
Product	Dilution	Surface Finish Removal	Substrate Deterioration	Color Change	Staining
MV Mangan Fjerner	1:3	1	0	0	2
MV Rust Fjerner	1:1	1	0	0	0
MV Salt Fjerner	1:1	1	0	0	0

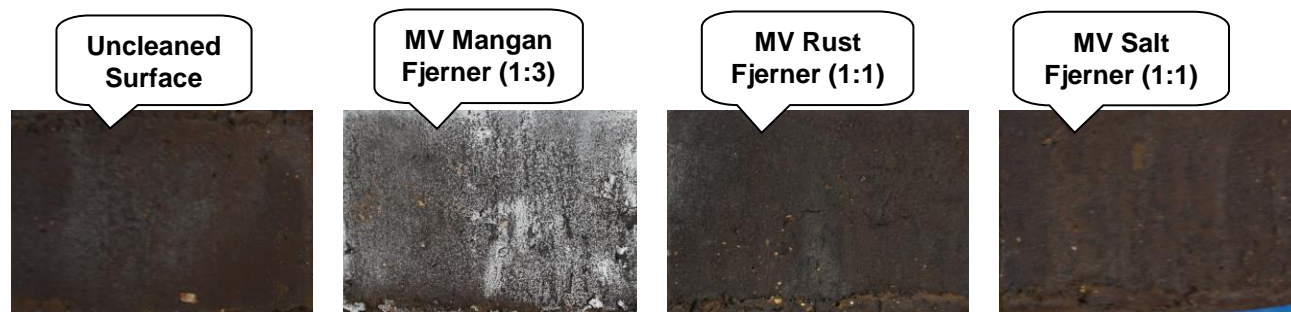
Name: "W170" Brick					
Product	Dilution	Surface Finish Removal	Substrate Deterioration	Color Change	Staining
MV Mangan Fjerner	1:3	0	0	0	3
MV Rust Fjerner	1:1	0	0	0	0
MV Salt Fjerner	1:1	0	0	0	0

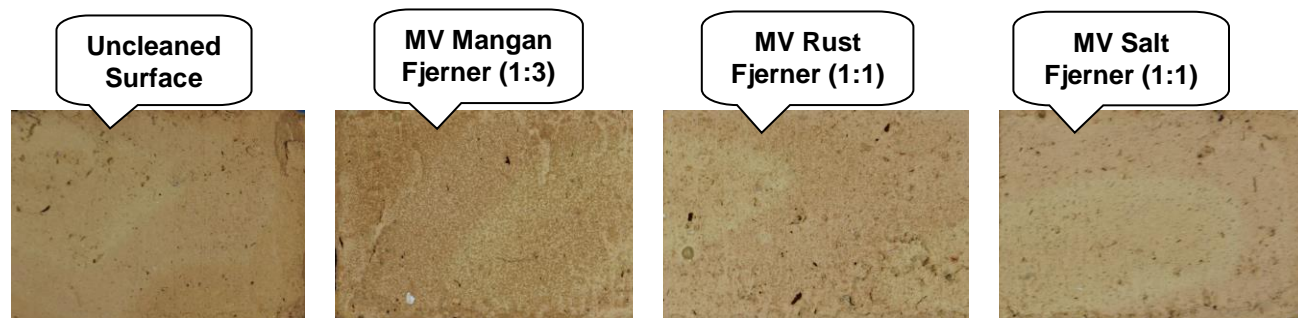
Name: "W209" Brick					
Product	Dilution	Surface Finish Removal	Substrate Deterioration	Color Change	Staining
MV Mangan Fjerner	1:3	2	0	0	0
MV Rust Fjerner	1:1	1	0	0	0
MV Salt Fjerner	1:1	0	0	0	0

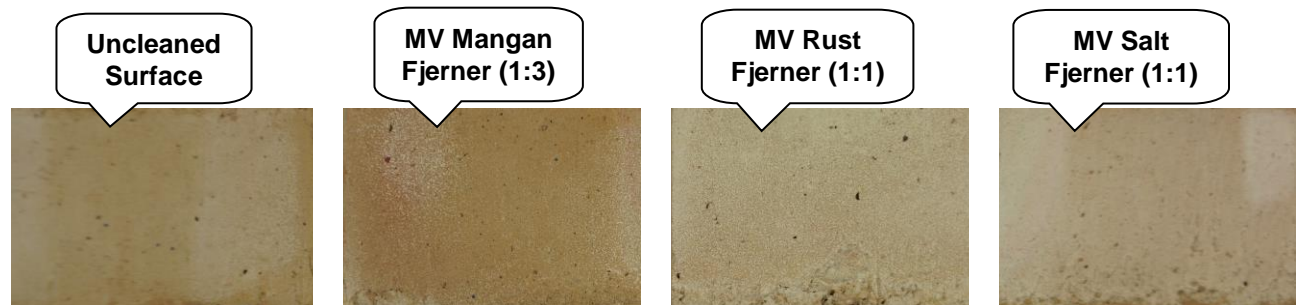
Name: "W212" Brick					
Product	Dilution	Surface Finish Removal	Substrate Deterioration	Color Change	Staining
MV Mangan Fjerner	1:3	1	0	2	0
MV Rust Fjerner	1:1	1*	0	0	0
MV Salt Fjerner	1:1	0	0	0	0

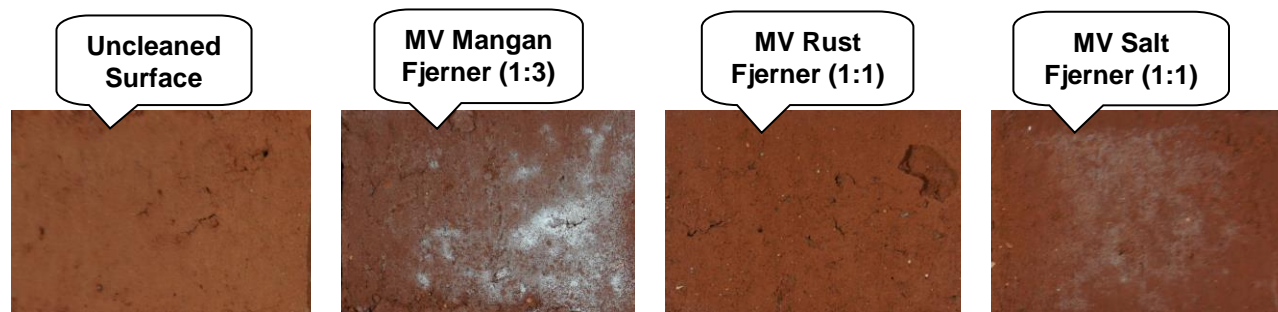
Name: "W309" Brick					
Product	Dilution	Surface Finish Removal	Substrate Deterioration	Color Change	Staining
MV Mangan Fjerner	1:3	0	0	0	2
MV Rust Fjerner	1:1	0	0	0	0
MV Salt Fjerner	1:1	0	0	0	1

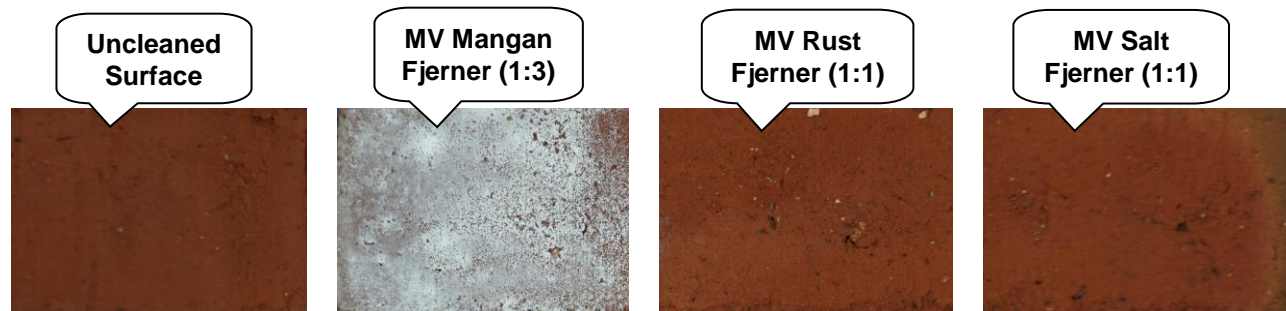
Name: "W409" Brick					
Product	Dilution	Surface Finish Removal	Substrate Deterioration	Color Change	Staining
MV Mangan Fjerner	1:3	0	0	0	3
MV Rust Fjerner	1:1	0	0	0	0
MV Salt Fjerner	1:1	0	0	0	0

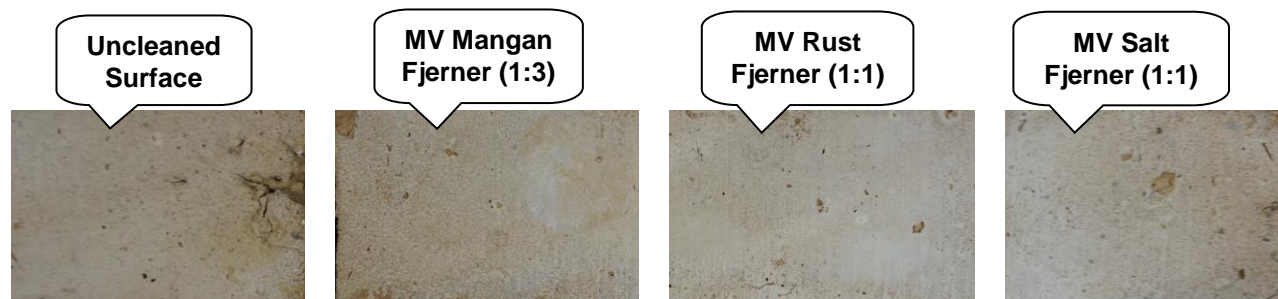
Name: "W445" Brick					
Product	Dilution	Surface Finish Removal	Substrate Deterioration	Color Change	Staining
MV Mangan Fjerner	1:3	0	0	0	0
MV Rust Fjerner	1:1	0	0	0	0
MV Salt Fjerner	1:1	0	0	0	0

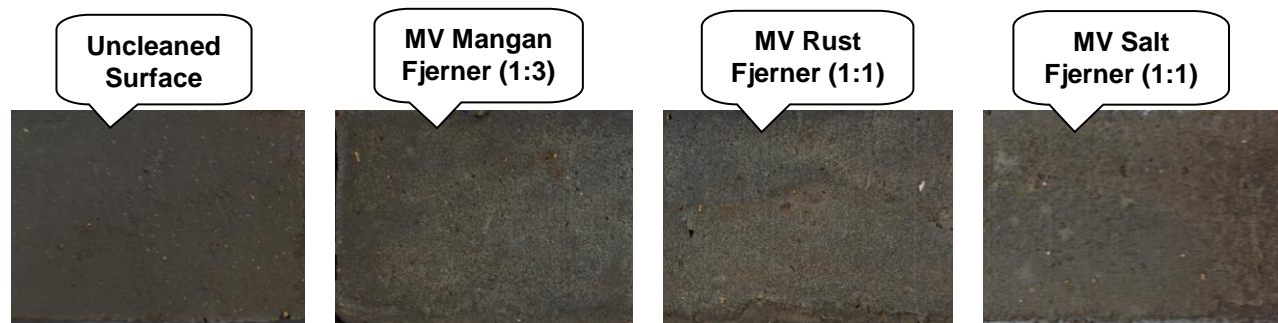
Name: "W451" Brick					
Product	Dilution	Surface Finish Removal	Substrate Deterioration	Color Change	Staining
MV Mangan Fjerner	1:3	1	0	0	1*
MV Rust Fjerner	1:1	1	0	0	0
MV Salt Fjerner	1:1	0	0	0	1*

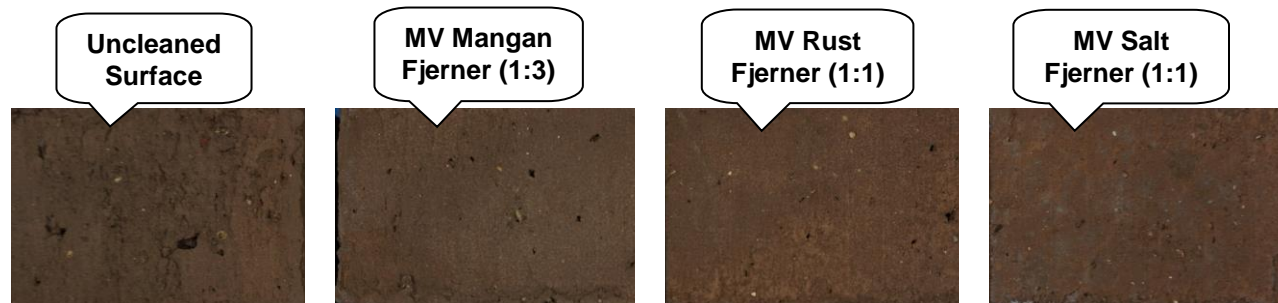
Name: "W452" Brick					
Product	Dilution	Surface Finish Removal	Substrate Deterioration	Color Change	Staining
MV Mangan Fjerner	1:3	1	0	0	0
MV Rust Fjerner	1:1	1	0	0	0
MV Salt Fjerner	1:1	0	0	0	0

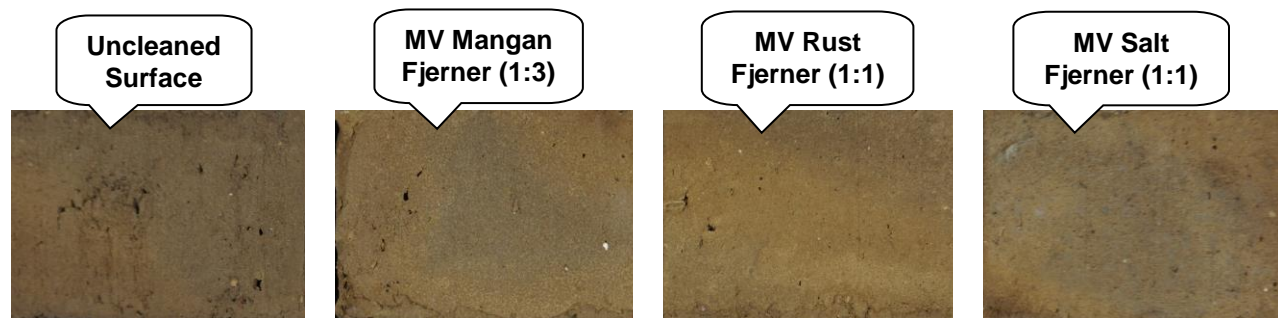
Name: "W453" Brick					
Product	Dilution	Surface Finish Removal	Substrate Deterioration	Color Change	Staining
MV Mangan Fjerner	1:3	1	0	0	0
MV Rust Fjerner	1:1	0	0	0	0
MV Salt Fjerner	1:1	1	0	0	0

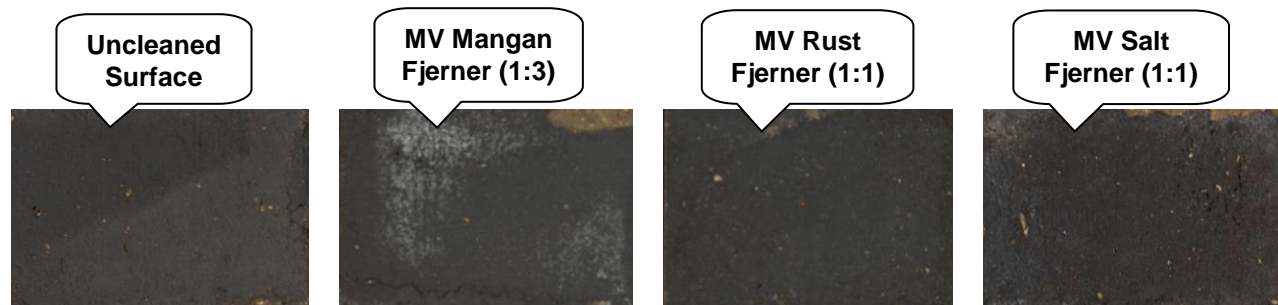
Name: "W454" Brick					
Product	Dilution	Surface Finish Removal	Substrate Deterioration	Color Change	Staining
MV Mangan Fjerner	1:3	0	0	0	1*
MV Rust Fjerner	1:1	0	0	0	0
MV Salt Fjerner	1:1	0	0	0	1*

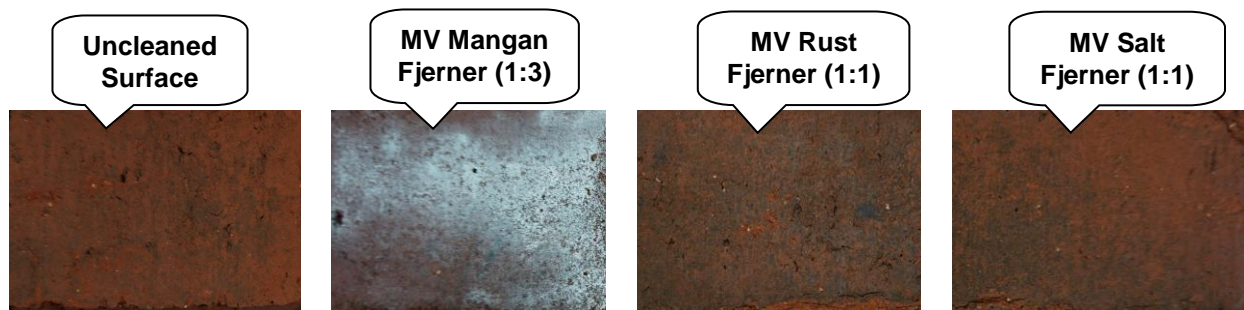
Name: "W466" Brick					
Product	Dilution	Surface Finish Removal	Substrate Deterioration	Color Change	Staining
MV Mangan Fjerner	1:3	0	0	0	3
MV Rust Fjerner	1:1	0	0	0	0
MV Salt Fjerner	1:1	0	0	0	0

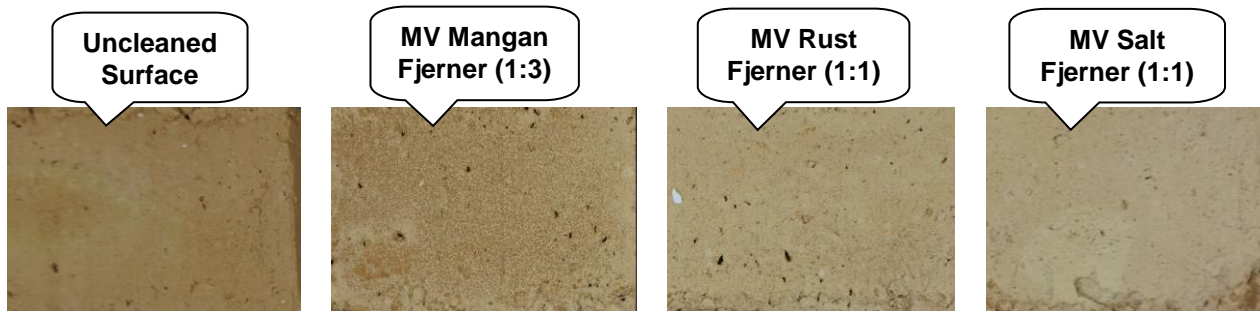
Name: "W470" Brick					
Product	Dilution	Surface Finish Removal	Substrate Deterioration	Color Change	Staining
MV Mangan Fjerner	1:3	2	0	0	0
MV Rust Fjerner	1:1	0	0	0	0
MV Salt Fjerner	1:1	0	0	0	0

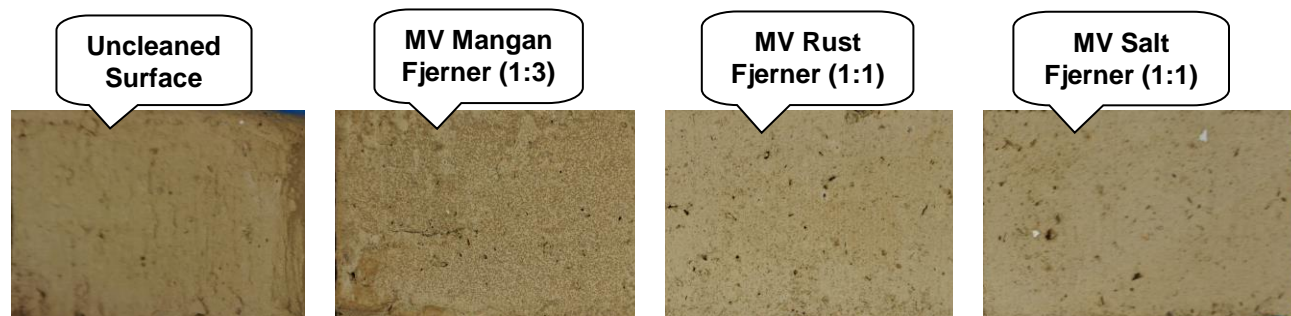
Name: "W479" Brick					
Product	Dilution	Surface Finish Removal	Substrate Deterioration	Color Change	Staining
MV Mangan Fjerner	1:3	3	0	0	0
MV Rust Fjerner	1:1	1	0	0	0
MV Salt Fjerner	1:1	0	0	0	0

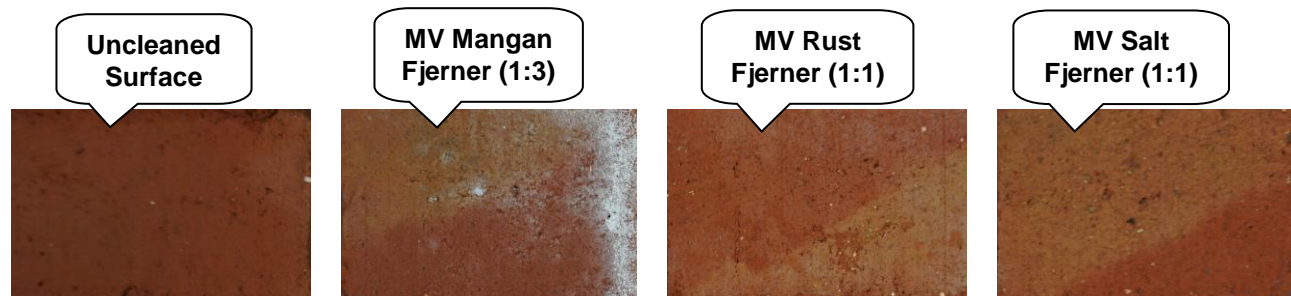
Name: "W490" Brick					
Product	Dilution	Surface Finish Removal	Substrate Deterioration	Color Change	Staining
MV Mangan Fjerner	1:3	0	0	0	2
MV Rust Fjerner	1:1	0	0	0	1*
MV Salt Fjerner	1:1	0	0	0	0

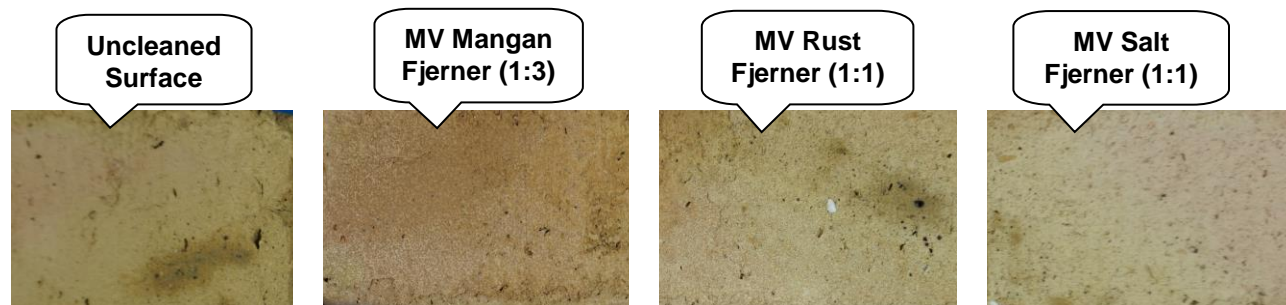
Name: "W491" Brick					
Product	Dilution	Surface Finish Removal	Substrate Deterioration	Color Change	Staining
MV Mangan Fjerner	1:3	3	0	2	0
MV Rust Fjerner	1:1	1*	0	0	0
MV Salt Fjerner	1:1	0	0	0	0

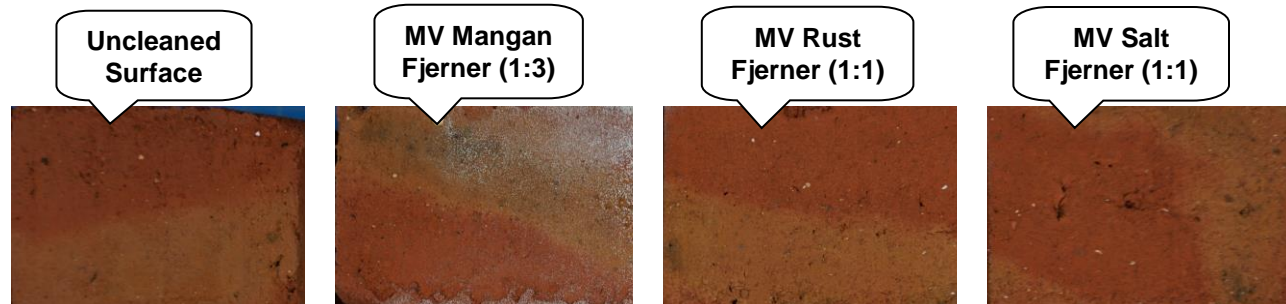
Name: "W492" Brick					
Product	Dilution	Surface Finish Removal	Substrate Deterioration	Color Change	Staining
MV Mangan Fjerner	1:3	0	0	0	2
MV Rust Fjerner	1:1	0	0	0	0
MV Salt Fjerner	1:1	0	0	0	0

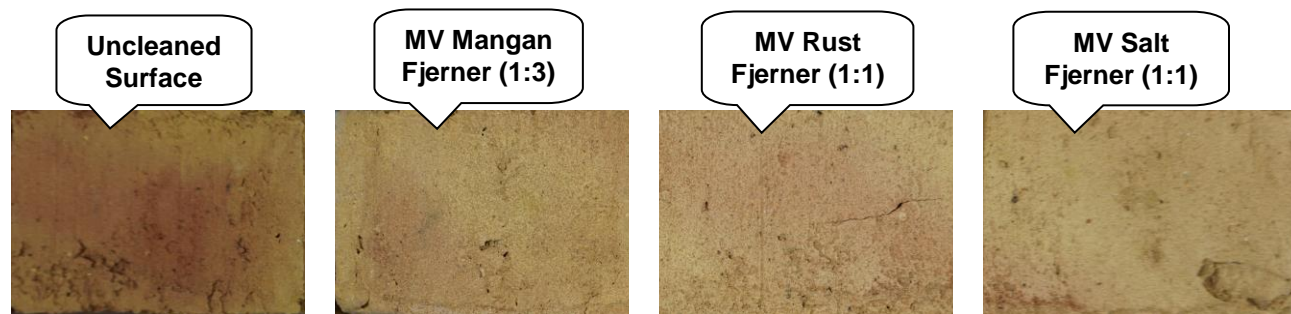
Name: "W494" Brick					
Product	Dilution	Surface Finish Removal	Substrate Deterioration	Color Change	Staining
MV Mangan Fjerner	1:3	1	0	0	0
MV Rust Fjerner	1:1	1	0	0	0
MV Salt Fjerner	1:1	0	0	0	0

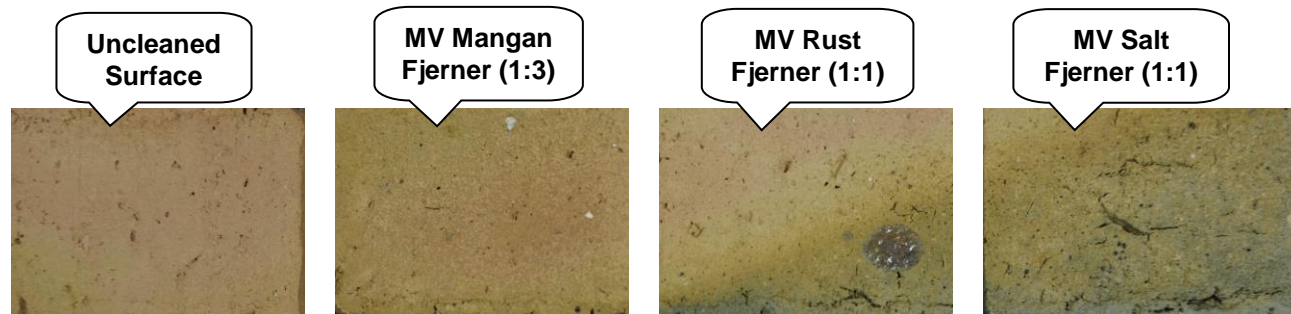
Name: "W495" Brick					
Product	Dilution	Surface Finish Removal	Substrate Deterioration	Color Change	Staining
MV Mangan Fjerner	1:3	1	0	0	0
MV Rust Fjerner	1:1	0	0	0	0
MV Salt Fjerner	1:1	0	0	0	0

NOTE: The brick as submitted displayed significant color variation prior to testing.

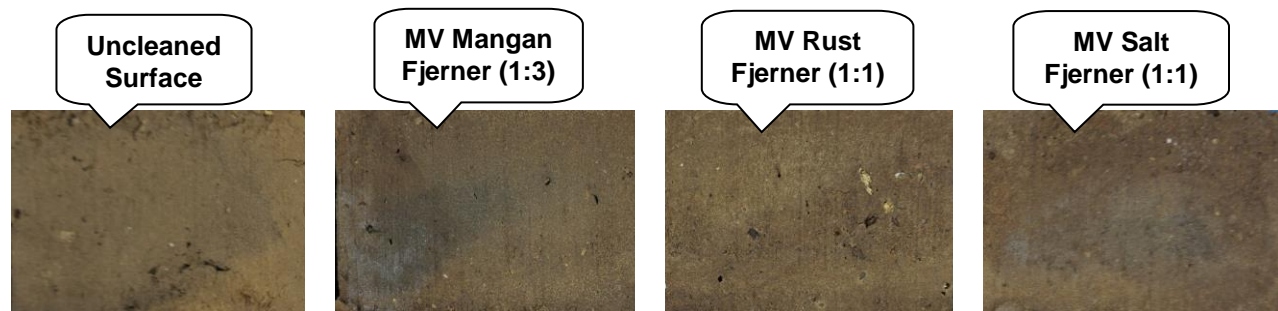
Name: "W496" Brick					
Product	Dilution	Surface Finish Removal	Substrate Deterioration	Color Change	Staining
MV Mangan Fjerner	1:3	1	0	0	1*
MV Rust Fjerner	1:1	1	0	0	0
MV Salt Fjerner	1:1	0	0	0	0

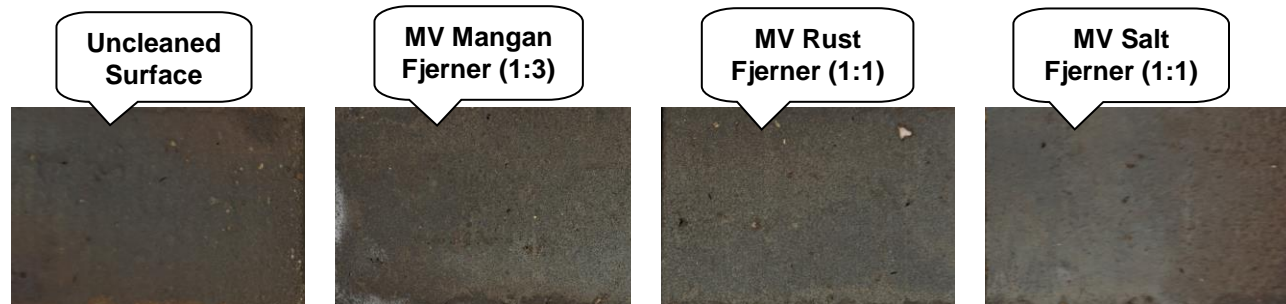
Name: "W498" Brick					
Product	Dilution	Surface Finish Removal	Substrate Deterioration	Color Change	Staining
MV Mangan Fjerner	1:3	1	0	0	0
MV Rust Fjerner	1:1	1	0	0	0
MV Salt Fjerner	1:1	0	0	0	0

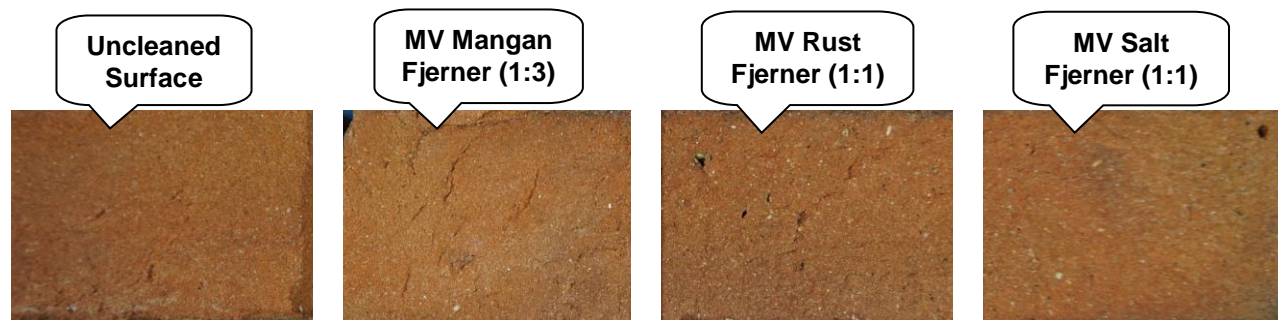
Name: "Veldbrons" Brick					
Product	Dilution	Surface Finish Removal	Substrate Deterioration	Color Change	Staining
MV Mangan Fjerner	1:3	0	0	0	0
MV Rust Fjerner	1:1	0	0	0	0
MV Salt Fjerner	1:1	0	0	0	0

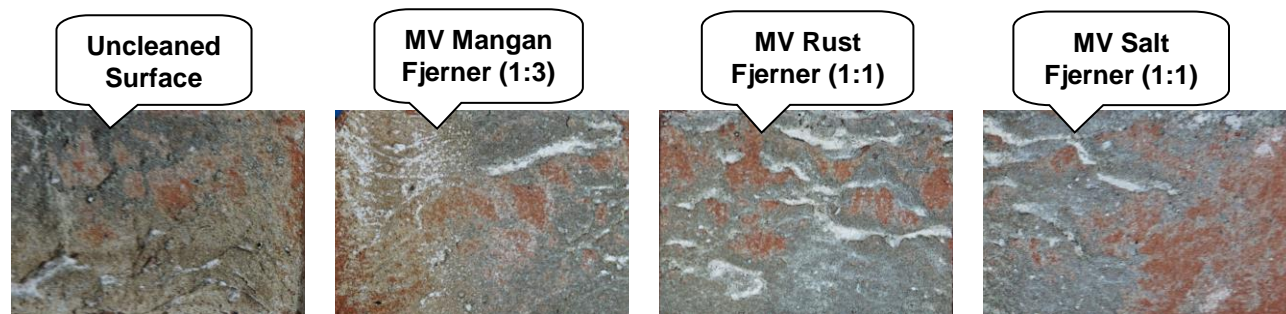
Name: "Bronsdroen" Brick					
Product	Dilution	Surface Finish Removal	Substrate Deterioration	Color Change	Staining
MV Mangan Fjerner	1:3	2	0	0	0
MV Rust Fjerner	1:1	2	0	0	0
MV Salt Fjerner	1:1	1	0	0	0

- MV Salt Fjerner resulted in moderate staining on the “PT449” brick.
- MV Salt Fjerner resulted in moderate surface finish removal of the “Bronsdroen” brick.

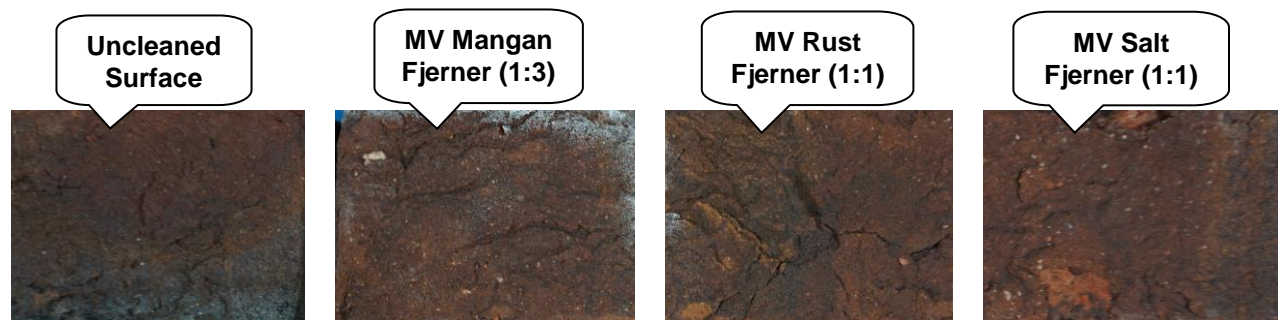
Name: "Blau Wrood" Brick					
Product	Dilution	Surface Finish Removal	Substrate Deterioration	Color Change	Staining
MV Mangan Fjerner	1:3	0	0	0	1
MV Rust Fjerner	1:1	0	0	0	0
MV Salt Fjerner	1:1	0	0	0	0

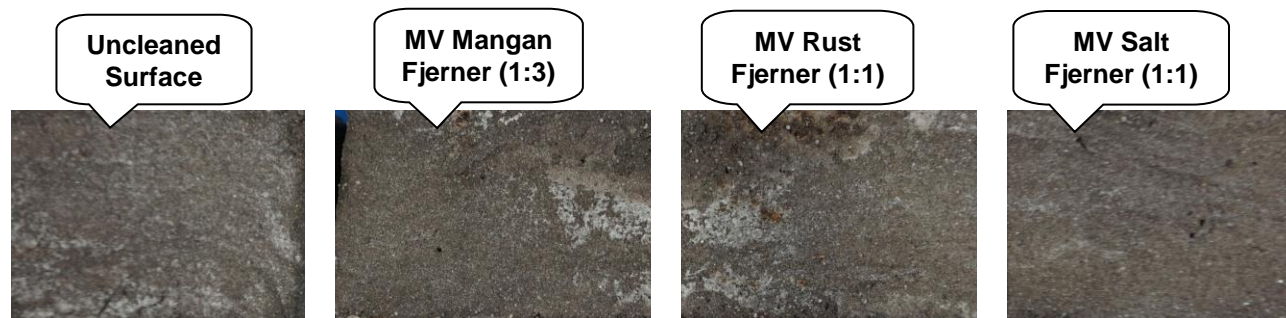
Name: "Vigo Rosa" Brick					
Product	Dilution	Surface Finish Removal	Substrate Deterioration	Color Change	Staining
MV Mangan Fjerner	1:3	0	0	0	0
MV Rust Fjerner	1:1	0	0	0	0
MV Salt Fjerner	1:1	0	0	0	0
