FORT WORTH POST OFFICE

INVESTING IN, CARING FOR A HISTORIC ASSET

By any definition, the main Post Office building in Fort Worth, Texas, is a commanding presence. A recent exterior restoration and cleaning brought renewed public attention, as well as rekindled devotion, to the historic structure's many special attributes.

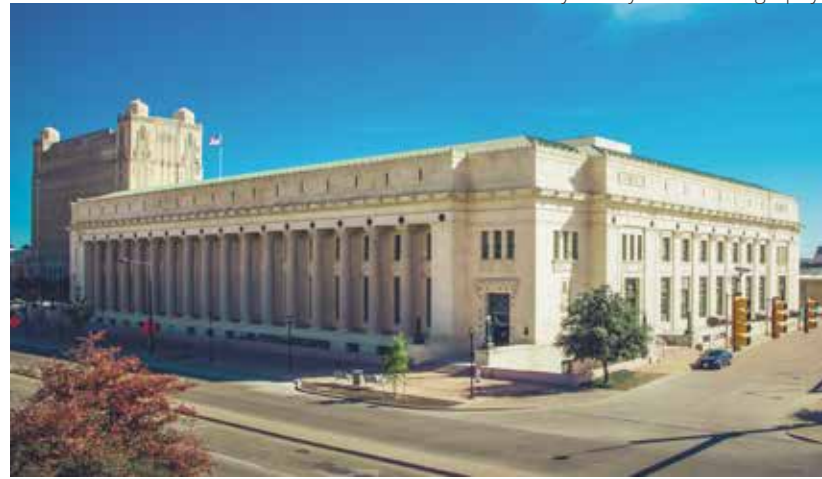
Austin, the building features a foundation perimeter wall and steps made of Texas granite. With a stately and prominent public face, the north façade boasts a 17-bay central block containing 16 colossal-order, unfluted columns of limestone. The regionally influenced Corinthian capitals consist of shorthorn cattle, acanthus leaves, and longhorn bucrania—a nod to the importance of the cattle industry and its economic impact on Fort Worth.

Additional embellishments include bronze medallions on the entablature, a pattern of lion's heads on the architrave around the building, and ornamental bas-relief panels on the main frontage. Multi-pane metal casement windows perforate the façade. Each corner pavilion includes large doors at ground level and three eight-pane windows.

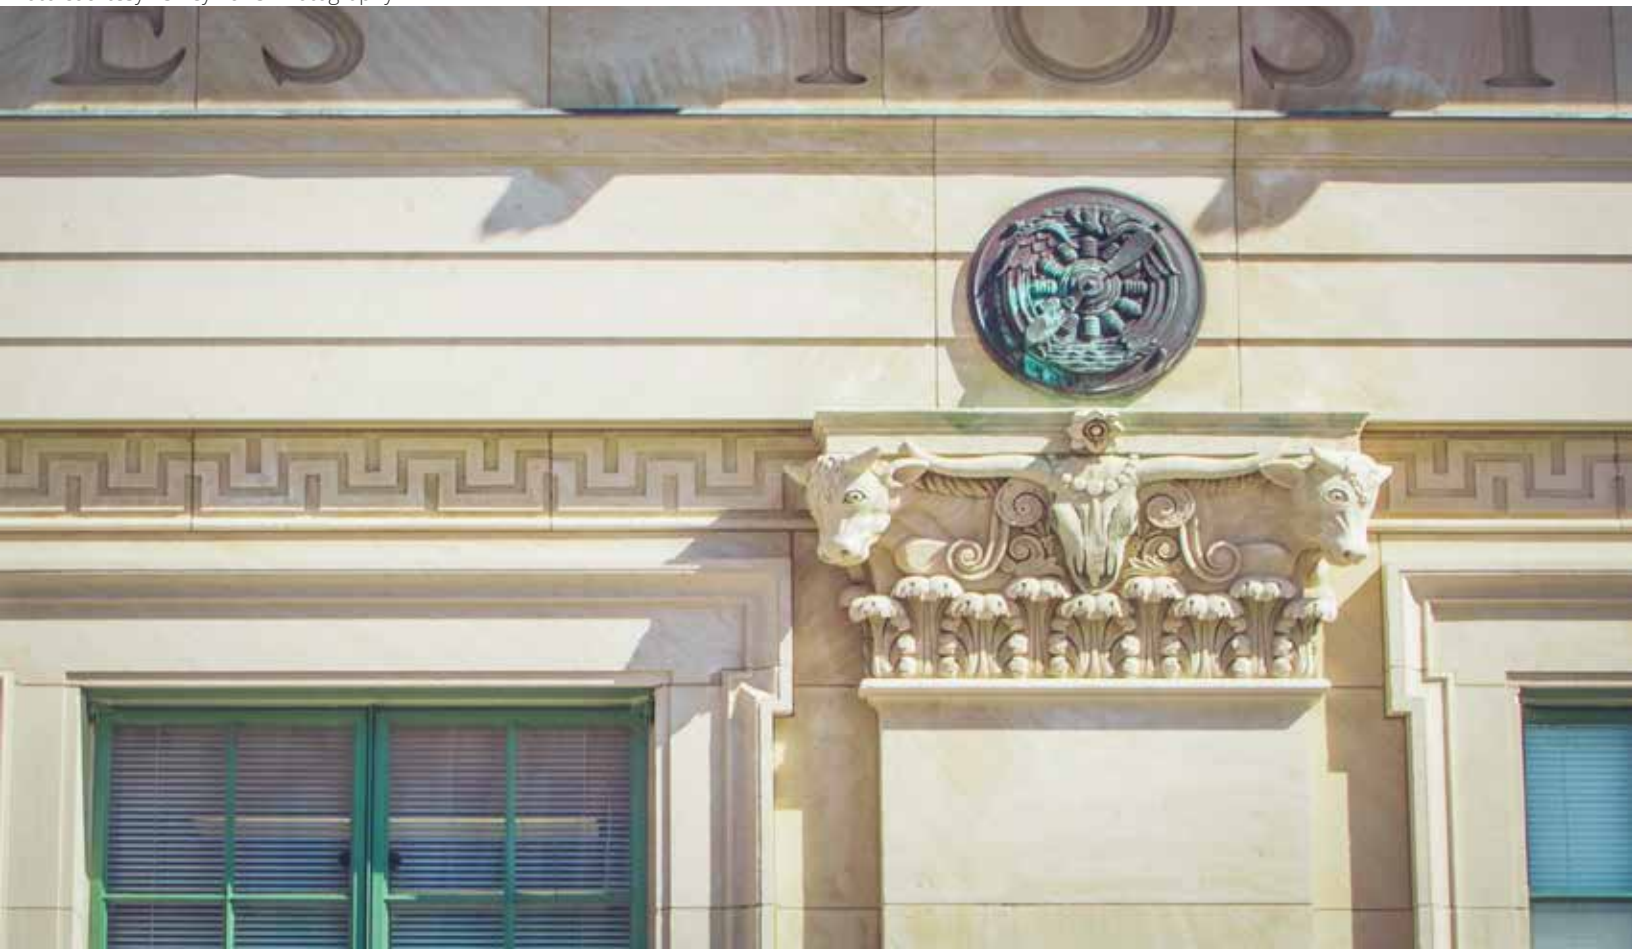
Photo courtesy Ashley Tullis Photography

of the site. By then, the damage to the Post Office was already done — and was extensive.

Carbon staining, usually dark brown, gray or black, is a typical result of repeated exposure to automobile traffic and burning of fossil fuels (coal, oil, gasoline, etc.). These pollutants leave a sticky, water-resistant film over the face of the substrate. Airborne pollutants adhere to the film and progressively accumulate on the surface. On acid-sensitive carbonate surfaces, like the Fort Worth office's Cordova cream limestone, acid rain further erodes carbon accumulation from projecting elements, resulting in pronounced streaking. Carbon stains also accumulate in carved recesses that are not exposed to rain washing. When exposed to heavy pollution, many of these substrates can develop carbon stains that obscure the entire surface.

Recent restoration work at the Fort Worth Post Office included a low-pressure spray cleaning of all exterior surfaces (steps and walls), abatement, re-cleaning, and new paint for all exterior windows.

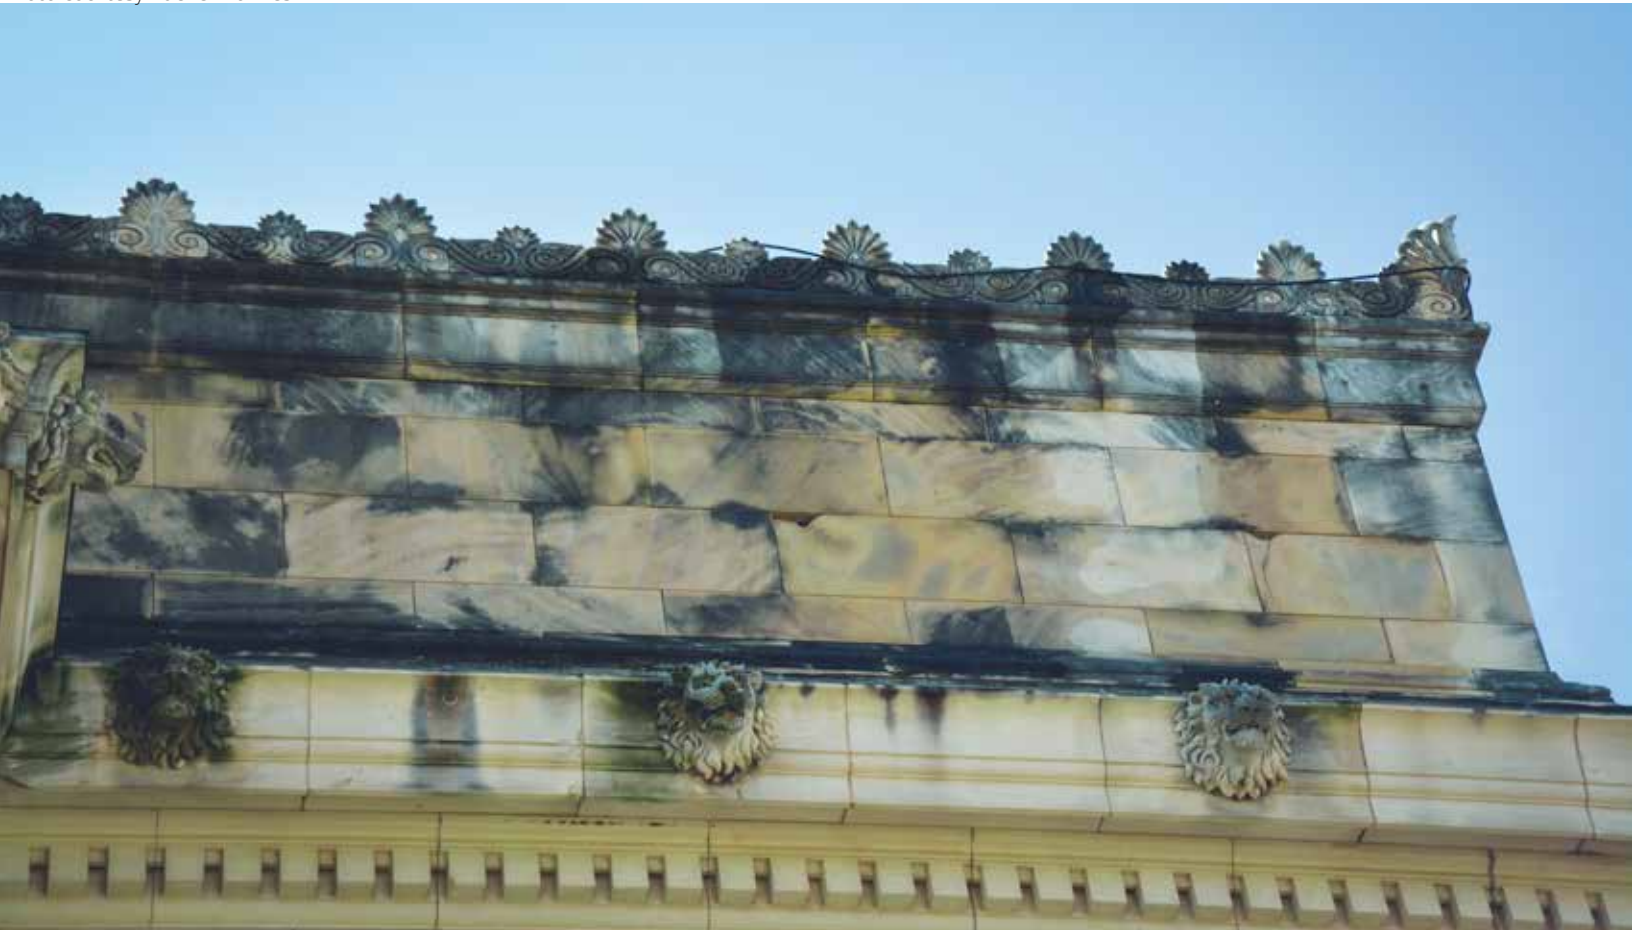
Photo courtesy Rachel Holmes

that cleaning residues are completely removed and that the masonry retains its natural color and appearance. The afterwash is a very mild, organic, acid-cleaning compound that will not damage or alter masonry, and it also works well in humid environments, making it ideal for Fort Worth's climate.

In 2015, PROSOCO's cleaning approach involved a two-step process, a prewash followed by an afterwash. Sure Klean® 766 Limestone & Masonry Prewash is a non-acidic, alkaline gel that's highly effective at dissolving heavy carbon crusts but capable of precise application for spot-cleaning. When used properly, the prewash dissolves and assists in removing heavy carbon encrustations from most masonry, including brick, terra cotta, sandstone, and limestone.

After using the prewash, the team determined the masonry needed to be neutralized with Sure Klean® Limestone & Masonry Afterwash. This process ensures

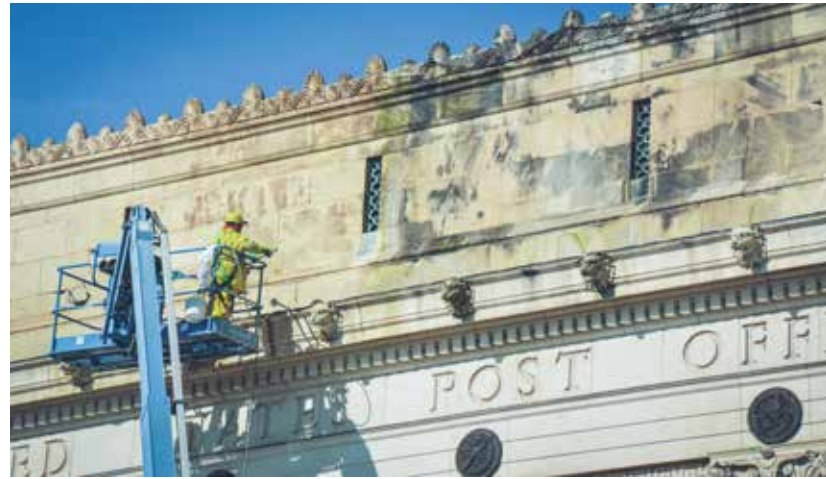
deep-seated carbon and biological stains. Many of these stains could have been targeted with acid-based cleaning compounds, but the selected system was the best choice for the staining, masonry and its condition.

In the case of the Post Office project, it was important to minimize any potential for additional water-related deterioration resulting from the sandblasting. "You want to be sensitive to particularly vulnerable, acid-sensitive surfaces, which means considering appropriate dwell times and dilution rates," said Holder. For example, the prewash can be diluted or used in concentrate with a dwell time of 30 minutes to 2 hours. This flexibility allows for the user to test various dilution rates at different contact times to determine the best fit for this job. The goal is to affect change in different ways and in response to different challenges, because, according
