Fall 1985

ProSoCo News

National Building Museum Opens Its Doors In Revitalized Pension Building

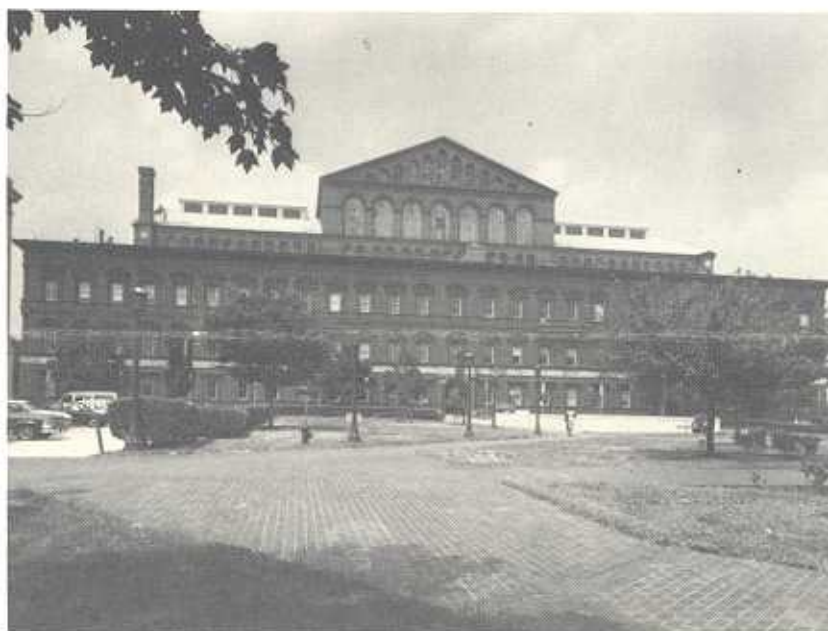
(Above) Built in 1881, the Pension Building in Washington, D.C. is now the National Building Museum.

Built in 1881, the Pension Building was designed by General Montgomery C. Meigs as an office building for the 1,500 clerks needed to process the pensions awarded after the Civil War. The building's surface had become blackened and crusted with carbon, the interior was badly in need of paint and the roof needed repair. The Building Museum set out to restore the old Pension Building to its original splendor.

The Pension Building is a massive structure, 400 linear feet by 200 linear feet in size, encompassing 15,500,000 bricks. The entire exterior surface was cleaned by crews from Historic Restoration, Inc. Cleaning began in September of 1984 and continued through December when winter set in. Work began again in April of this year, continuing until June.

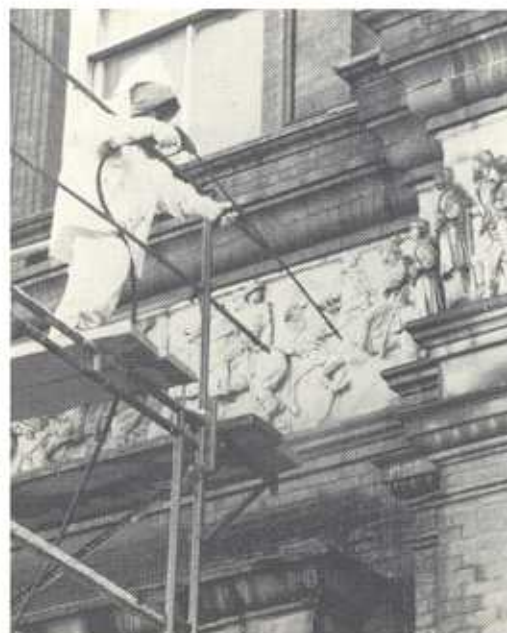
(Right) Encircling the entire Pension Building is a sculptured terra cotta band or frieze, 1,200 feet long, and three feet high. Sculptor Caspar Buberl designed the frieze to depict various aspects of life in the Union Army during the Civil War - horses pulling wagons, soldiers in various garb and condition, even boats of sailors rowing past. In the fall '84 issue of National Building Museum Blueprints, editor Joyce Elliott notes that "the frieze has come to life and is revealed as a major work of American 19th century sculpture", note that it is "freed from a century of severely encrusted dirt".

terra cotta frieze which encircles the building. There was no need for a prewash application on either surface. GSA inspectors visiting the site twice a day, concurred. Cleaning materials were rinsed from the surface with 500-600 psi cold water.

As the Pension Building came clean, decorative brickwork and sculptured terra cotta slowly became visible. Photographers and observers watching the Pension Building remarked that each time they visited the site there was more to see as the building emerged from beneath the layers of grime. *Blueprints*, the official publication of The National Building Museum, noted in their fall '84 issue, "The effect of the cleaning has been astounding passersby who are seeing for the first time the startlingly beautiful color of the brick walls and terra cotta ornament contrasted with the buff colored frieze".

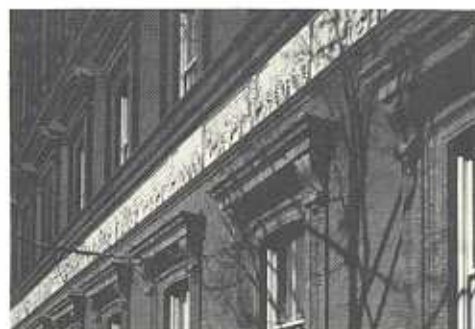
The terra cotta frieze stretches down the side of the cleaned Pension Building.

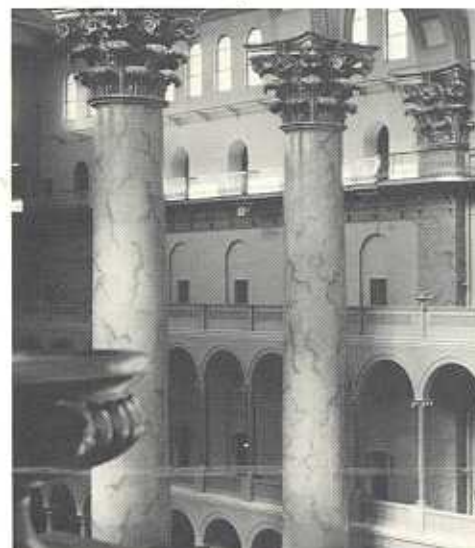
The beautiful Great Hall, with columns marbleized.

Inside the Pension Building is the famous Great Hall, a huge vaulted open court where inaugural balls were held for years. The Hall is an airy, light space with a 75 foot ceiling painted light blue to suggest the sky. This unusual use of open space was considered very radical in 1881. The eight massive columns in the Great Hall are constructed of 55,000 brick, seventy-five feet high, painted to look like marble.

Sure Klean® Heavy Duty Paint Stripper was used to remove paint which was 15-20 layers deep on the massive columns. Two applications of Heavy Duty Paint Stripper were used, the first with a dwell time of 4-6 hours, the second coat being left on overnight. Working inside meant that the contractor used a small gas-powered pressure washer and collected residues with a wet vac. Pressure was maintained around 400 psi. The pressure rig was operated in a doorway with doors open for ventilation.

The Great Hall columns have been repainted to suggest Siena marble. Elaborate studies of the building archives suggested the historical color scheme which was chosen to paint the interior, including the columns.

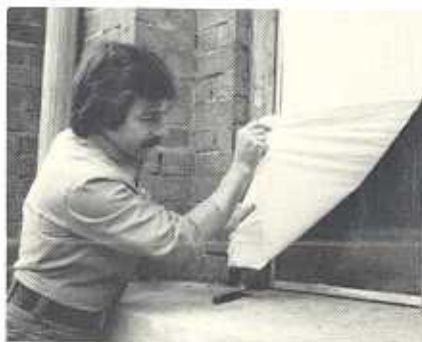
Easy removal of Acid Stop® - lift and peel.

Application of Acid Stop® can be five times faster than putting up polyethylene. Workmen simply brush or roller apply the material to the glass or metal surface, taking care to keep the coating off porous masonry, wood and painted surfaces. The coating should be 1.5 to 2 mils thick, creating a uniformly white area. The masking agent is allowed to thoroughly dry (20 minutes) before exposing it to cleaning solutions, water pressure, etc. When cleaning is complete the material is simply peeled from the surface by lifting one corner and pulling off in one piece.

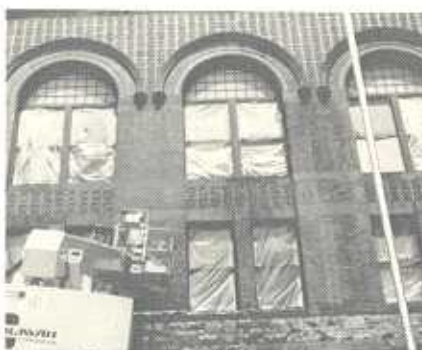
Polyurethane, used to protect windows during restoration cleaning, often comes loose several times during a job.

A heavy gauge polyethylene is frequently used to cover windows. The polyethylene is cut to fit and taped around the edges with duct tape, or stapled to window frames. This method can be effective however it has limitations:

1. Windows can't be opened and closed while cleaning progresses. This can be a serious problem if an occupied building does not have air conditioning, especially if the cleaning continues over a long period of time.
2. Installation and removal of the polyethylene requires a lot of time and labor.
3. The material often comes loose and has to be replaced, sometimes three times or more during a job. Kevin Petri of All Purpose Steam Cleaning, in windy Mizzoula, Montana, says "... when we estimate the cost of window protection using polyethylene we allow enough labor and material to repair the polyethylene at least twice."

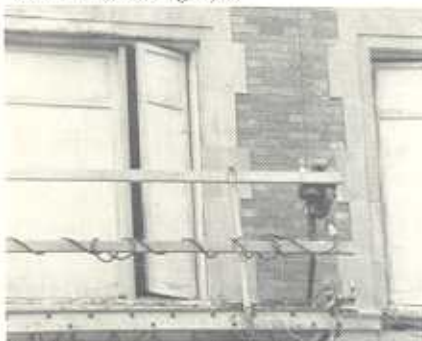
Acid Stop® allows windows to be opened while job is progressing.

One alternative is to use a liquid masking agent such as Sure Klean® Acid Stop®. This is a liquid chemical protection that dries on the window to protect it. After the cleaning job is finished, the material is simply peeled off the glass or metal surface. Acid Stop® is easier to apply, allows windows to be opened and closed, and stays in place after the material is applied.

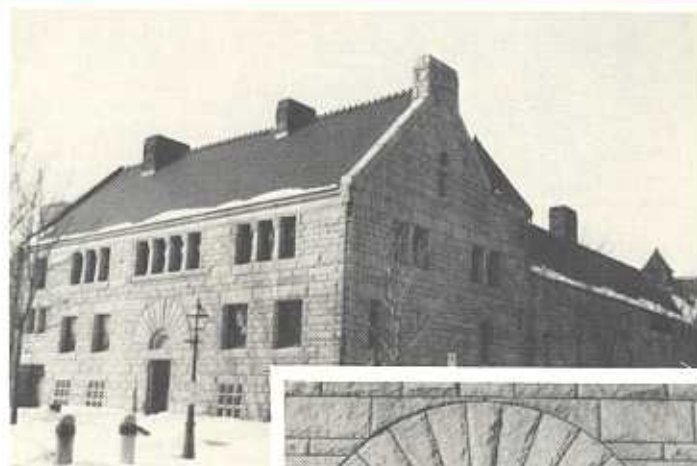
Twelve hand-carved pieces of granite were used to create the organic motif above the entrance to Glessner House.

Cleaning was completed by February and everyone involved with restoration of the Glessner House said the change was amazing. Before cleaning began, the Glessner House was a dark, heavy structure that looked like a fortress. Now that it has been cleaned, Susan Tindall, says "the granite just sparkles. The entire house has a totally different mood."

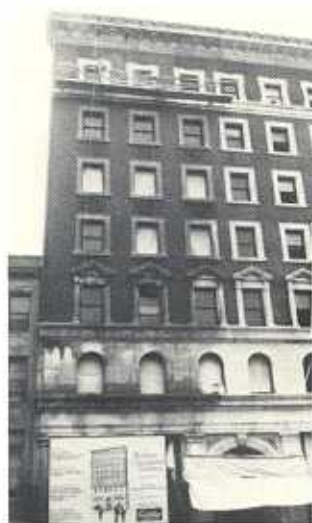
Water vapor escapes into the air as workers clean the arched granite entrance of the Warren Chambers.

Peter Dalton of Chapman Waterproofing mentioned, "we used garden oscillators to presoak the building and loosen carbon" on the white marble facade. After presoaking, Limestone Prewash/Afterwash was used to clean the marble, Restoration Cleaner was used to clean the brick.

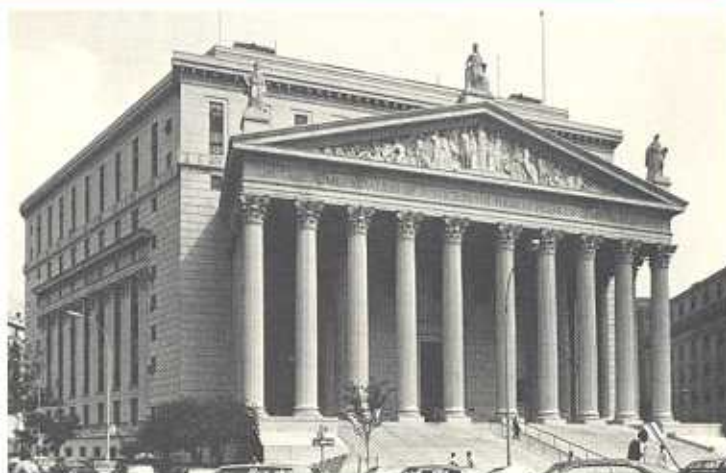
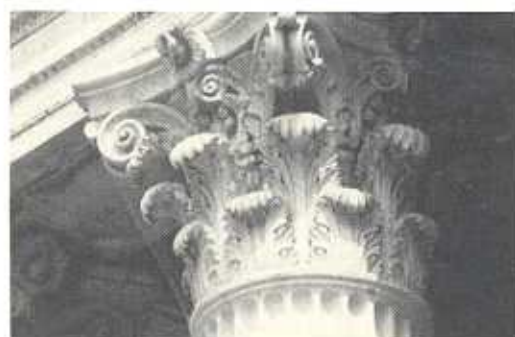
(Above) Pigeon Control netting on the New York State Supreme Court Building is not visible from the street. (Right) Telephoto closeup shows Pigeon Control around column capitals.

In the summer of 1984, the Courthouse was cleaned using Sure Klean® Heavy Duty Restoration Cleaner. Windows were protected with Acid Stop®. Following cleaning and other repairs, Conservare® Pigeon Control was put in place. The netting in a gray color (to blend with the gray granite) was attached around cornices, statuary and decorative stone work, to protect the structure from pigeons in the future.
