ProSoCo News

Summer 1988

A capital restoration for a dignified nation

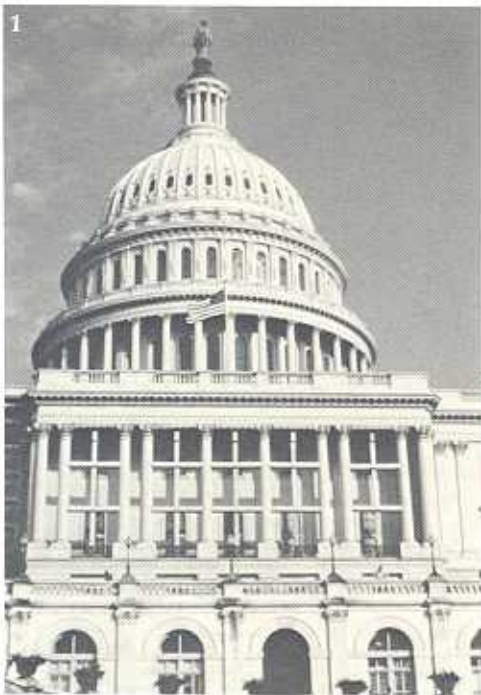
1. Huge wooden trusses braced the weakened colonnade for two decades before the collapse of nearly 100 square feet of original sandstone veneer.

- 1983 Nearly 100 square feet of sandstone veneer slabs, each about eight inches thick, fell from the West front of the Capitol, crashing down on the courtyard. This particular veneer came from a section built in 1802-1807 — the original House wing of the building. The collapse occurred on April 27, two days after a House Appropriations Committee had approved \$70.5 million to buttress the deteriorating walls.

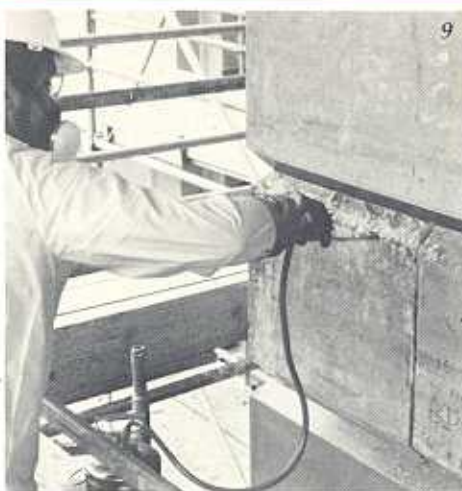
9. Specially adapted airless spray applicators were used by the contractor to apply H Stone Strengthener. The equipment provided a controlled, low pressure spray of the material.

sections 72 feet across by seven feet tall. Again, specially adapted airless spray equipment was utilized. Each precisely executed cycle consisted of a series of three consecutive saturating coats, applied bottom to top at 10 to 15 minute intervals. Five cycles of the consolidation treatment were applied to the sandstone and three cycles to the replacement limestone at 45 minute intervals. "I thought the job went pretty much according to plan," said Mike Nagle of Brisk. "It was a great joint effort between the contractor and manufacturer." Because the walls were being heated prior to application, penetration was much better than expected; one-and-one-half to four inches on the sandstone and one to one-and-one-half inches on the limestone. "The depth of penetration is one of the main considerations for an effective consolidation," commented John Bourne.

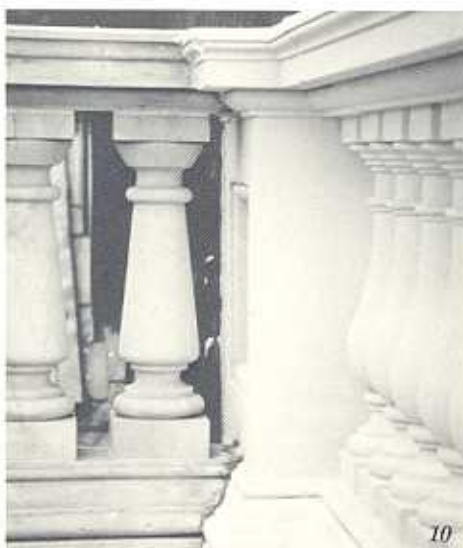
10. BMC protects masonry surfaces from accelerated deterioration related to the presence of water. The microporous film maintains as much as 95% moisture vapor transmission.

Following treatment with Conservare® H, the next step was to apply Conservare® Breathable Masonry Coating. A water-based coating, BMC is chemically compatible with the stone consolidation treatment and completes the protection "system" selected for the project. BMC maintains 95% of the natural moisture vapor transmission of the stone. "Moisture is inherent to natural stone and masonry substrates," explained Mike Boyer, vice president, marketing, for ProSoCo. "Exceptional vapor permeability of the coating also reduces the potential for peeling, blistering and other common coating failures. This is important not only for the integrity of the coating, but also the stability of the underlying stone. If excessive moisture is allowed to accumulate behind the coating, deterioration of the stone and mortar accelerates."

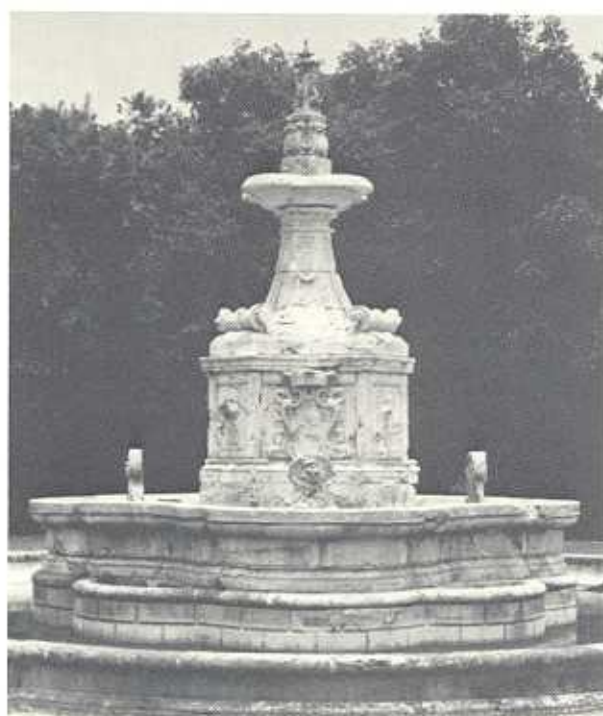
Centuries old and among those treated with stone strengthener is the Bassano di Sutri. This Baroque fountain was purchased for Vizcaya from a town near Rome bearing the same name.

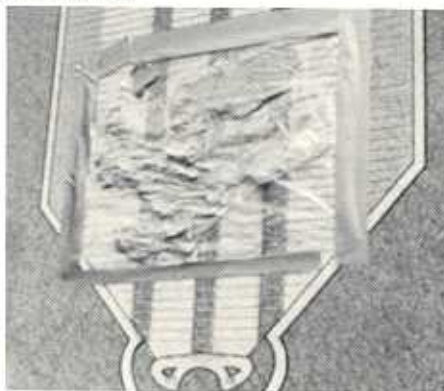
The 940 Paint Stripper system was used to remove ink stains from the polished granite of the Vietnam Veterans Memorial in Kansas City, Missouri. The poultice mixture shown here proved extremely effective in removing deep set ink stains that defaced the memorial.

A poultice is a moist paste produced by blending an absorbent dry powder with a liquid. To remove graffiti shadows, Sure Klean® Marble Poultice (dry powder) is blended with 940 Paint Stripper and water to form a poultice paste. This paste is trowel applied over the stained area, covered and left for 3 to 6 hours. Solvents in the 940 Paint Stripper penetrate into the masonry dissolving and mobilizing the graffiti shadows. As the poultice mix dries, the solvents and graffiti shadows are absorbed into the poultice paste for removal.
