BACK ON TRACK: A STORY OF REVIVAL FOR KANSAS CITY'S UNION STATION

Union Station

LOCATION Kansas City, Missouri

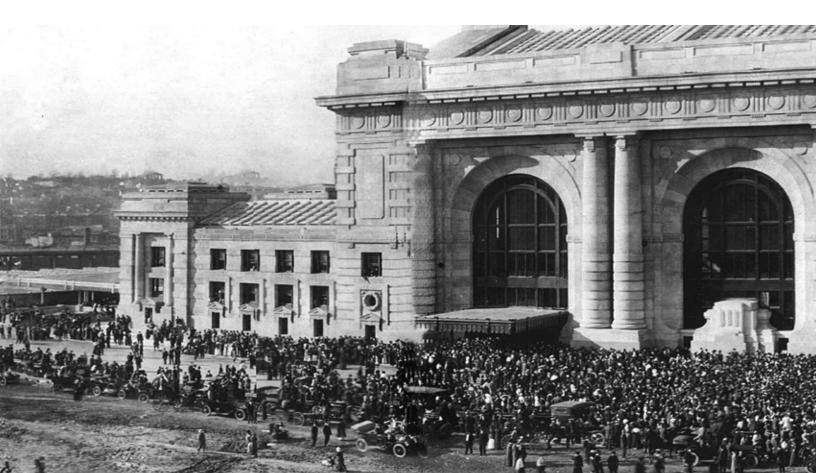
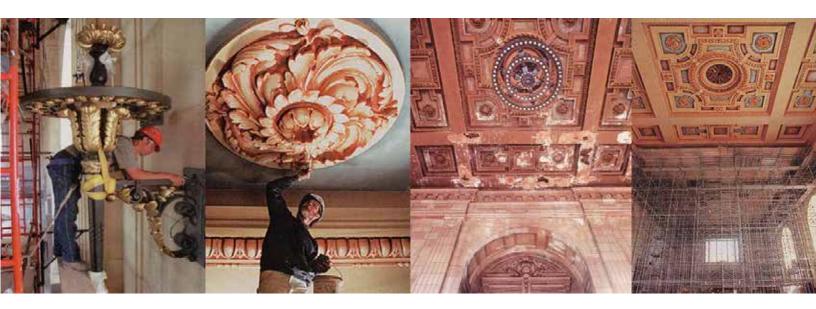
"We let the prewash dwell about 30 to 50 minutes and the afterwash 3 to 5 minutes," said BRC Job Foreman Todd Pastorius. "We could see immediate results, even before the surface dried. The difference was literally black and white -well, off-white, really, since that was the original color of the limestone."

Although the original specs called for cleaning the station with ionized water, test panels revealed better results with a custom blend of PROSOCO's **766 Limestone & Masonry Prewash**, followed by **Limestone & Masonry Afterwash**.

Though the cleaning was straightforward -- brush and low-pressure spray application, followed by a 1,000-psi fresh water spray rinse, the building itself provided plenty of challenges. An underground viaduct ran the length of the station's front, Zoerb explained. It was unstable, so workers couldn't drive their trucks up to the site to upload. Instead, every piece of equipment was hand-carried to its place.
