*Pallet Tag Program  
Laboratory Report*

**Petersen Tegl**  
Broager, Denmark

*Project No. 1905-05 PTP*

**SUBJECT:** Petersen Tegl  
Broager, Denmark  
New Construction Cleaning and Adverse Effects Evaluation

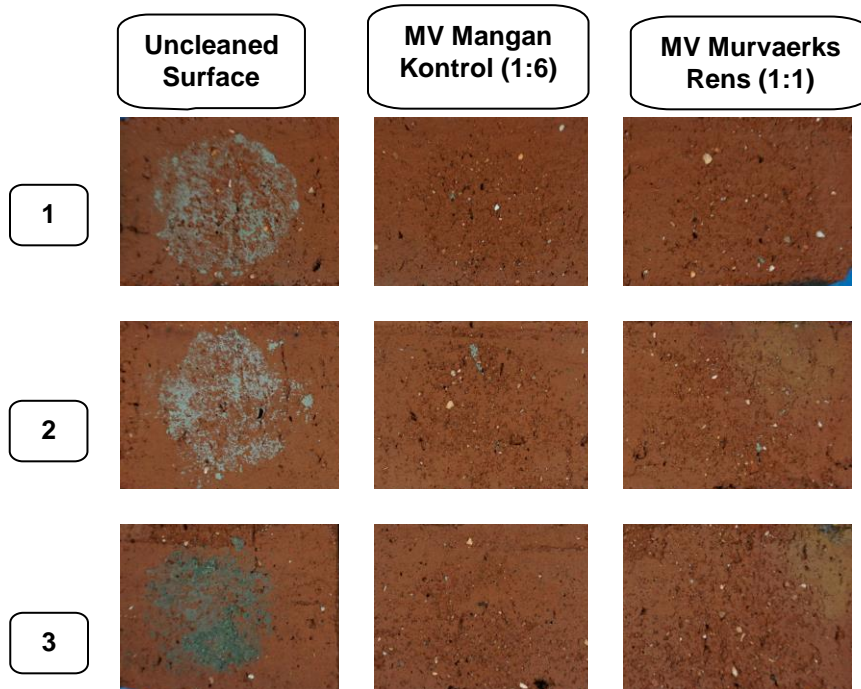
**“D33” Brick After Cleaning**

Information regarding surface alteration can be found under the “New Construction Cleaning” section of the report (pp.8-28).

It is recommended that the selected cleaners always be used in the lowest possible concentration.

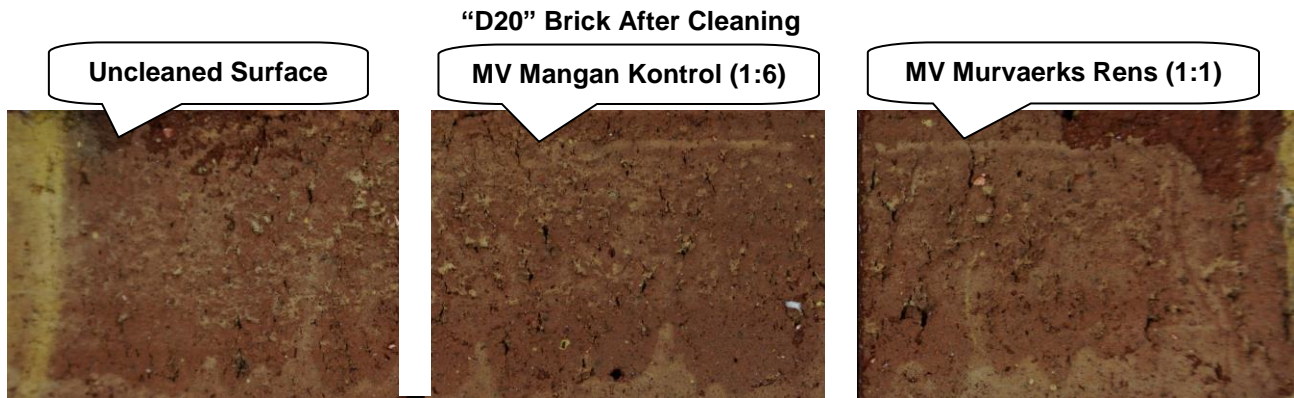
<b>Name: "D20" Brick</b>					
Product	Dilution	Surface Finish Removal	Substrate Deterioration	Color Change	Staining
MV Mangan Kontrol	1:6	0	0	0	0
MV Murvaerks Rens	1:1	0	0	0	0

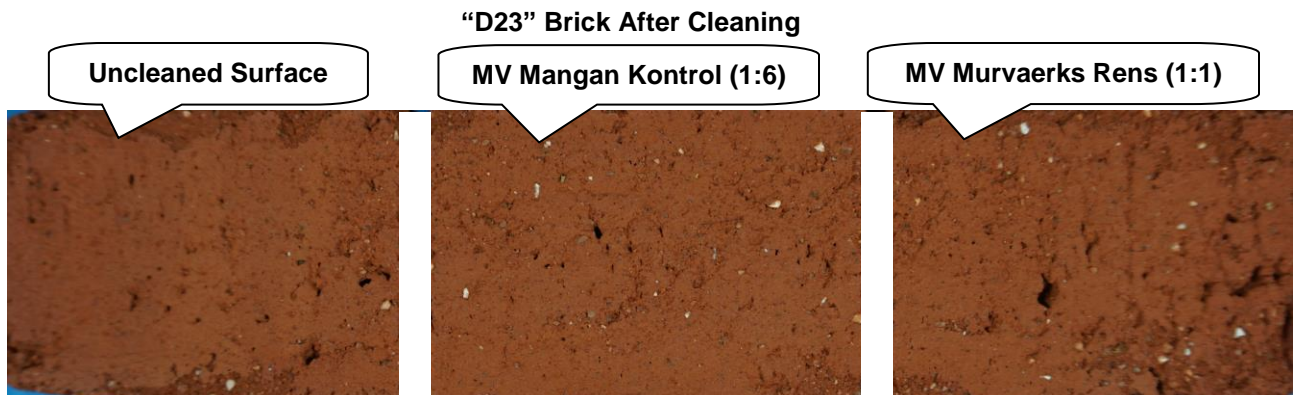
<b>Name: "D23" Brick</b>					
Product	Dilution	Surface Finish Removal	Substrate Deterioration	Color Change	Staining
MV Mangan Kontrol	1:6	0	0	0	0
MV Murvaerks Rens	1:1	0	0	0	0

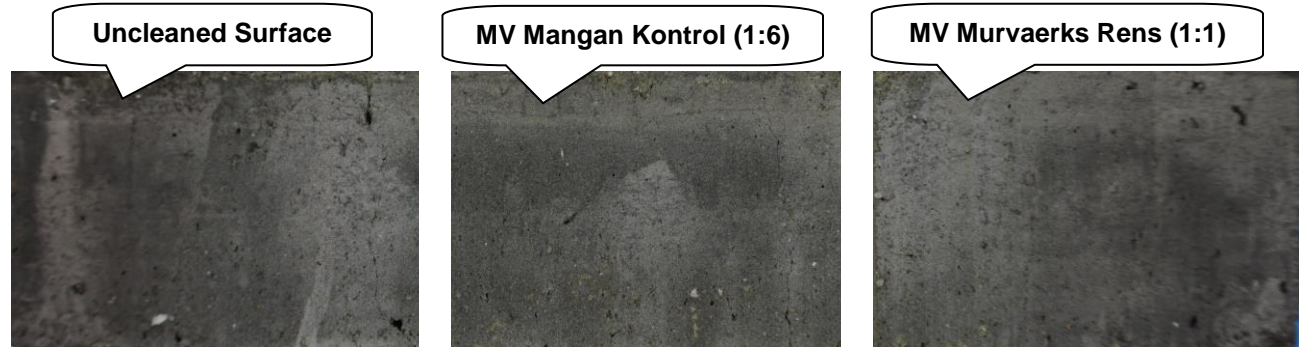
**"D29" Brick After Cleaning**

Name: "D29" Brick					
Product	Dilution	Surface Finish Removal	Substrate Deterioration	Color Change	Staining
MV Mangan Kontrol	1:6	0	0	0	0
MV Murvaerks Rens	1:1	0	0	0	0

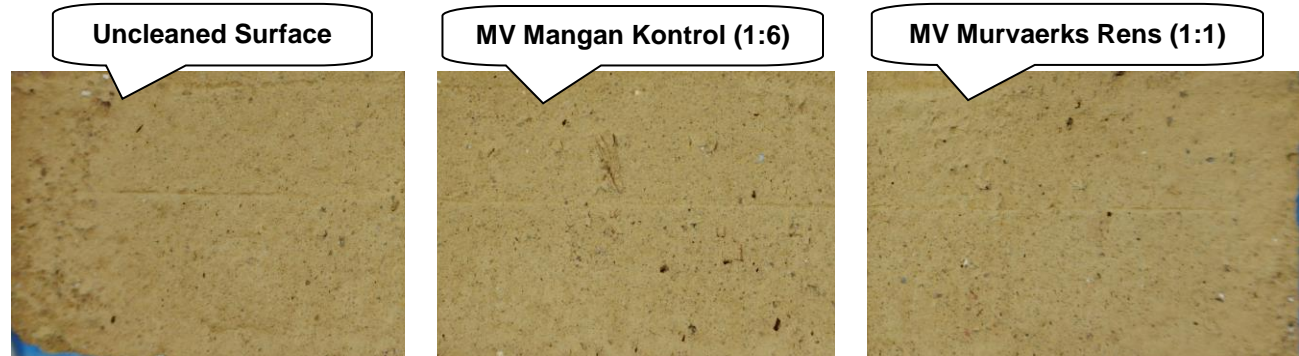
**"D31" Brick After Cleaning**

Name: "D31" Brick					
Product	Dilution	Surface Finish Removal	Substrate Deterioration	Color Change	Staining
MV Mangan Kontrol	1:6	0	0	0	0
MV Murvaerks Rens	1:1	0	0	0	0

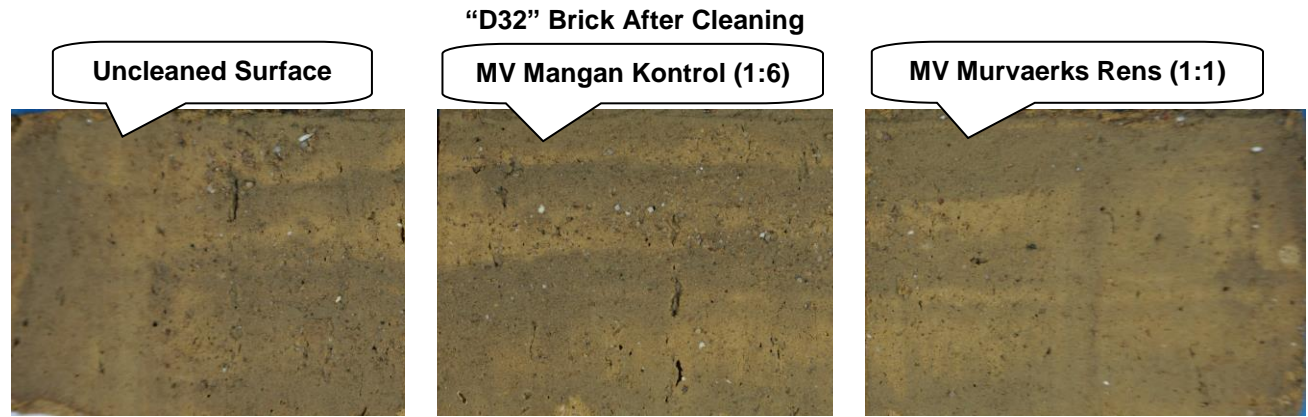
Name: "D32" Brick					
Product	Dilution	Surface Finish Removal	Substrate Deterioration	Color Change	Staining
MV Mangan Kontrol	1:6	0	0	0	0
MV Murvaerks Rens	1:1	0	0	0	0

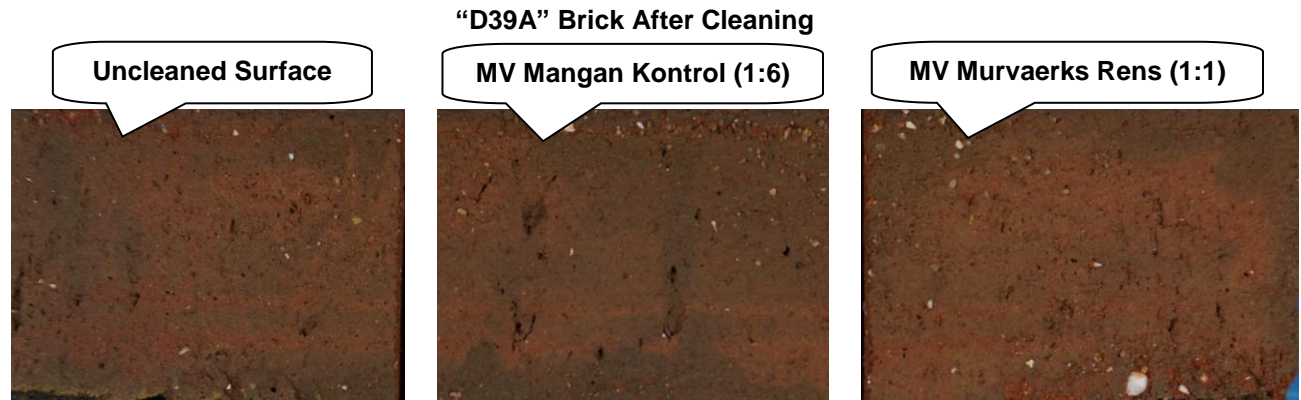
Name: "D39A" Brick					
Product	Dilution	Surface Finish Removal	Substrate Deterioration	Color Change	Staining
MV Mangan Kontrol	1:6	0	0	0	0
MV Murvaerks Rens	1:1	0	0	0	0

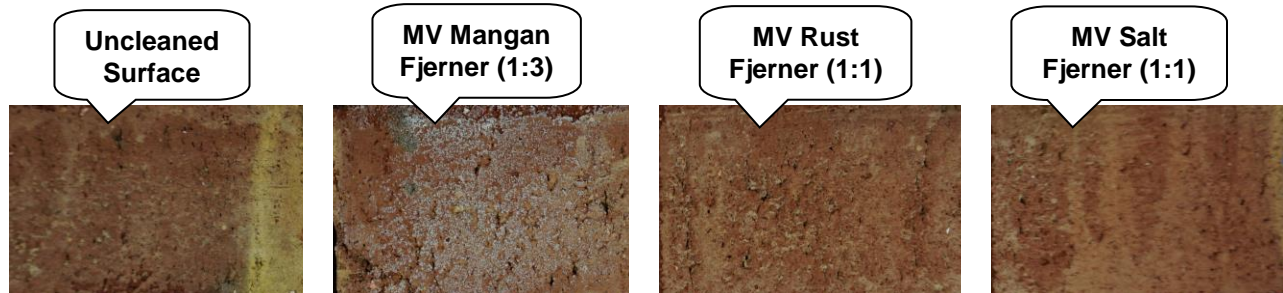
**"D20" Brick After Testing**

Name: "D20" Brick					
Product	Dilution	Surface Finish Removal	Substrate Deterioration	Color Change	Staining
MV Mangan Fjerner	1:3	0	0	0	2
MV Rust Fjerner	1:1	0	0	0	0
MV Salt Fjerner	1:1	0	0	0	0

**NOTE:** The brick as submitted displayed significant color variation prior to testing.

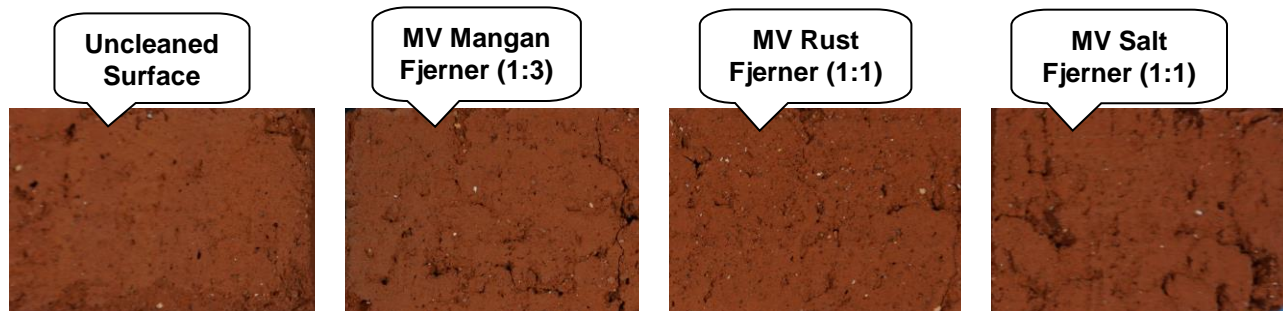
**"D23" Brick After Testing**

Name: "D23" Brick					
Product	Dilution	Surface Finish Removal	Substrate Deterioration	Color Change	Staining
MV Mangan Fjerner	1:3	0	0	0	0
MV Rust Fjerner	1:1	0	0	0	0
MV Salt Fjerner	1:1	0	0	0	0

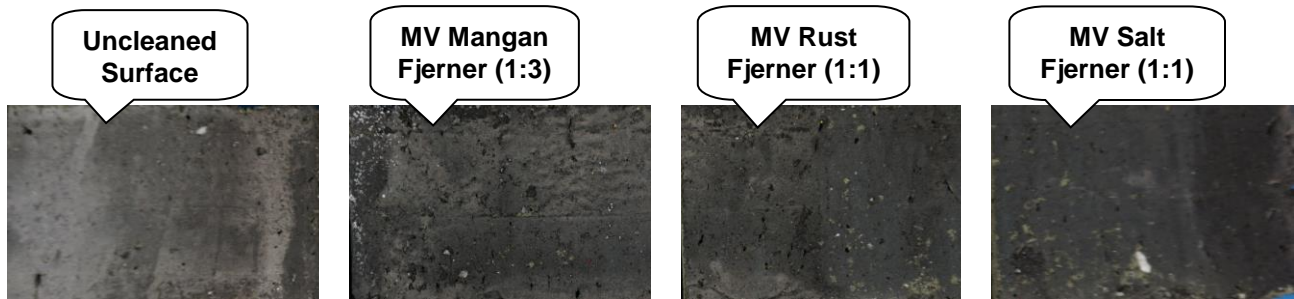
**"D29" Brick After Testing**

Name: "D29" Brick					
Product	Dilution	Surface Finish Removal	Substrate Deterioration	Color Change	Staining
MV Mangan Fjerner	1:3	0	0	0	0
MV Rust Fjerner	1:1	0	0	0	0
MV Salt Fjerner	1:1	0	0	0	0

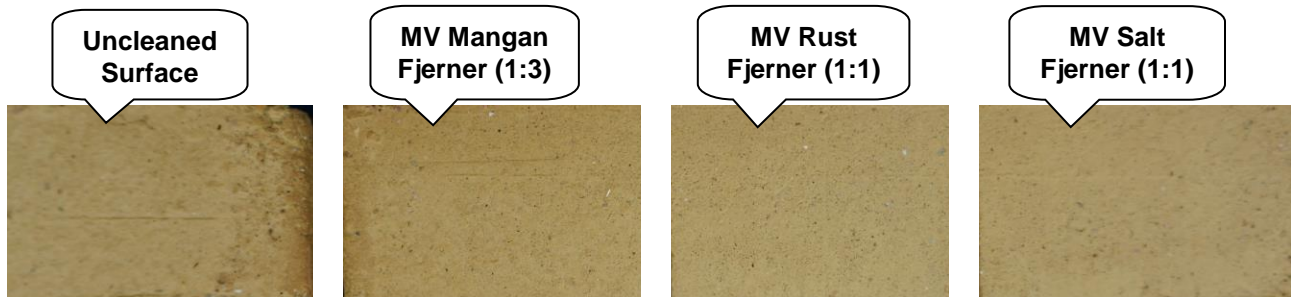
**"D31" Brick After Testing**

Name: "D31" Brick					
Product	Dilution	Surface Finish Removal	Substrate Deterioration	Color Change	Staining
MV Mangan Fjerner	1:3	1	0	0	0
MV Rust Fjerner	1:1	0	0	0	0
MV Salt Fjerner	1:1	0	0	0	0

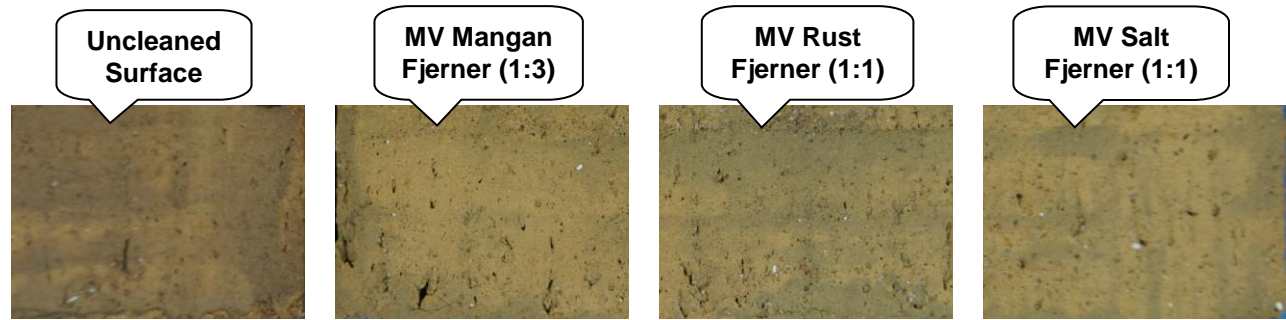
**"D32" Brick After Testing**

Name: "D32" Brick					
Product	Dilution	Surface Finish Removal	Substrate Deterioration	Color Change	Staining
MV Mangan Fjerner	1:3	0	0	0	0
MV Rust Fjerner	1:1	0	0	0	0
MV Salt Fjerner	1:1	0	0	0	0

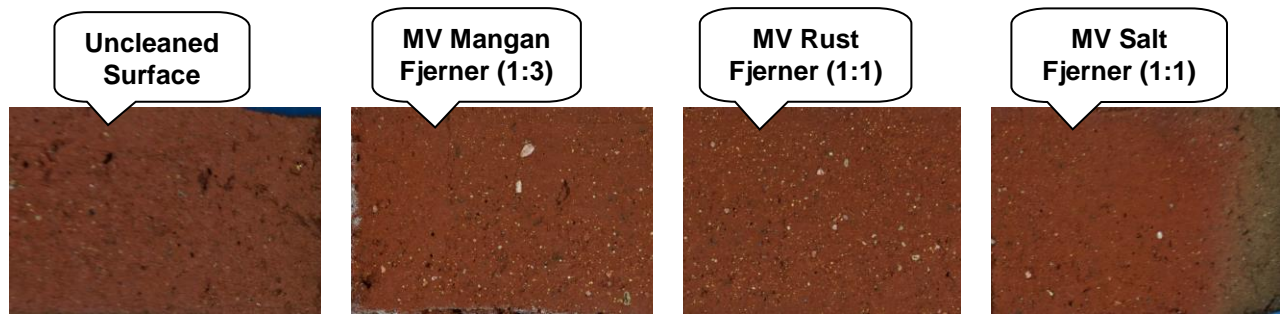
**"D34" Brick After Testing**

Name: "D34" Brick					
Product	Dilution	Surface Finish Removal	Substrate Deterioration	Color Change	Staining
MV Mangan Fjerner	1:3	0	0	0	0
MV Rust Fjerner	1:1	0	0	0	0
MV Salt Fjerner	1:1	0	0	0	0

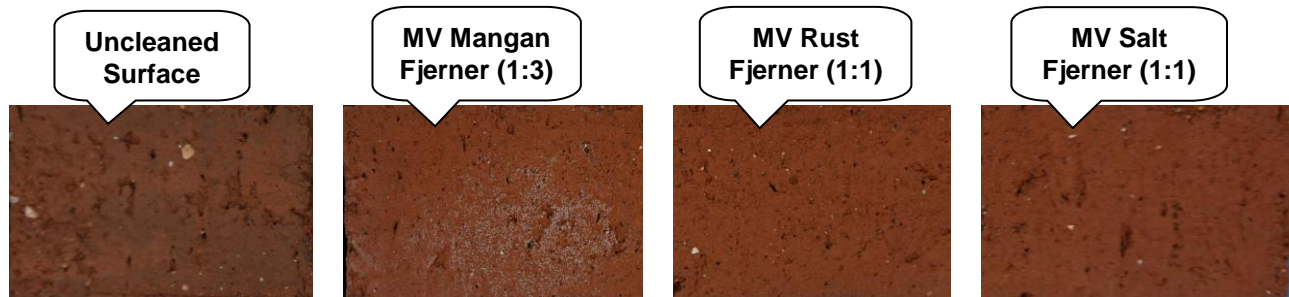
**"D35" Brick After Testing**

Name: "D35" Brick					
Product	Dilution	Surface Finish Removal	Substrate Deterioration	Color Change	Staining
MV Mangan Fjerner	1:3	0	0	0	1
MV Rust Fjerner	1:1	0	0	0	0
MV Salt Fjerner	1:1	0	0	0	0

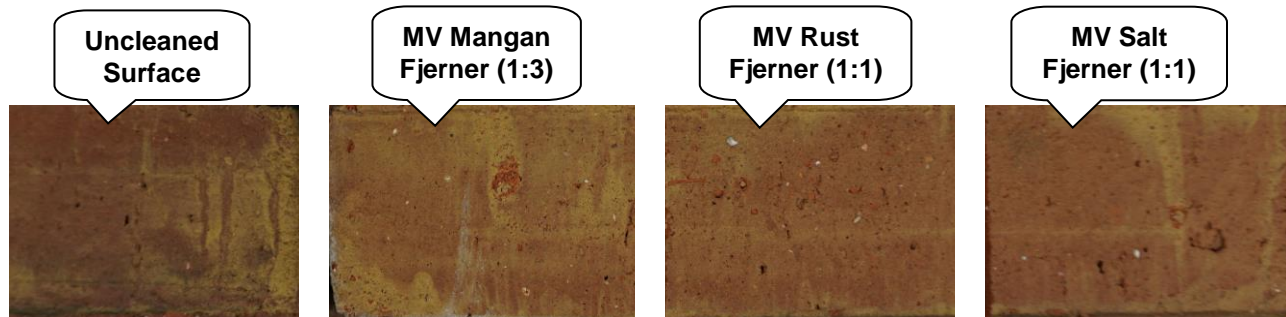
**"D38" Brick After Testing**

Name: "D38" Brick					
Product	Dilution	Surface Finish Removal	Substrate Deterioration	Color Change	Staining
MV Mangan Fjerner	1:3	0	0	0	1*
MV Rust Fjerner	1:1	0	0	0	0
MV Salt Fjerner	1:1	0	0	0	0

\*NOTE: Very slight change compared to uncleaned surface.

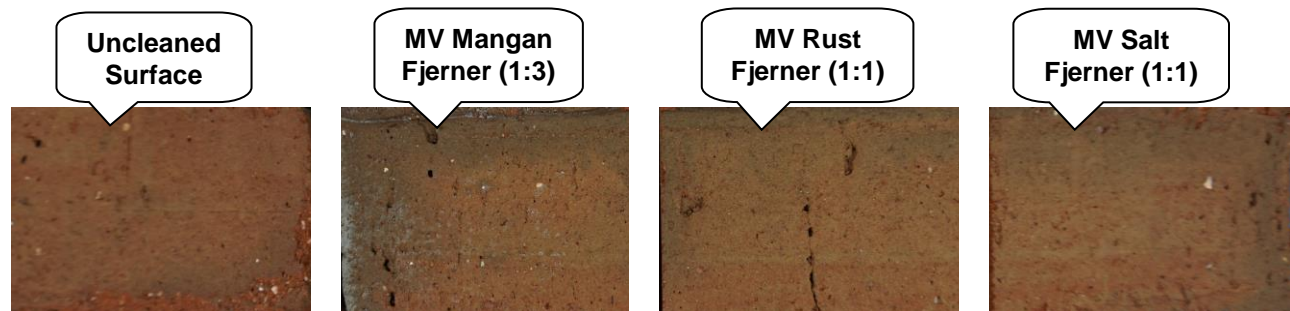
**"D39B" Brick After Testing**

Name: "D39B" Brick					
Product	Dilution	Surface Finish Removal	Substrate Deterioration	Color Change	Staining
MV Mangan Fjerner	1:3	0	0	0	1*
MV Rust Fjerner	1:1	0	0	0	0
MV Salt Fjerner	1:1	0	0	0	0

**\*NOTE: Very slight change compared to uncleaned surface.**

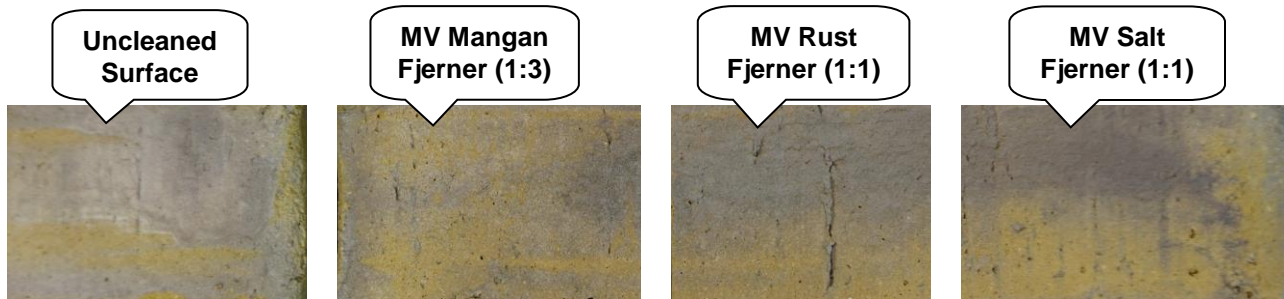
**"D42" Brick After Testing**

Name: "D42" Brick					
Product	Dilution	Surface Finish Removal	Substrate Deterioration	Color Change	Staining
MV Mangan Fjerner	1:3	1	0	0	0
MV Rust Fjerner	1:1	0	0	0	0
MV Salt Fjerner	1:1	0	0	0	0

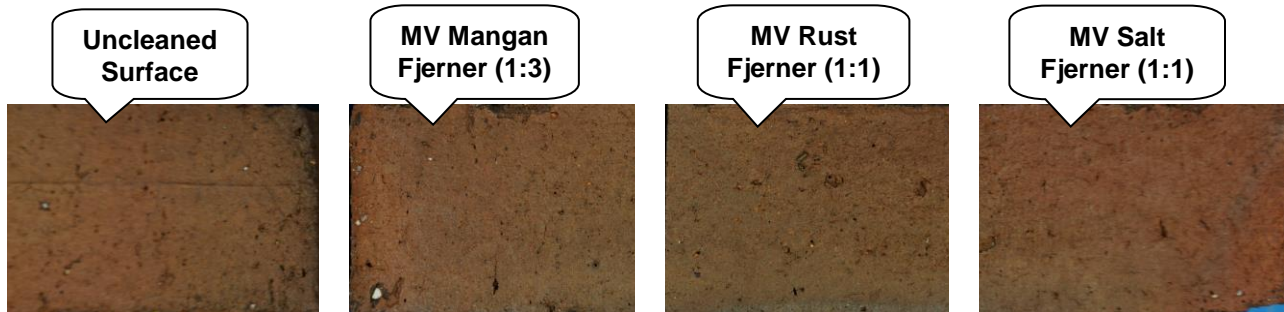
**"D43" Brick After Testing**

Name: "D43" Brick					
Product	Dilution	Surface Finish Removal	Substrate Deterioration	Color Change	Staining
MV Mangan Fjerner	1:3	0	0	0	0
MV Rust Fjerner	1:1	0	0	0	0
MV Salt Fjerner	1:1	0	0	0	0

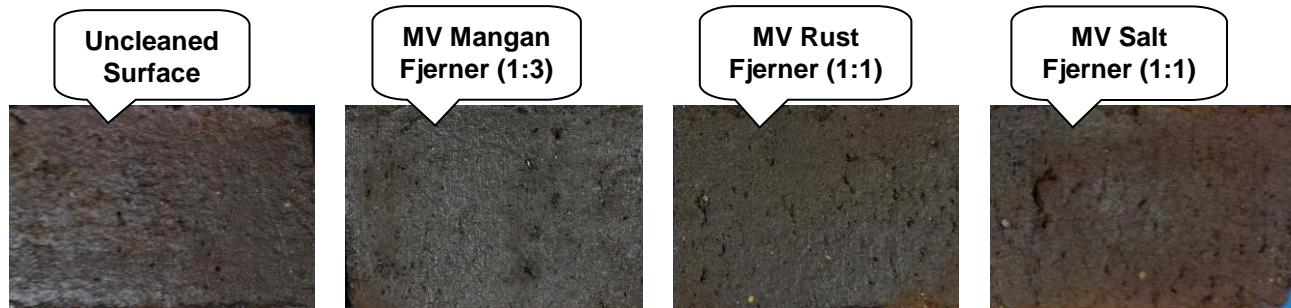
**"D45" Brick After Testing**

Name: "D45" Brick					
Product	Dilution	Surface Finish Removal	Substrate Deterioration	Color Change	Staining
MV Mangan Fjerner	1:3	0	0	0	1
MV Rust Fjerner	1:1	0	0	0	0
MV Salt Fjerner	1:1	0	0	0	0

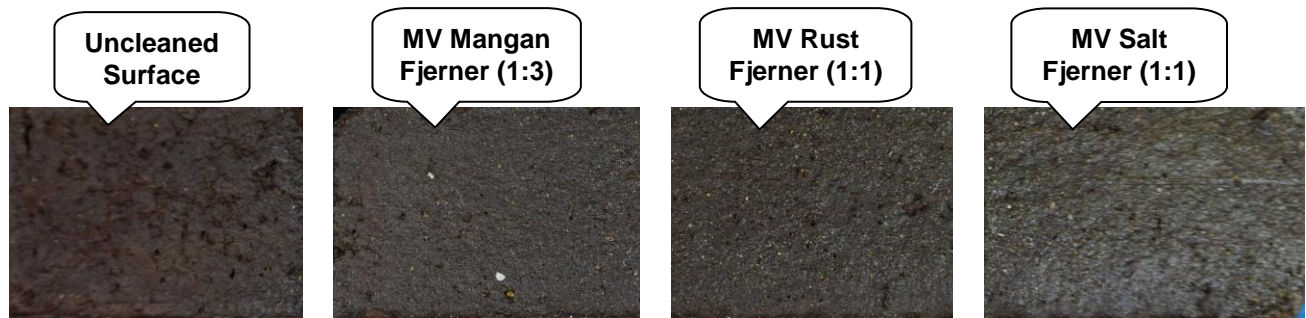
**"D49" Brick After Testing**

Name: "D49" Brick					
Product	Dilution	Surface Finish Removal	Substrate Deterioration	Color Change	Staining
MV Mangan Fjerner	1:3	0	0	0	0
MV Rust Fjerner	1:1	0	0	0	0
MV Salt Fjerner	1:1	0	0	0	0

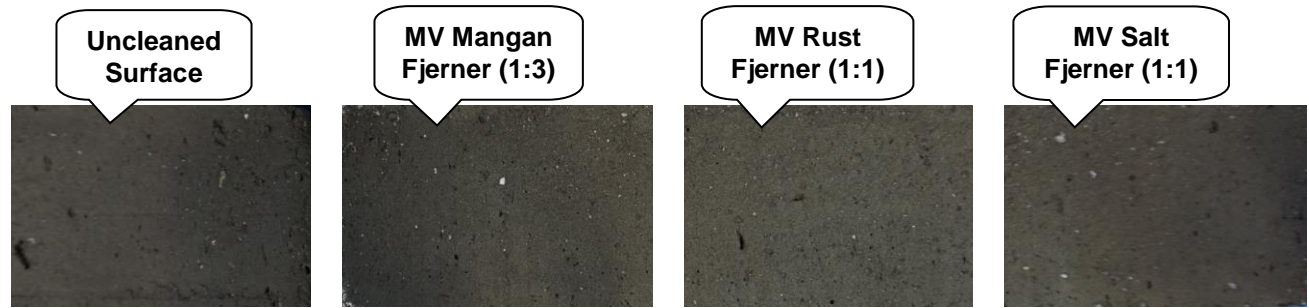
**"D54" Brick After Testing**

Name: "D54" Brick					
Product	Dilution	Surface Finish Removal	Substrate Deterioration	Color Change	Staining
MV Mangan Fjerner	1:3	0	0	0	0
MV Rust Fjerner	1:1	0	0	0	0
MV Salt Fjerner	1:1	0	0	0	0

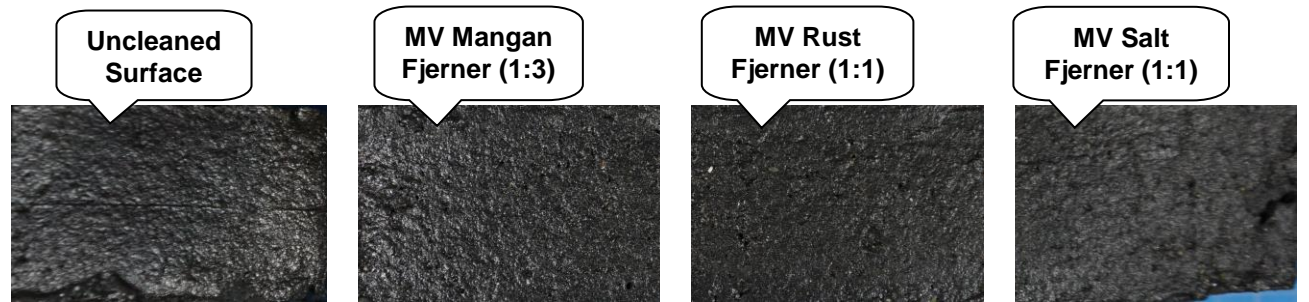
**"D55" Brick After Testing**

Name: "D55" Brick					
Product	Dilution	Surface Finish Removal	Substrate Deterioration	Color Change	Staining
MV Mangan Fjerner	1:3	0	0	0	0
MV Rust Fjerner	1:1	0	0	0	0
MV Salt Fjerner	1:1	0	0	0	0

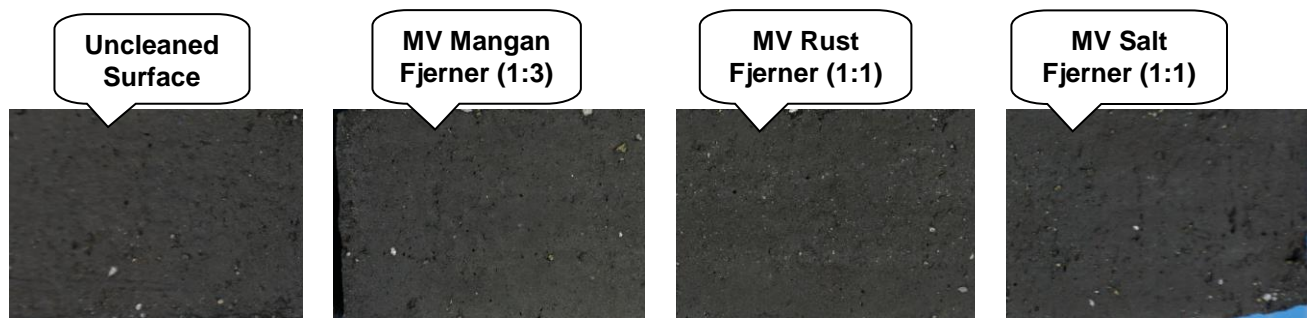
**"D58" Brick After Testing**

Name: "D58" Brick					
Product	Dilution	Surface Finish Removal	Substrate Deterioration	Color Change	Staining
MV Mangan Fjerner	1:3	0	0	0	0
MV Rust Fjerner	1:1	0	0	0	0
MV Salt Fjerner	1:1	0	0	0	0

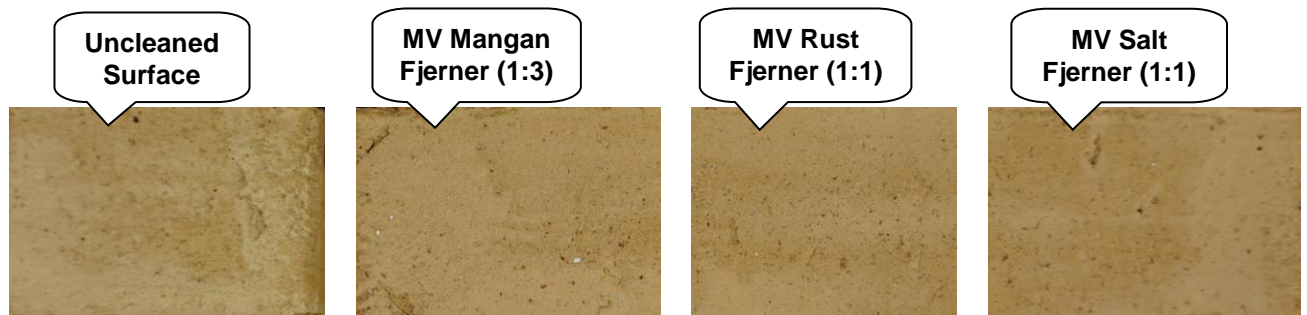
**"D70" Brick After Testing**

Name: "D70" Brick					
Product	Dilution	Surface Finish Removal	Substrate Deterioration	Color Change	Staining
MV Mangan Fjerner	1:3	1*	0	0	0
MV Rust Fjerner	1:1	0	0	0	0
MV Salt Fjerner	1:1	0	0	0	0

\*NOTE: Very slight change compared to uncleaned surface.

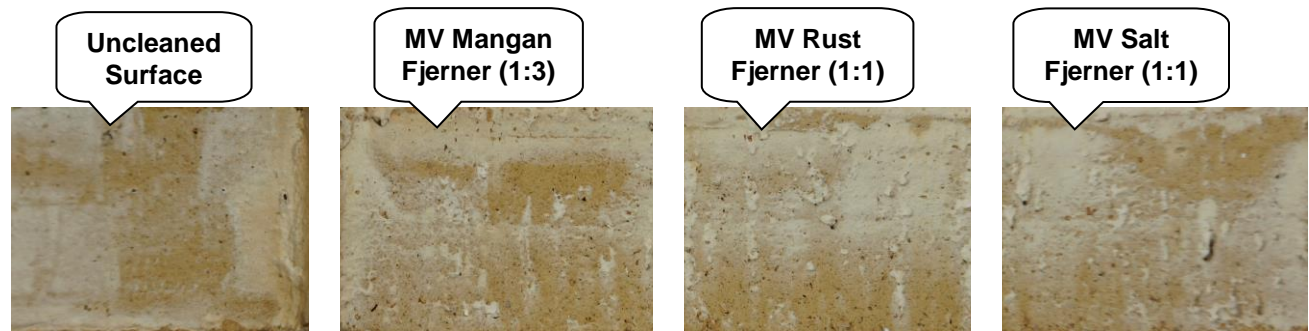
**"D71" Brick After Testing**

Name: "D71" Brick					
Product	Dilution	Surface Finish Removal	Substrate Deterioration	Color Change	Staining
MV Mangan Fjerner	1:3	0	0	0	0
MV Rust Fjerner	1:1	0	0	0	0
MV Salt Fjerner	1:1	0	0	0	0

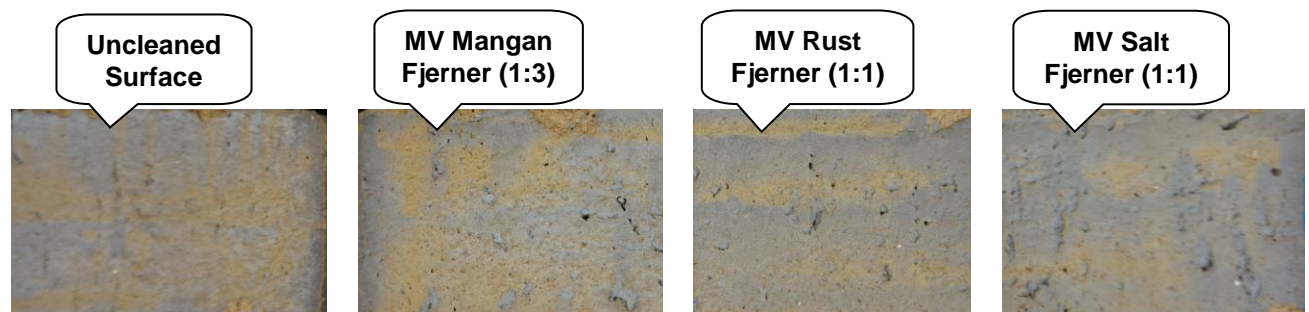
**"D72" Brick After Testing**

Name: "D72" Brick					
Product	Dilution	Surface Finish Removal	Substrate Deterioration	Color Change	Staining
MV Mangan Fjerner	1:3	0	0	0	0
MV Rust Fjerner	1:1	0	0	0	0
MV Salt Fjerner	1:1	0	0	0	0

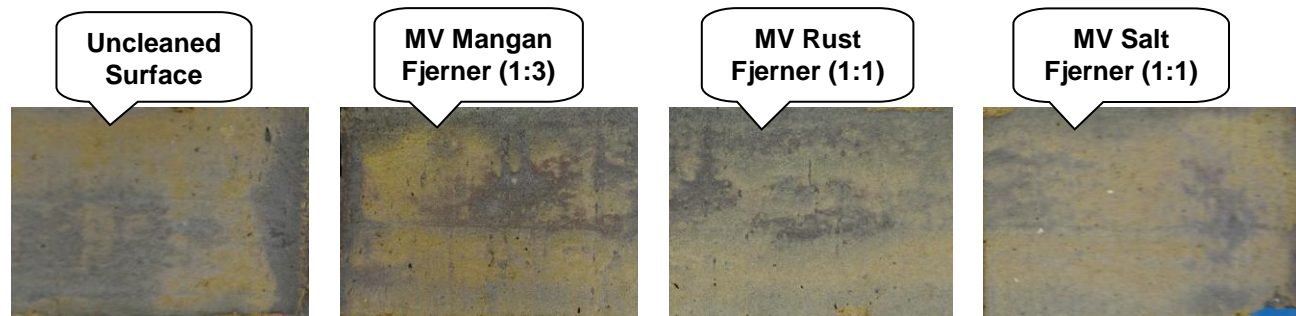
**"D73" Brick After Testing**

Name: "D73" Brick					
Product	Dilution	Surface Finish Removal	Substrate Deterioration	Color Change	Staining
MV Mangan Fjerner	1:3	0	0	0	0
MV Rust Fjerner	1:1	0	0	0	0
MV Salt Fjerner	1:1	0	0	0	0

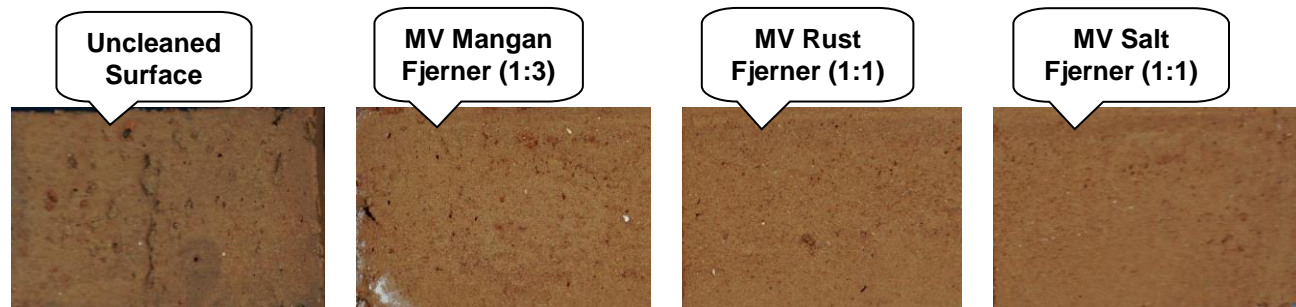
**"D76" Brick After Testing**

Name: "D76" Brick					
Product	Dilution	Surface Finish Removal	Substrate Deterioration	Color Change	Staining
MV Mangan Fjerner	1:3	1	0	0	0
MV Rust Fjerner	1:1	0	0	0	0
MV Salt Fjerner	1:1	0	0	0	0

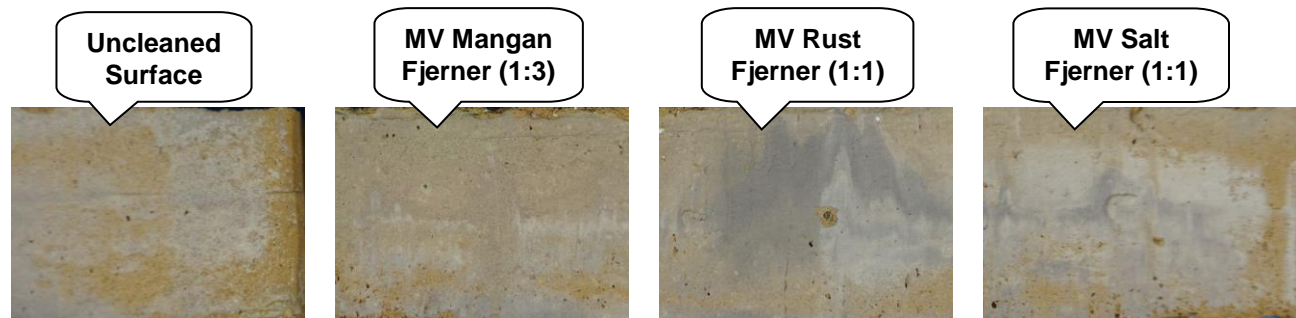
**"D78" Brick After Testing**

Name: "D78" Brick					
Product	Dilution	Surface Finish Removal	Substrate Deterioration	Color Change	Staining
MV Mangan Fjerner	1:3	1	0	0	0
MV Rust Fjerner	1:1	0	0	0	0
MV Salt Fjerner	1:1	0	0	0	0

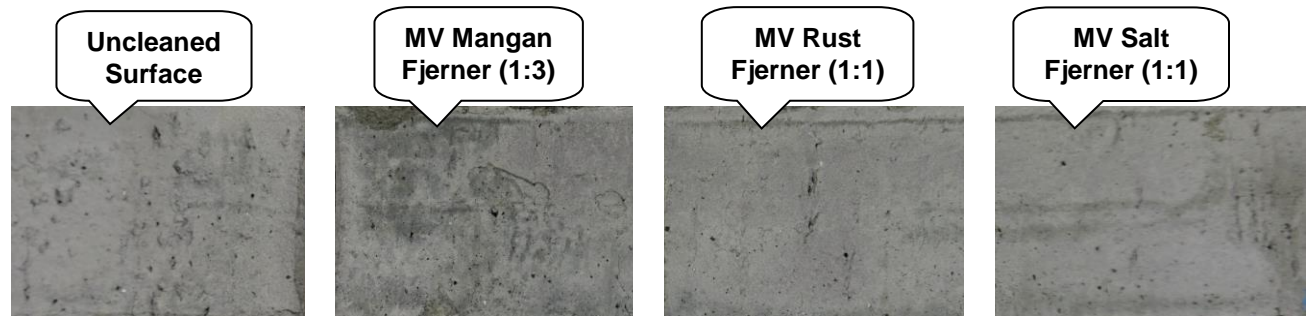
**"D81" Brick After Testing**

Name: "D81" Brick					
Product	Dilution	Surface Finish Removal	Substrate Deterioration	Color Change	Staining
MV Mangan Fjerner	1:3	0	0	0	0
MV Rust Fjerner	1:1	0	0	0	0
MV Salt Fjerner	1:1	0	0	0	0

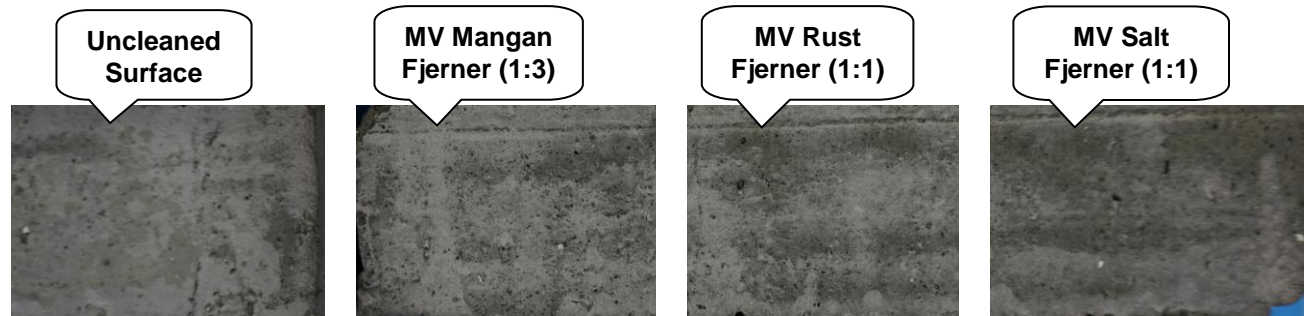
**"D91" Brick After Testing**

Name: "D91" Brick					
Product	Dilution	Surface Finish Removal	Substrate Deterioration	Color Change	Staining
MV Mangan Fjerner	1:3	0	0	0	0
MV Rust Fjerner	1:1	0	0	0	0
MV Salt Fjerner	1:1	0	0	0	0

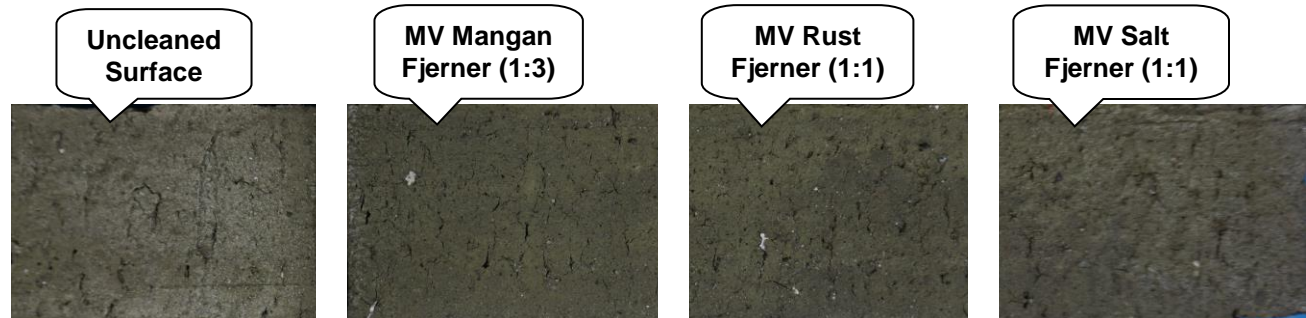
**"D92" Brick After Testing**

Name: "D92" Brick					
Product	Dilution	Surface Finish Removal	Substrate Deterioration	Color Change	Staining
MV Mangan Fjerner	1:3	0	0	0	0
MV Rust Fjerner	1:1	0	0	0	0
MV Salt Fjerner	1:1	0	0	0	0

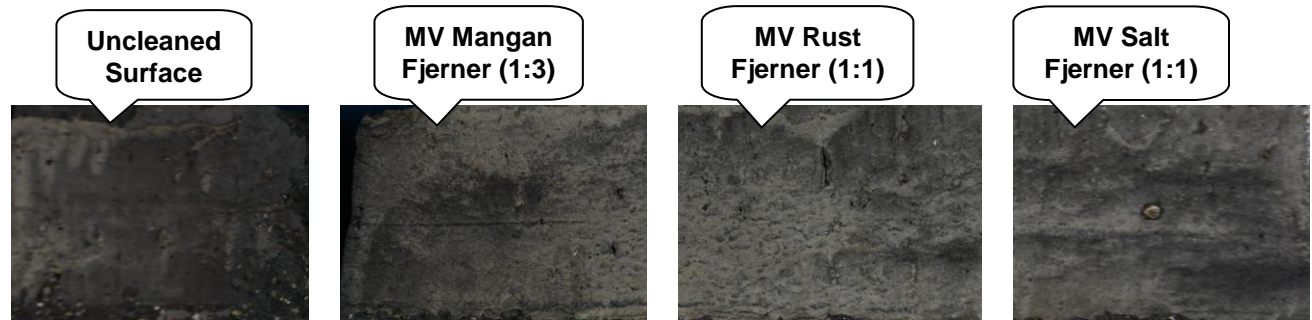
**"D96" Brick After Testing**

Name: "D96" Brick					
Product	Dilution	Surface Finish Removal	Substrate Deterioration	Color Change	Staining
MV Mangan Fjerner	1:3	0	0	0	0
MV Rust Fjerner	1:1	0	0	0	0
MV Salt Fjerner	1:1	0	0	0	0

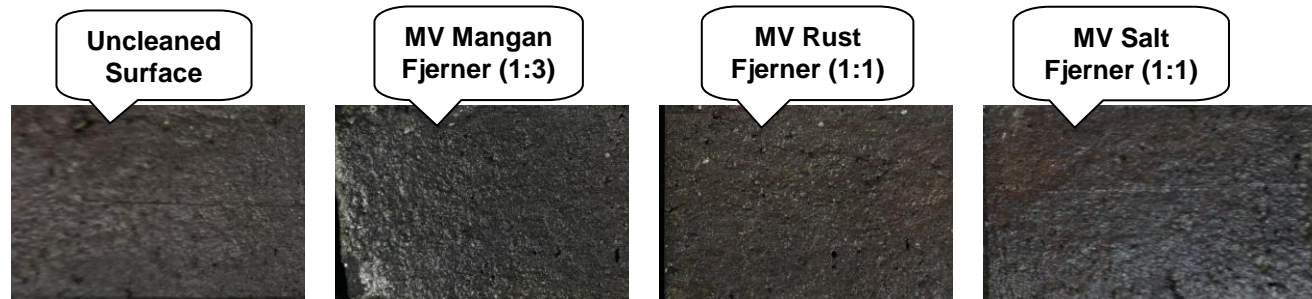
**"D97" Brick After Testing**

Name: "D97" Brick					
Product	Dilution	Surface Finish Removal	Substrate Deterioration	Color Change	Staining
MV Mangan Fjerner	1:3	0	0	0	0
MV Rust Fjerner	1:1	0	0	0	0
MV Salt Fjerner	1:1	0	0	0	0

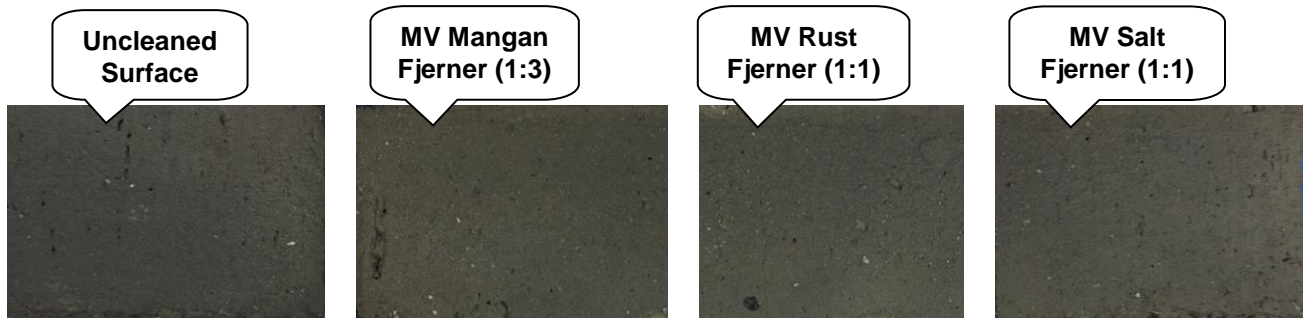
**"D98" Brick After Testing**

Name: "D98" Brick					
Product	Dilution	Surface Finish Removal	Substrate Deterioration	Color Change	Staining
MV Mangan Fjerner	1:3	0	0	0	0
MV Rust Fjerner	1:1	0	0	0	0
MV Salt Fjerner	1:1	0	0	0	0

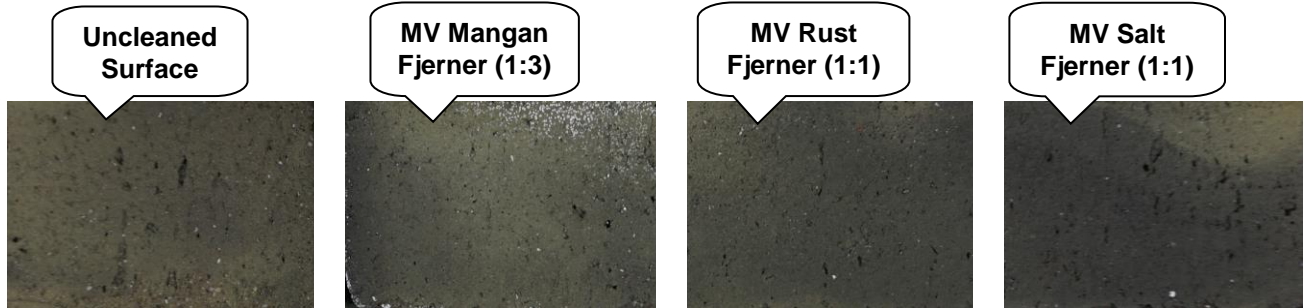
**"D137" Brick After Testing**

Name: "D137" Brick					
Product	Dilution	Surface Finish Removal	Substrate Deterioration	Color Change	Staining
MV Mangan Fjerner	1:3	0	0	0	1*
MV Rust Fjerner	1:1	0	0	0	0
MV Salt Fjerner	1:1	0	0	0	0

**\*NOTE:** Very slight change compared to uncleaned surface.

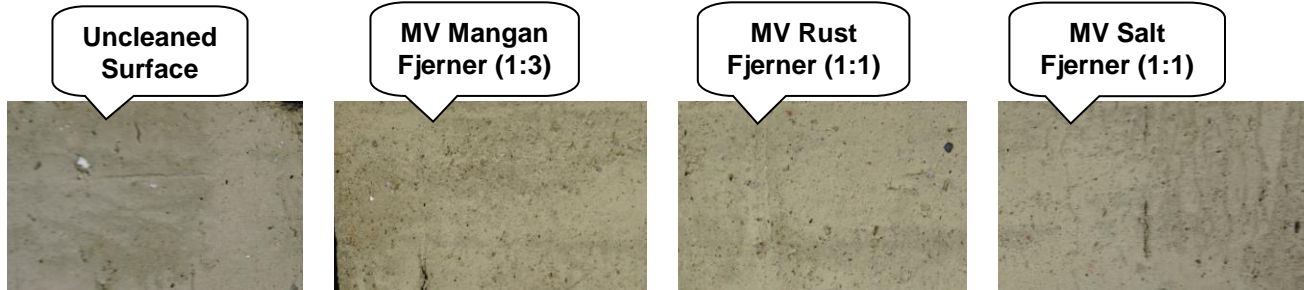
**"D190" Brick After Testing**

Name: "D190" Brick					
Product	Dilution	Surface Finish Removal	Substrate Deterioration	Color Change	Staining
MV Mangan Fjerner	1:3	0	0	0	0
MV Rust Fjerner	1:1	0	0	0	0
MV Salt Fjerner	1:1	0	0	0	0

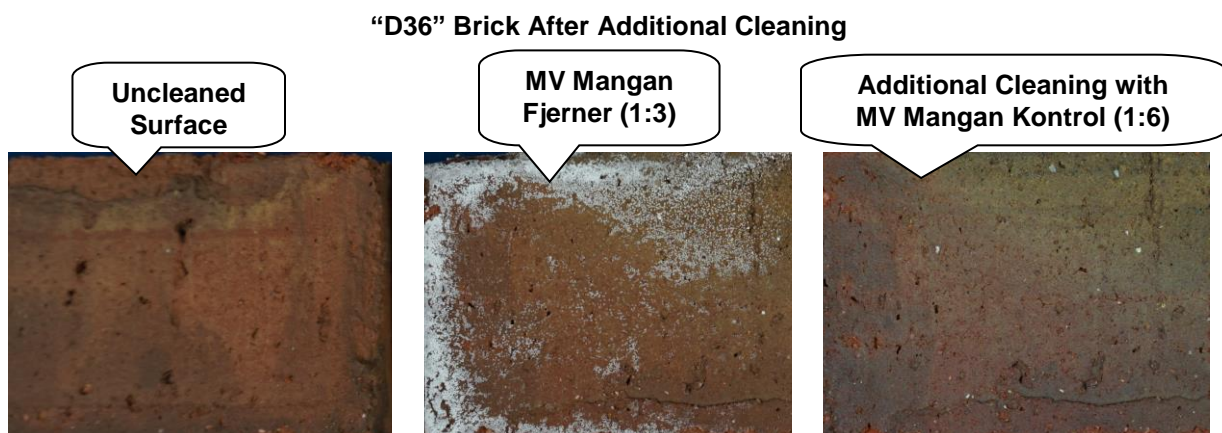
MV Mangan Fjerner occasionally resulted in a white haze (stain) forming on the surface of some of the samples. MV Mangan Kontrol diluted with six parts water was tested in order to determine if it would remove this white haze. MV Mangan Kontrol was successful in removing the white haze completely as seen in the photograph below.

It is recommended that the selected stain removal product always be used in the lowest possible concentration.
