From the Ashes

PROSOCO and Project Phoenix

‘Classic’ cleaner cleans classic brick building

New product line solves concrete cleaning problems

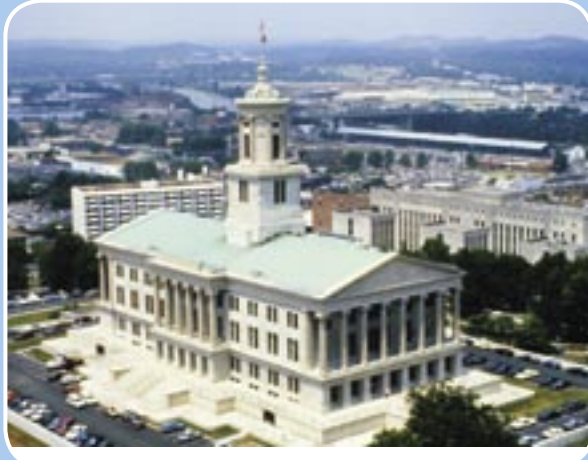
The architect who designed this southern structure in the mid-1840s is entombed within its walls. He took to his grave the secret of the location of the building's cornerstone. It has never been located. In 1987, workers used one ton of Sure Klean® Marble Poulitice to strip away decades of smoke, pollution and other grime from the locally quarried gray-blue interior limestone walls.

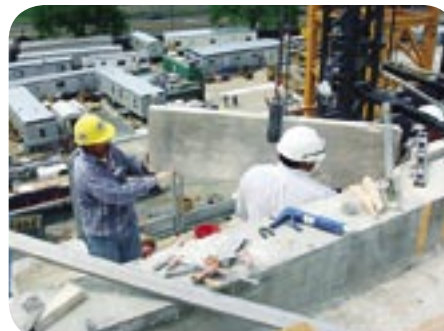
Workers attach a limestone panel to the concrete exterior of the Pentagon's E-ring.

By April, MasonryArts workers were putting the stone back on the poured concrete walls, both salvaged stone and newly quarried replacement stone, trucked in from Indiana.

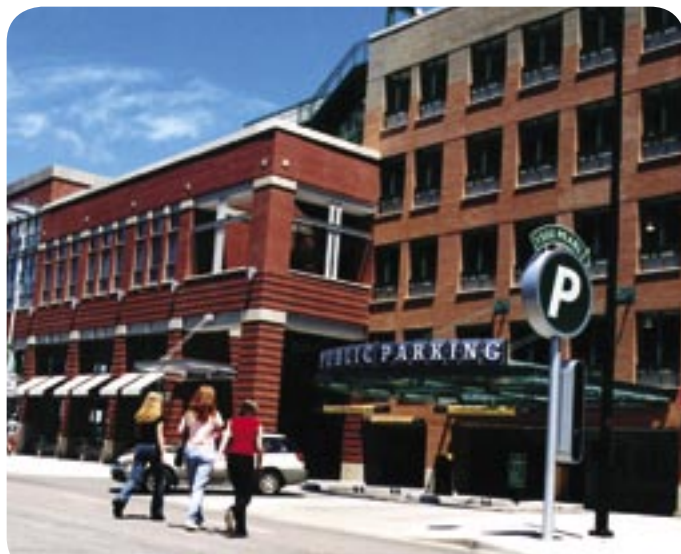
Central Masonry used PROSOCO's “classic” Sure Klean® 600 Detergent for post-construction clean down of this Boulder, Colorado, parking structure. The building adjoins Pearl Street Mall, an historic preservation area.

Masonry contractor Central Masonry of Littleton, Colo., used PROSOCO's “classic” brick cleaner—Sure Klean® 600 Detergent—for post-construction cleandown of the brick and limestone facades.

The Central Masonry crew used brushes to apply and agitate the cleaner on the wet bricks. They pressure-washed the spent cleaner and dissolved mortar and dirt off the brick.

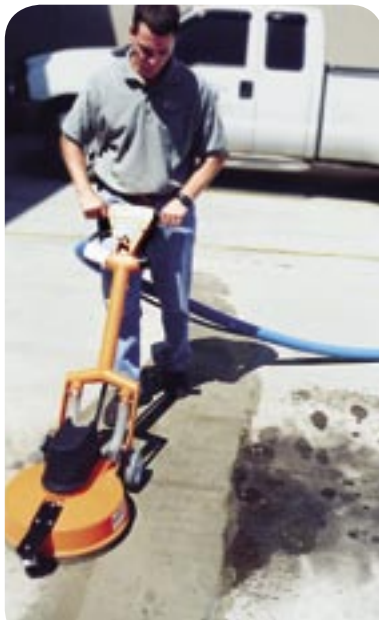
Jeff Plumlee, general manager of ConcreteScience® of Kansas, uses vacuum extraction to rid concrete of deeply embedded oil and grease stains after pretreatment with a PROSOCO product.

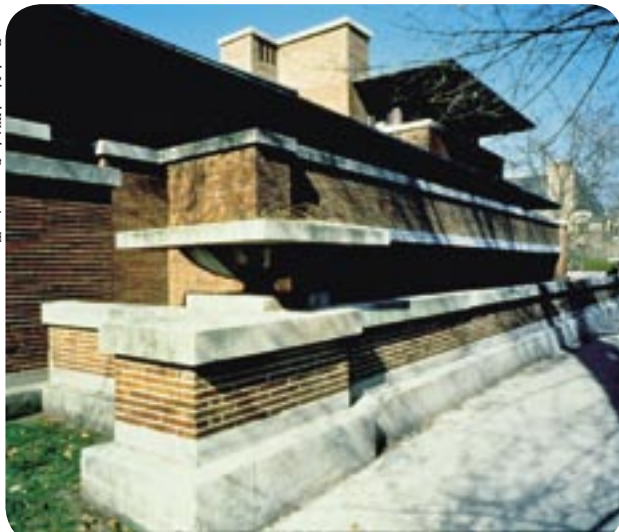
Frank Lloyd Wright's Robie House—Early 20th Century "coal-age" soiling was removed in the late 20th Century with PROSOCO restoration products.

Mr. Zuidema and his crew used Sure Klean® 766 Limestone & Masonry Prewash followed by Sure Klean® Limestone & Masonry Afterwash to hand-clean the brick using brushes and buckets. The 766, an alkaline gel, breaks up contaminants for rinsing away. The mildly acidic Afterwash pH-neutralizes and brightens the cleaned surface.

The protection included plastic sheeting, tape, and silicon spray. To avoid wind drift, workers brushed on rather than sprayed the brown bricks with Sure Klean® Restoration Cleaner. They let the cleaner dwell two to three minutes.
